## HISTORIC PRESERVATION BOARD

City Hall – 1<sup>st</sup> Floor Board Room, 510 N. Baker Street, Mount Dora, FL  
May 24, 2023 at 3:00 PM

**RE:** **Tab 1 - Certificate of Appropriateness; 1010 N Tremain (Location); Remove and Replace Four Aluminum Windows with Vinyl Windows and Expand Three of the Window Openings (Request); Carolyn L. Phillips (Owner); Windows Plus, C/O David Keaton (Applicant).**

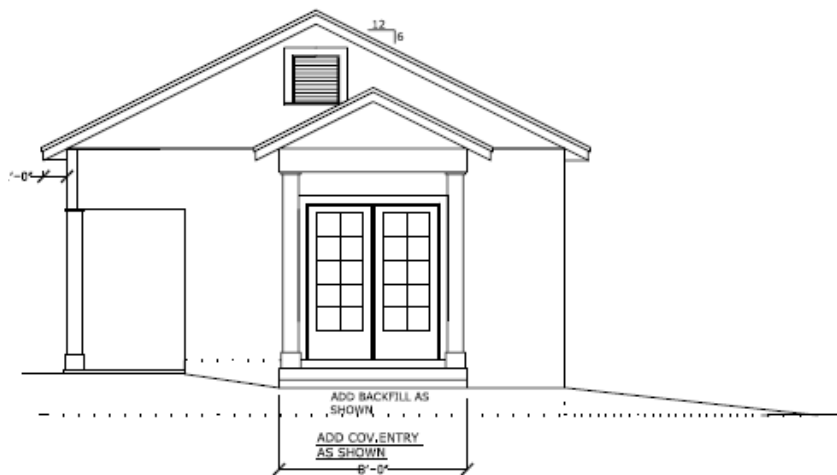
**FRONT ELEVATION**

Pressure treated lumber construction.  
Stem wall with masonry steps and slab  
Asphalt shingle to match main home  
Wood lap siding/Repair to match existing

**(PROPOSED) ELEVATIONS**

1. Expand window openings on the western façade and replace with a door;
2. Construct a covered entry for the western entry with wood columns;
3. Decrease door opening on southern elevation and replace with windows;
4. Remove patio and steps on southern elevation (existing entrance);
5. Repair and/or replace wood lap siding as needed;
6. Reroof with architectural shingles; and
7. Remove and replace either (8) wood windows with vinyl windows.
