**HISTORIC PRESERVATION BOARD**  
**City Hall – 1<sup>st</sup> Floor Board Room, 510 N. Baker Street, Mount Dora, FL**  
**June 28, 2023 at 3:00 PM**

**AGENDA**

**CITY OF  
MOUNT DORA, FLORIDA  
HISTORIC PRESERVATION May  
BOARD  
MINUTES**

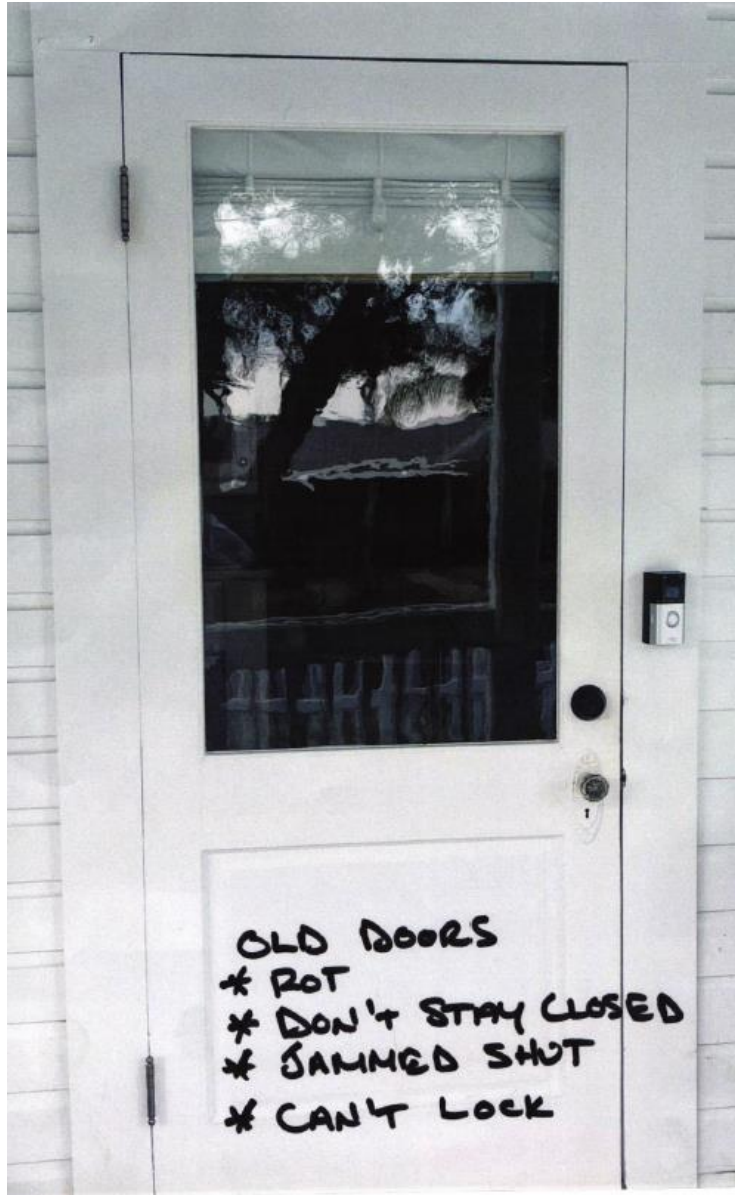
Existing Wood Door

The Applicant is seeking to replace four (4) wood doors with fiberglass and composite doors because the existing doors do not stay closed and are rotted. The proposed doors are the same style of the existing doors. Under Standard 2, doors and entrances and associated detailing should be preserved. Replacement doors should either match the original - under Standard 6 or substitute new materials and designs sympathetic to the original under Standard 9. Under Standard 3 historic doors that do not match the composition and stylistic details of the building or missing door should not be substituted. The Applicant contends that the existing wood doors are rotted. If the doors cannot be repaired and the doors are deteriorated, the proposed replacement door is the same style and would satisfy the guidelines.

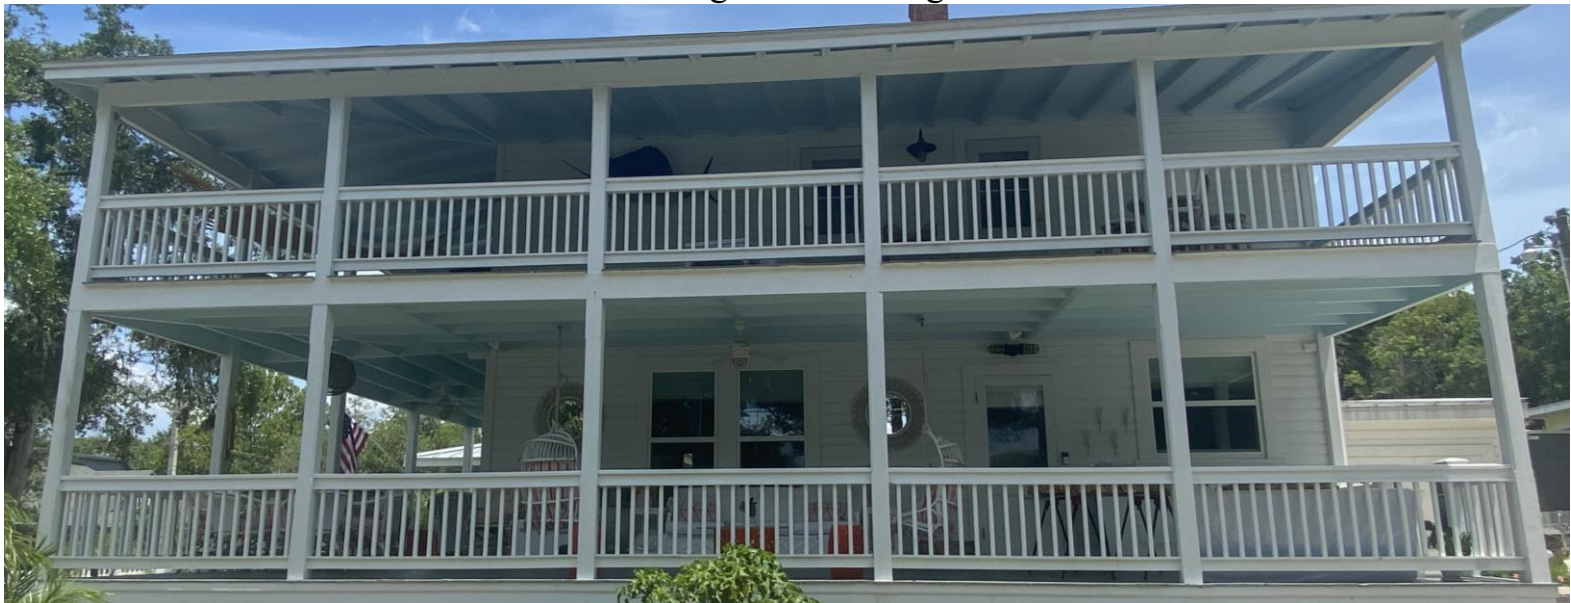
Existing Wood Railings:

The Applicant is also seeking to remove the existing wood porch and wood railings due to rot and replace the porch with a wood alternative and PVC railings. The Applicant included three possible options for railings in the submittal, one of which matches the style of the existing railing. The guidelines state that rehabilitation efforts should avoid removing an entire wood feature that is unrepairable and not replacing it; or replacing it with a new feature that does not convey the same visual appearance.

1. The replacement railings should match the style of the existing railings (option 3).
2. The steps should include railings matching the replacement railings on the porch, similar to the former wood steps.

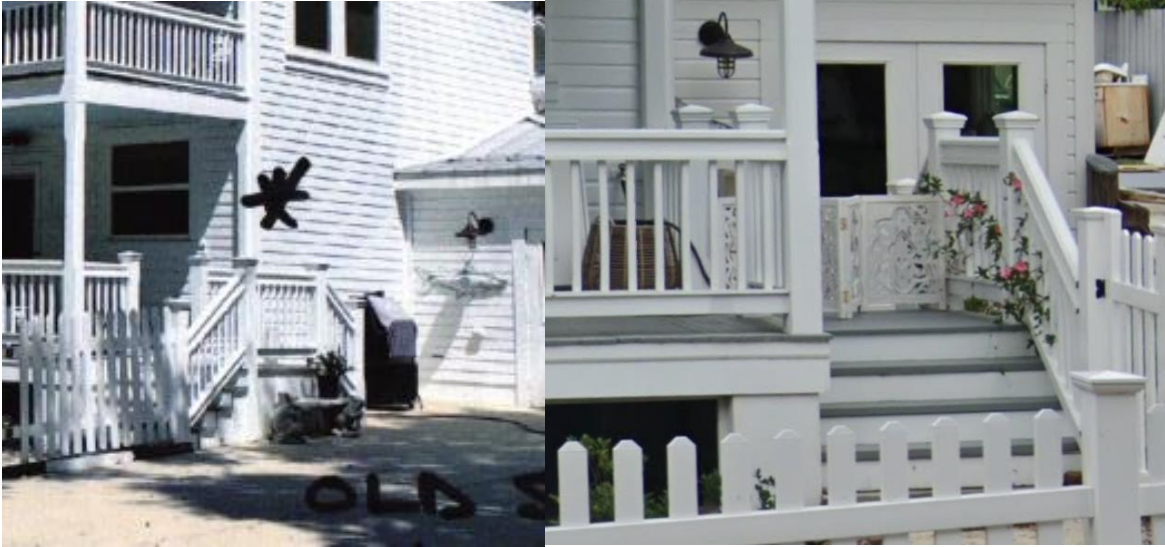
Rear Wood Steps

**Remove wood stairs on front and back of house and replace with concrete stairs with brick veneers and slate stair treads**

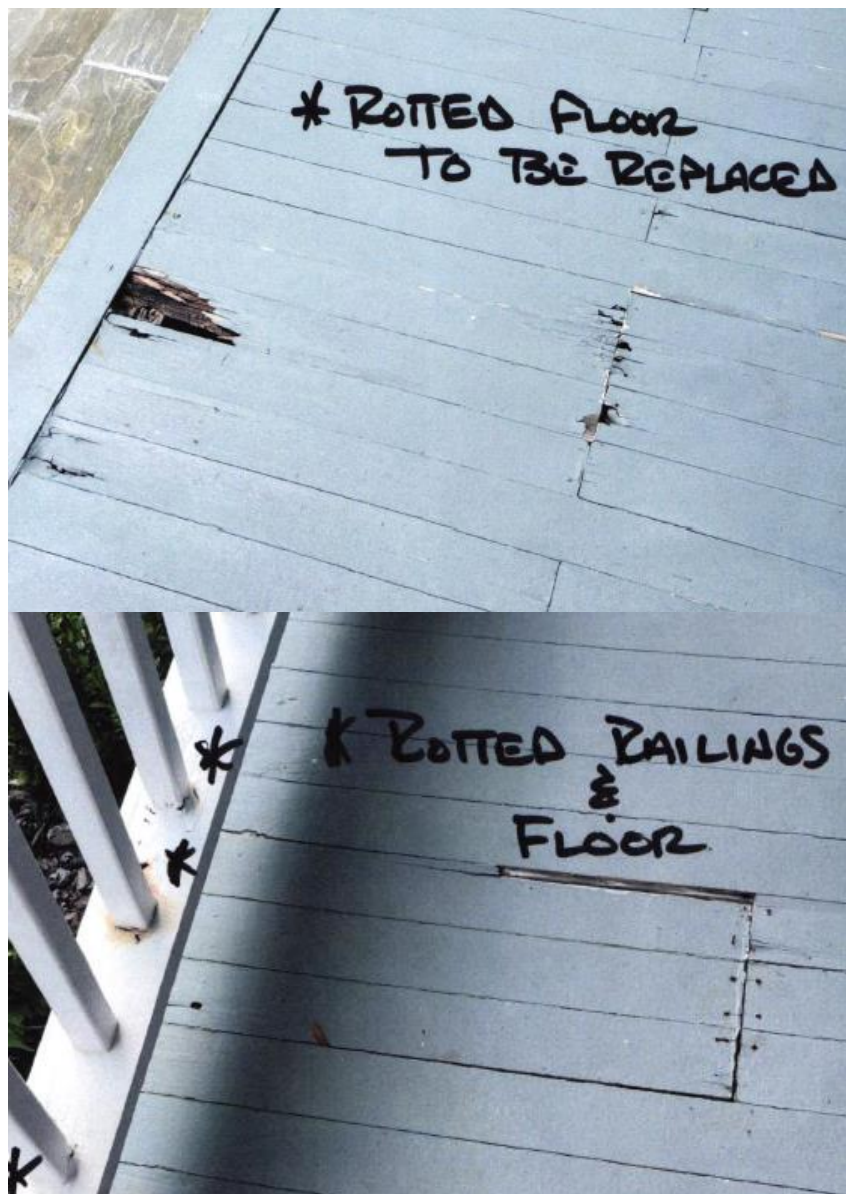
Current Wood Porch

Full Description of Proposed Alteration(s) or Construction including materials; please attach additional documentation if needed: REPLACE DOWNSTAIRS & UPSTAIRS PORCH FLOORS & RAILINGS WITH A WOOD ALTERNATIVE BECAUSE OF ROT.

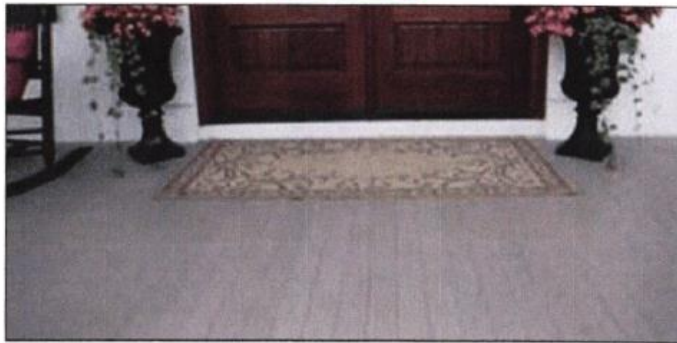
**\* PORCH FLOORING**

Tongue and groove installation with a slight crack between boards... just like wood porch flooring! Wood grain surface is almost impossible to distinguish from wood porch decking.

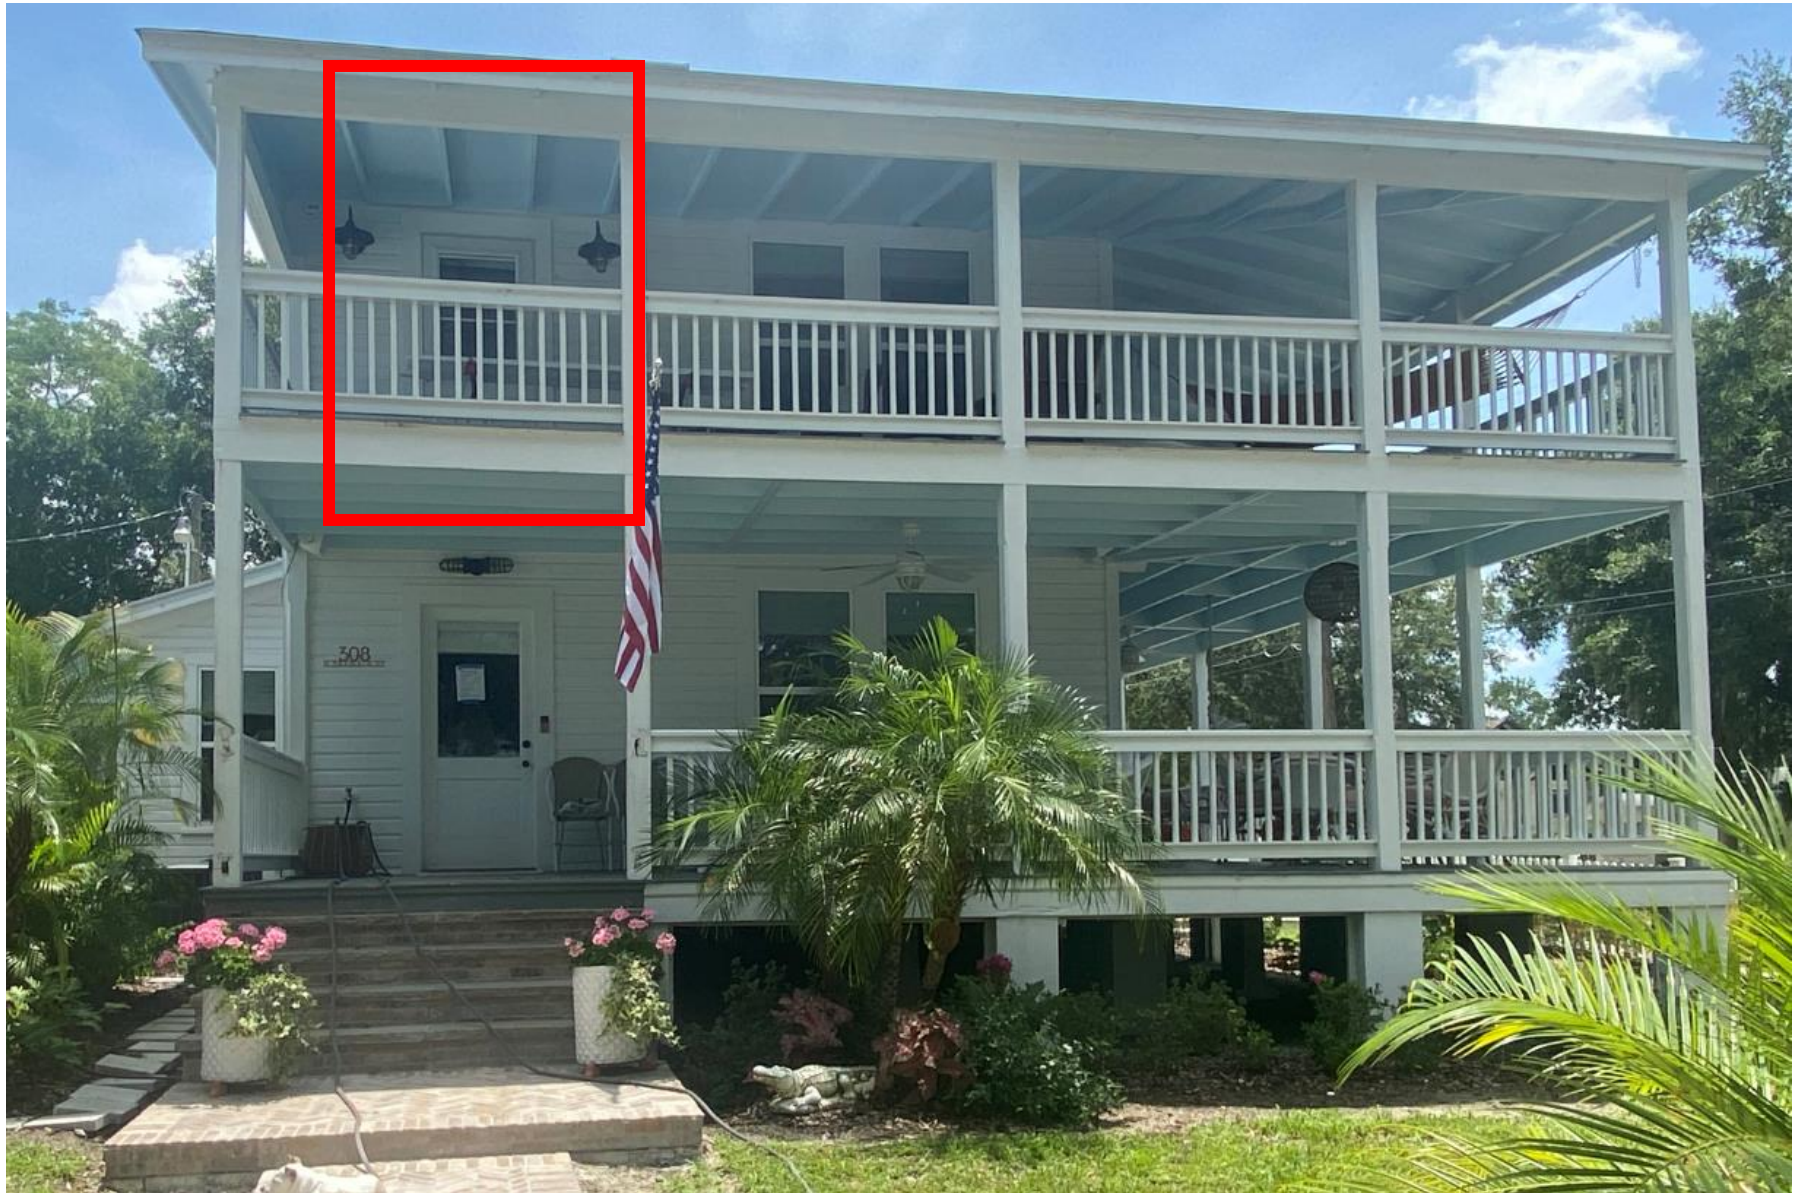
Current Door to be replaced with a vinyl window matching the size of the existing windows

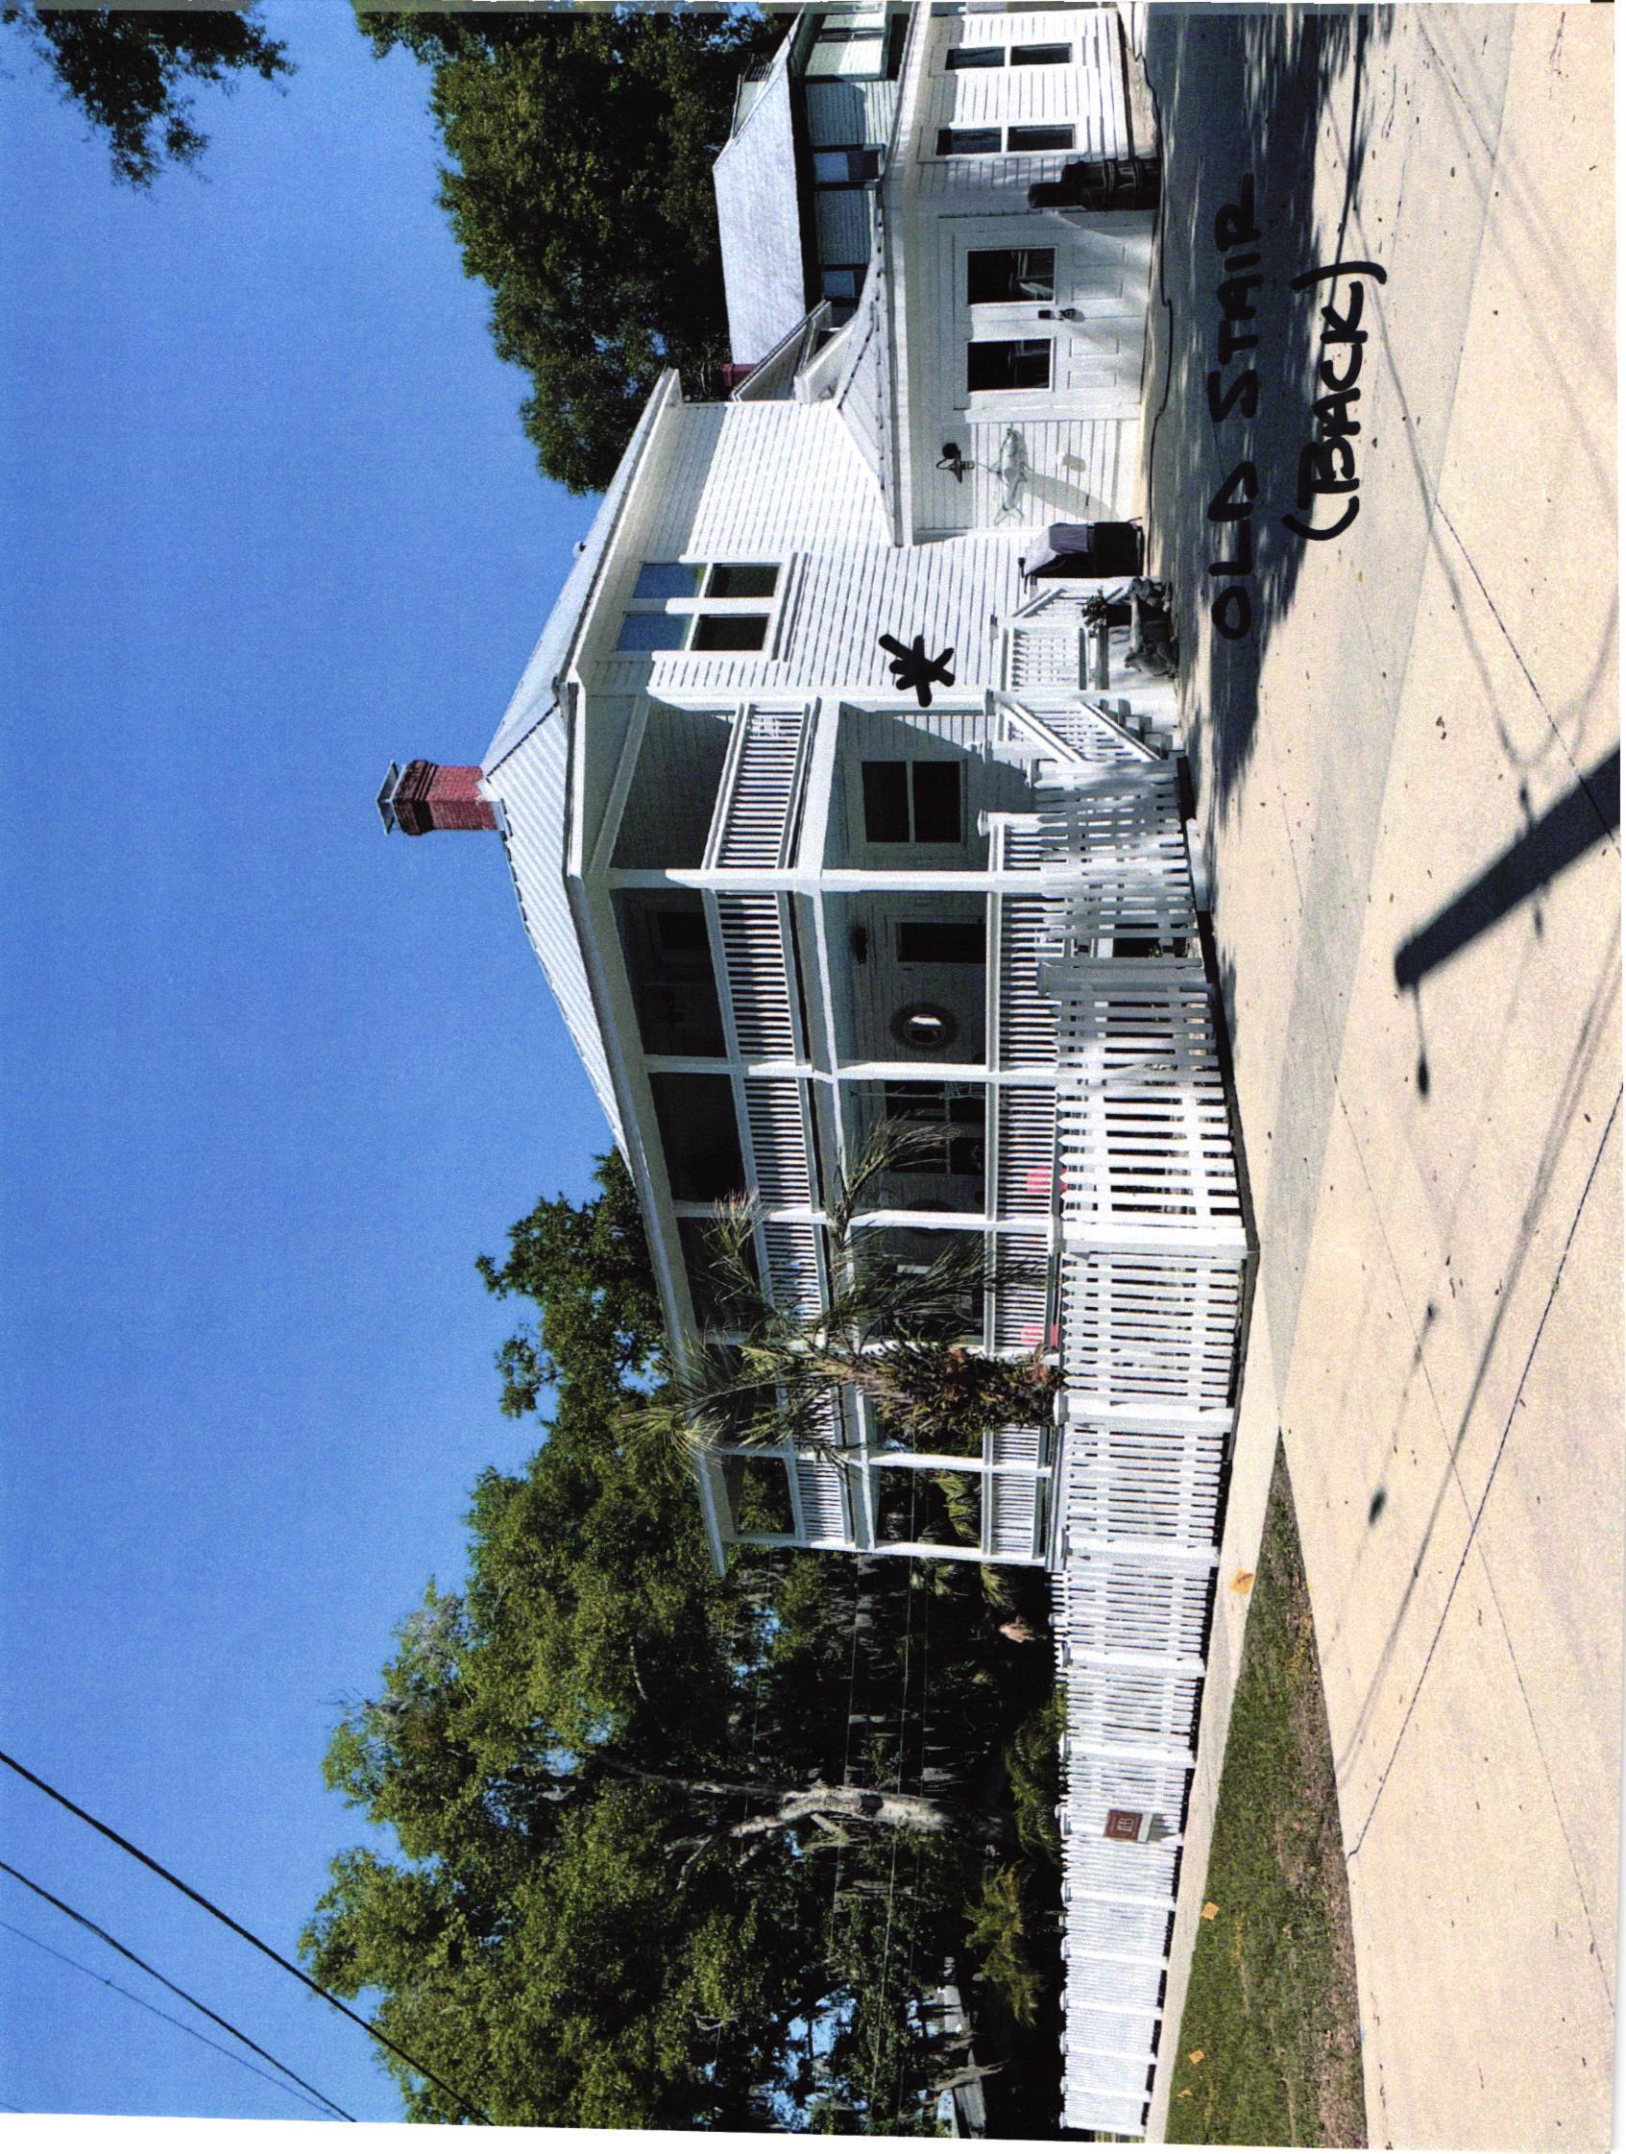
OLD STAIR  
(BACK)

The previous wood steps in the front and rear of the residence have been removed and replaced with concrete stairs with brick veneers and the Applicant is seeking approval of this after-the-fact work. The new stairs do not have railings like the former wood stairs. The guidelines state that rehabilitation efforts should avoid resurfacing frame buildings with new material that is inappropriate or was unavailable when the building was constructed such as artificial stone, brick veneer, asbestos or asphalt shingles, rustic shakes, and vinyl or aluminum siding.

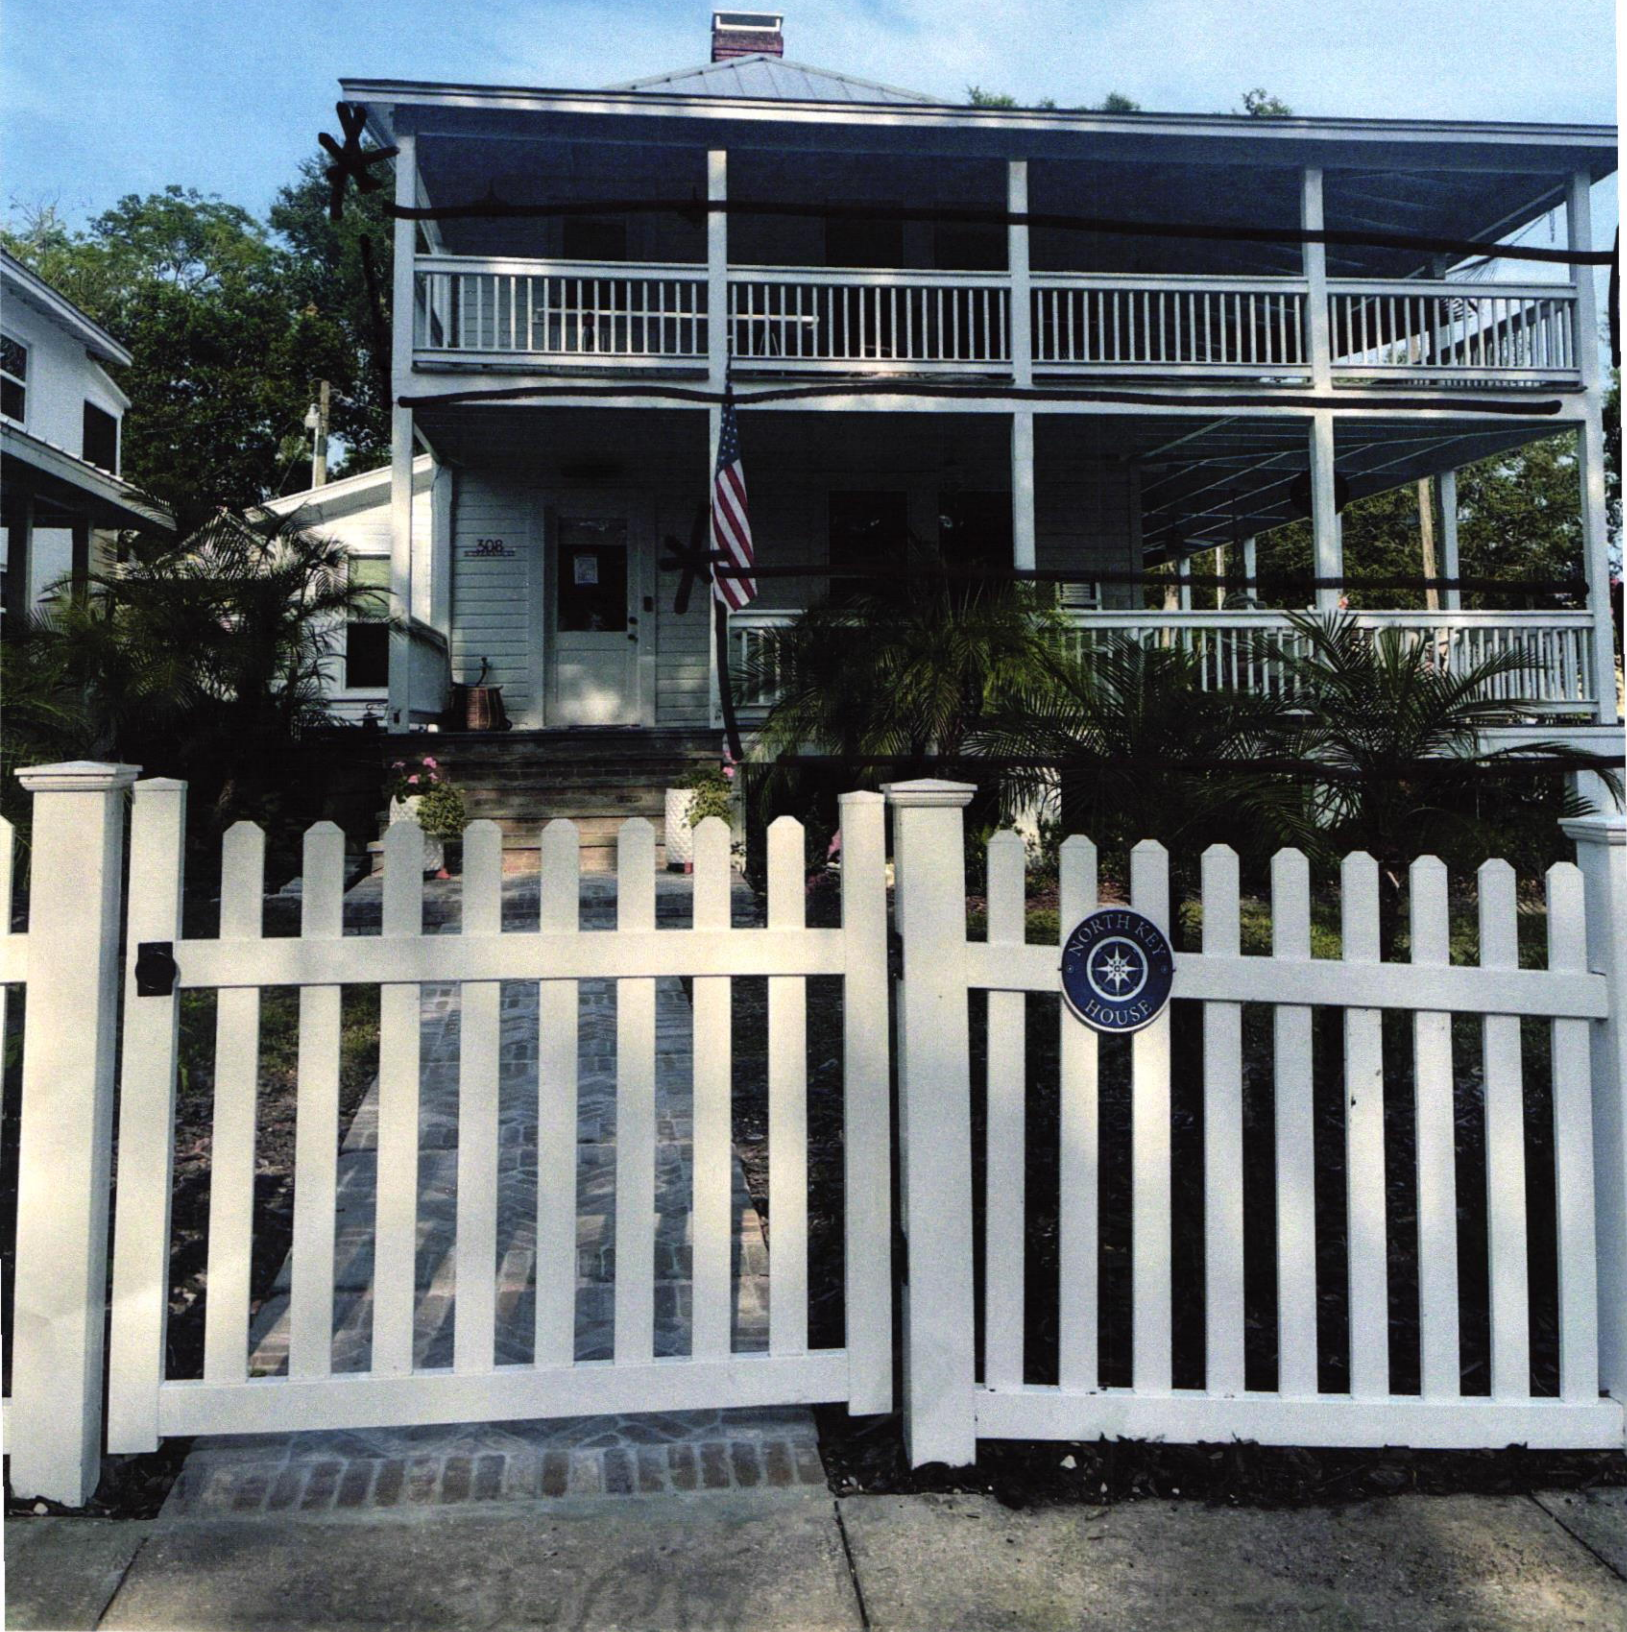
\* NEEDS REPLACING  
\* ROT

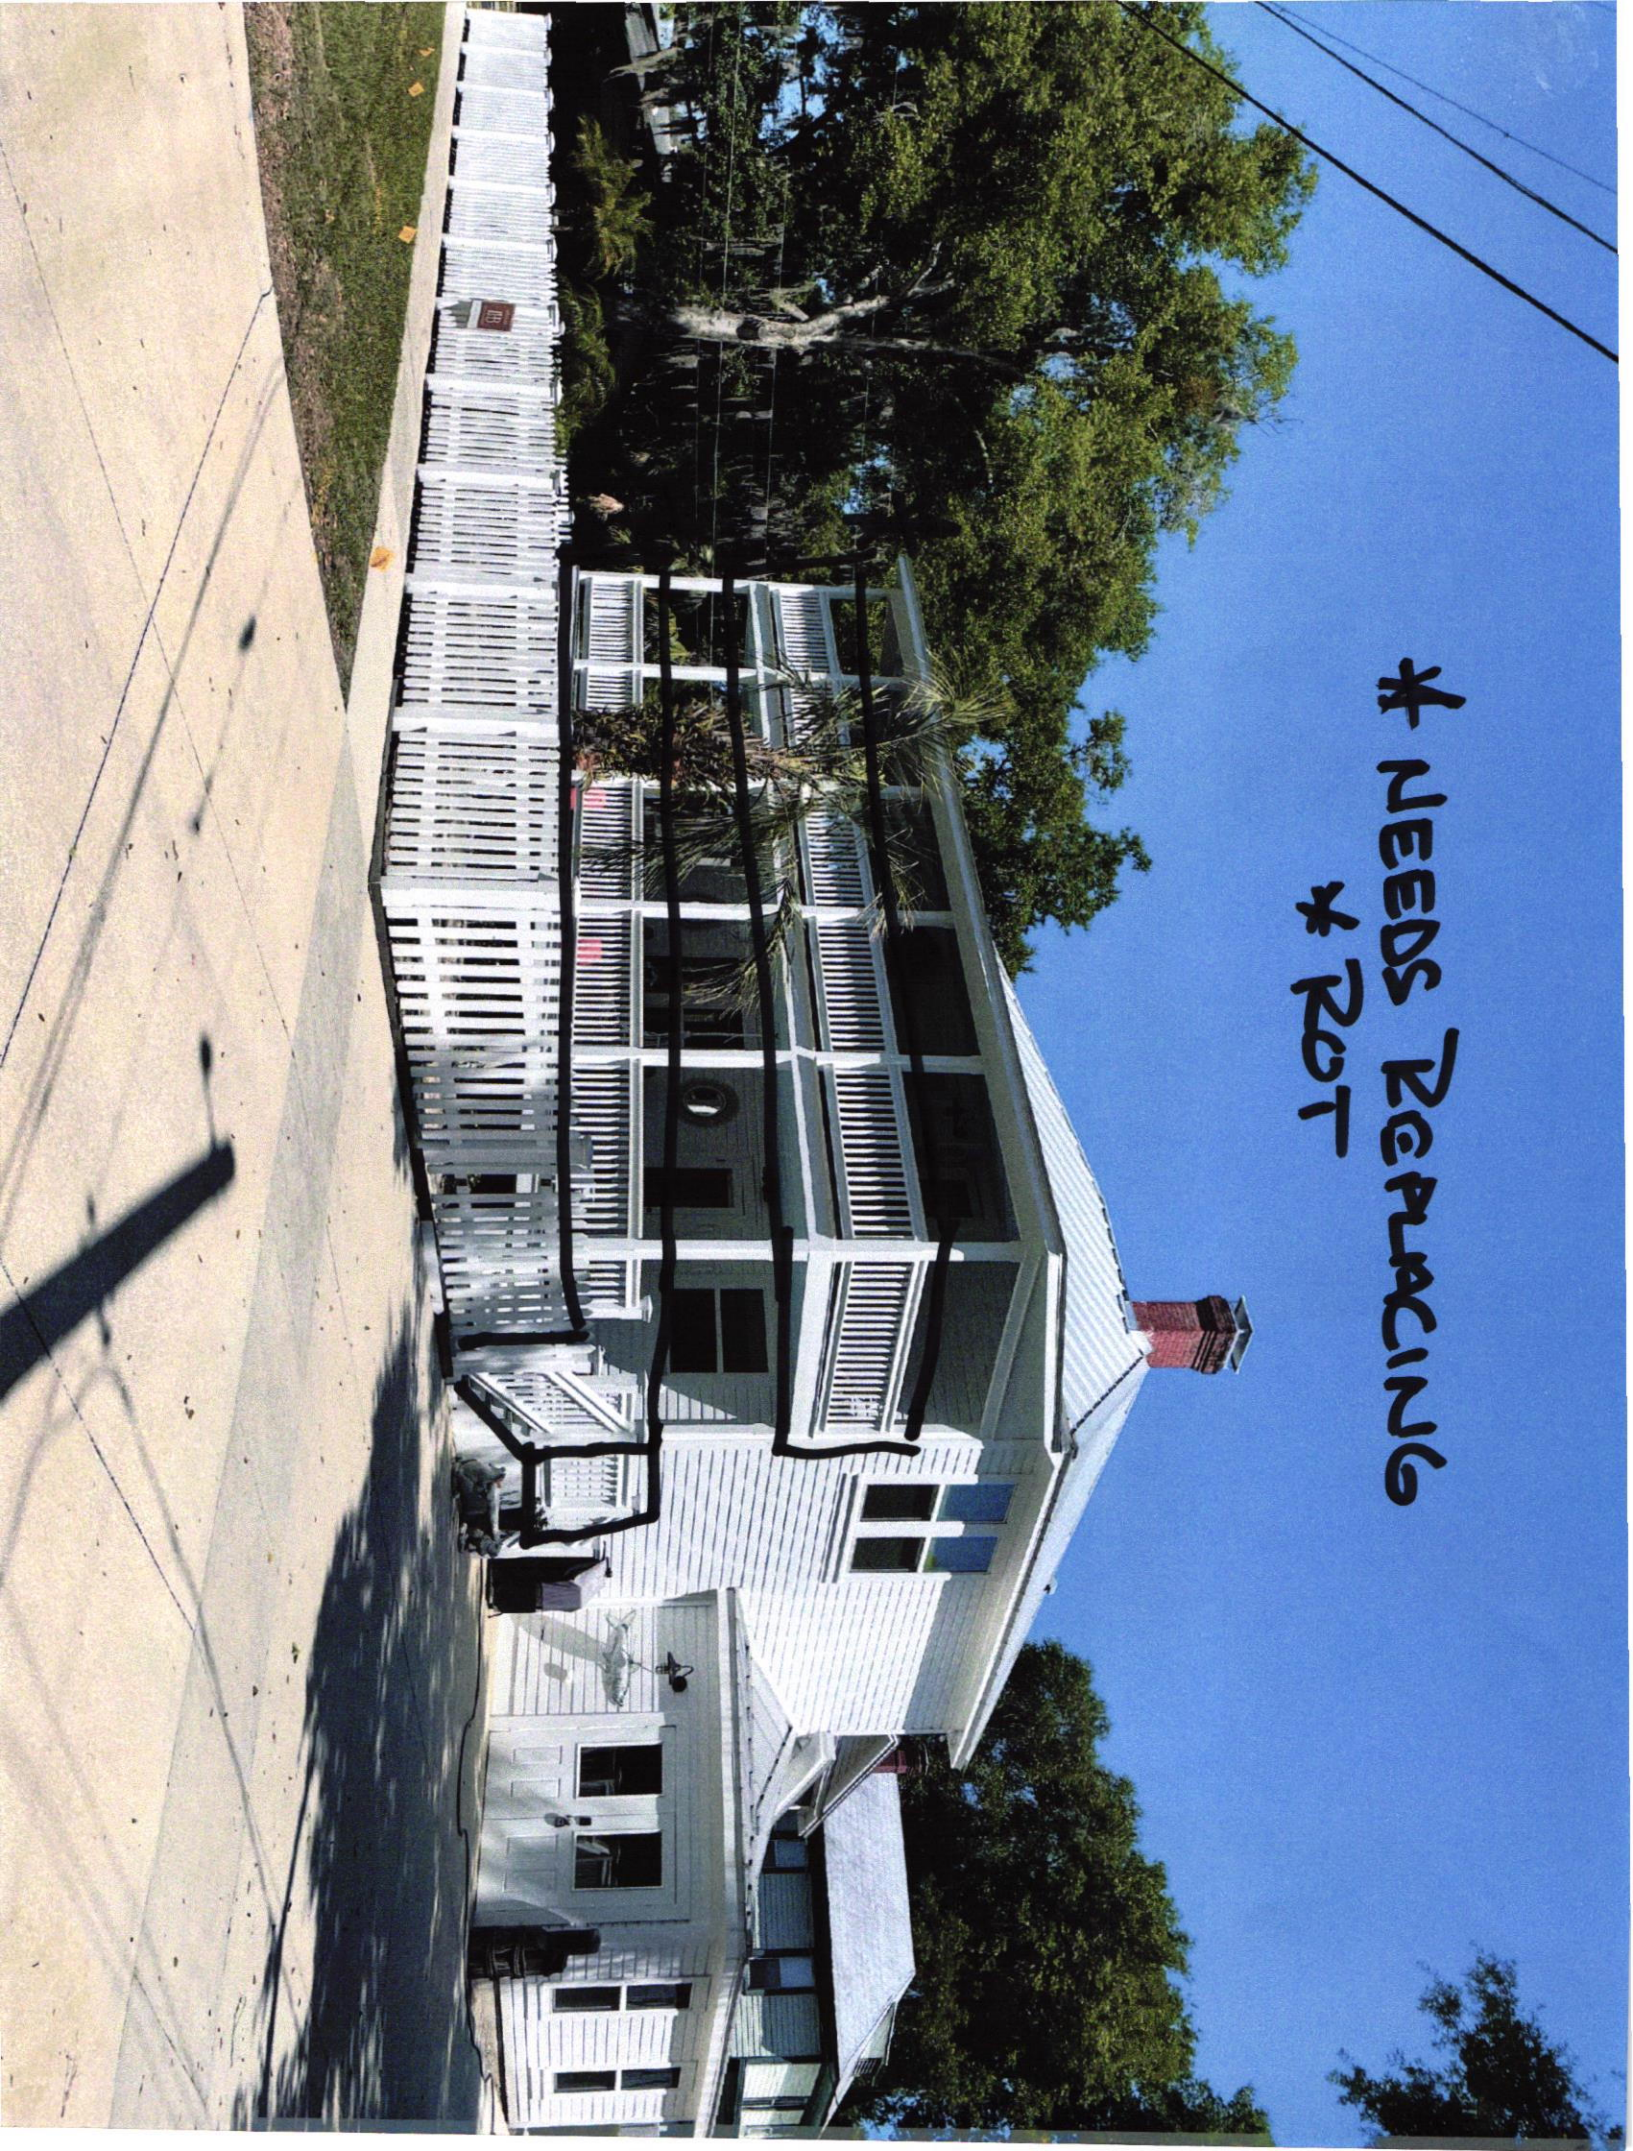
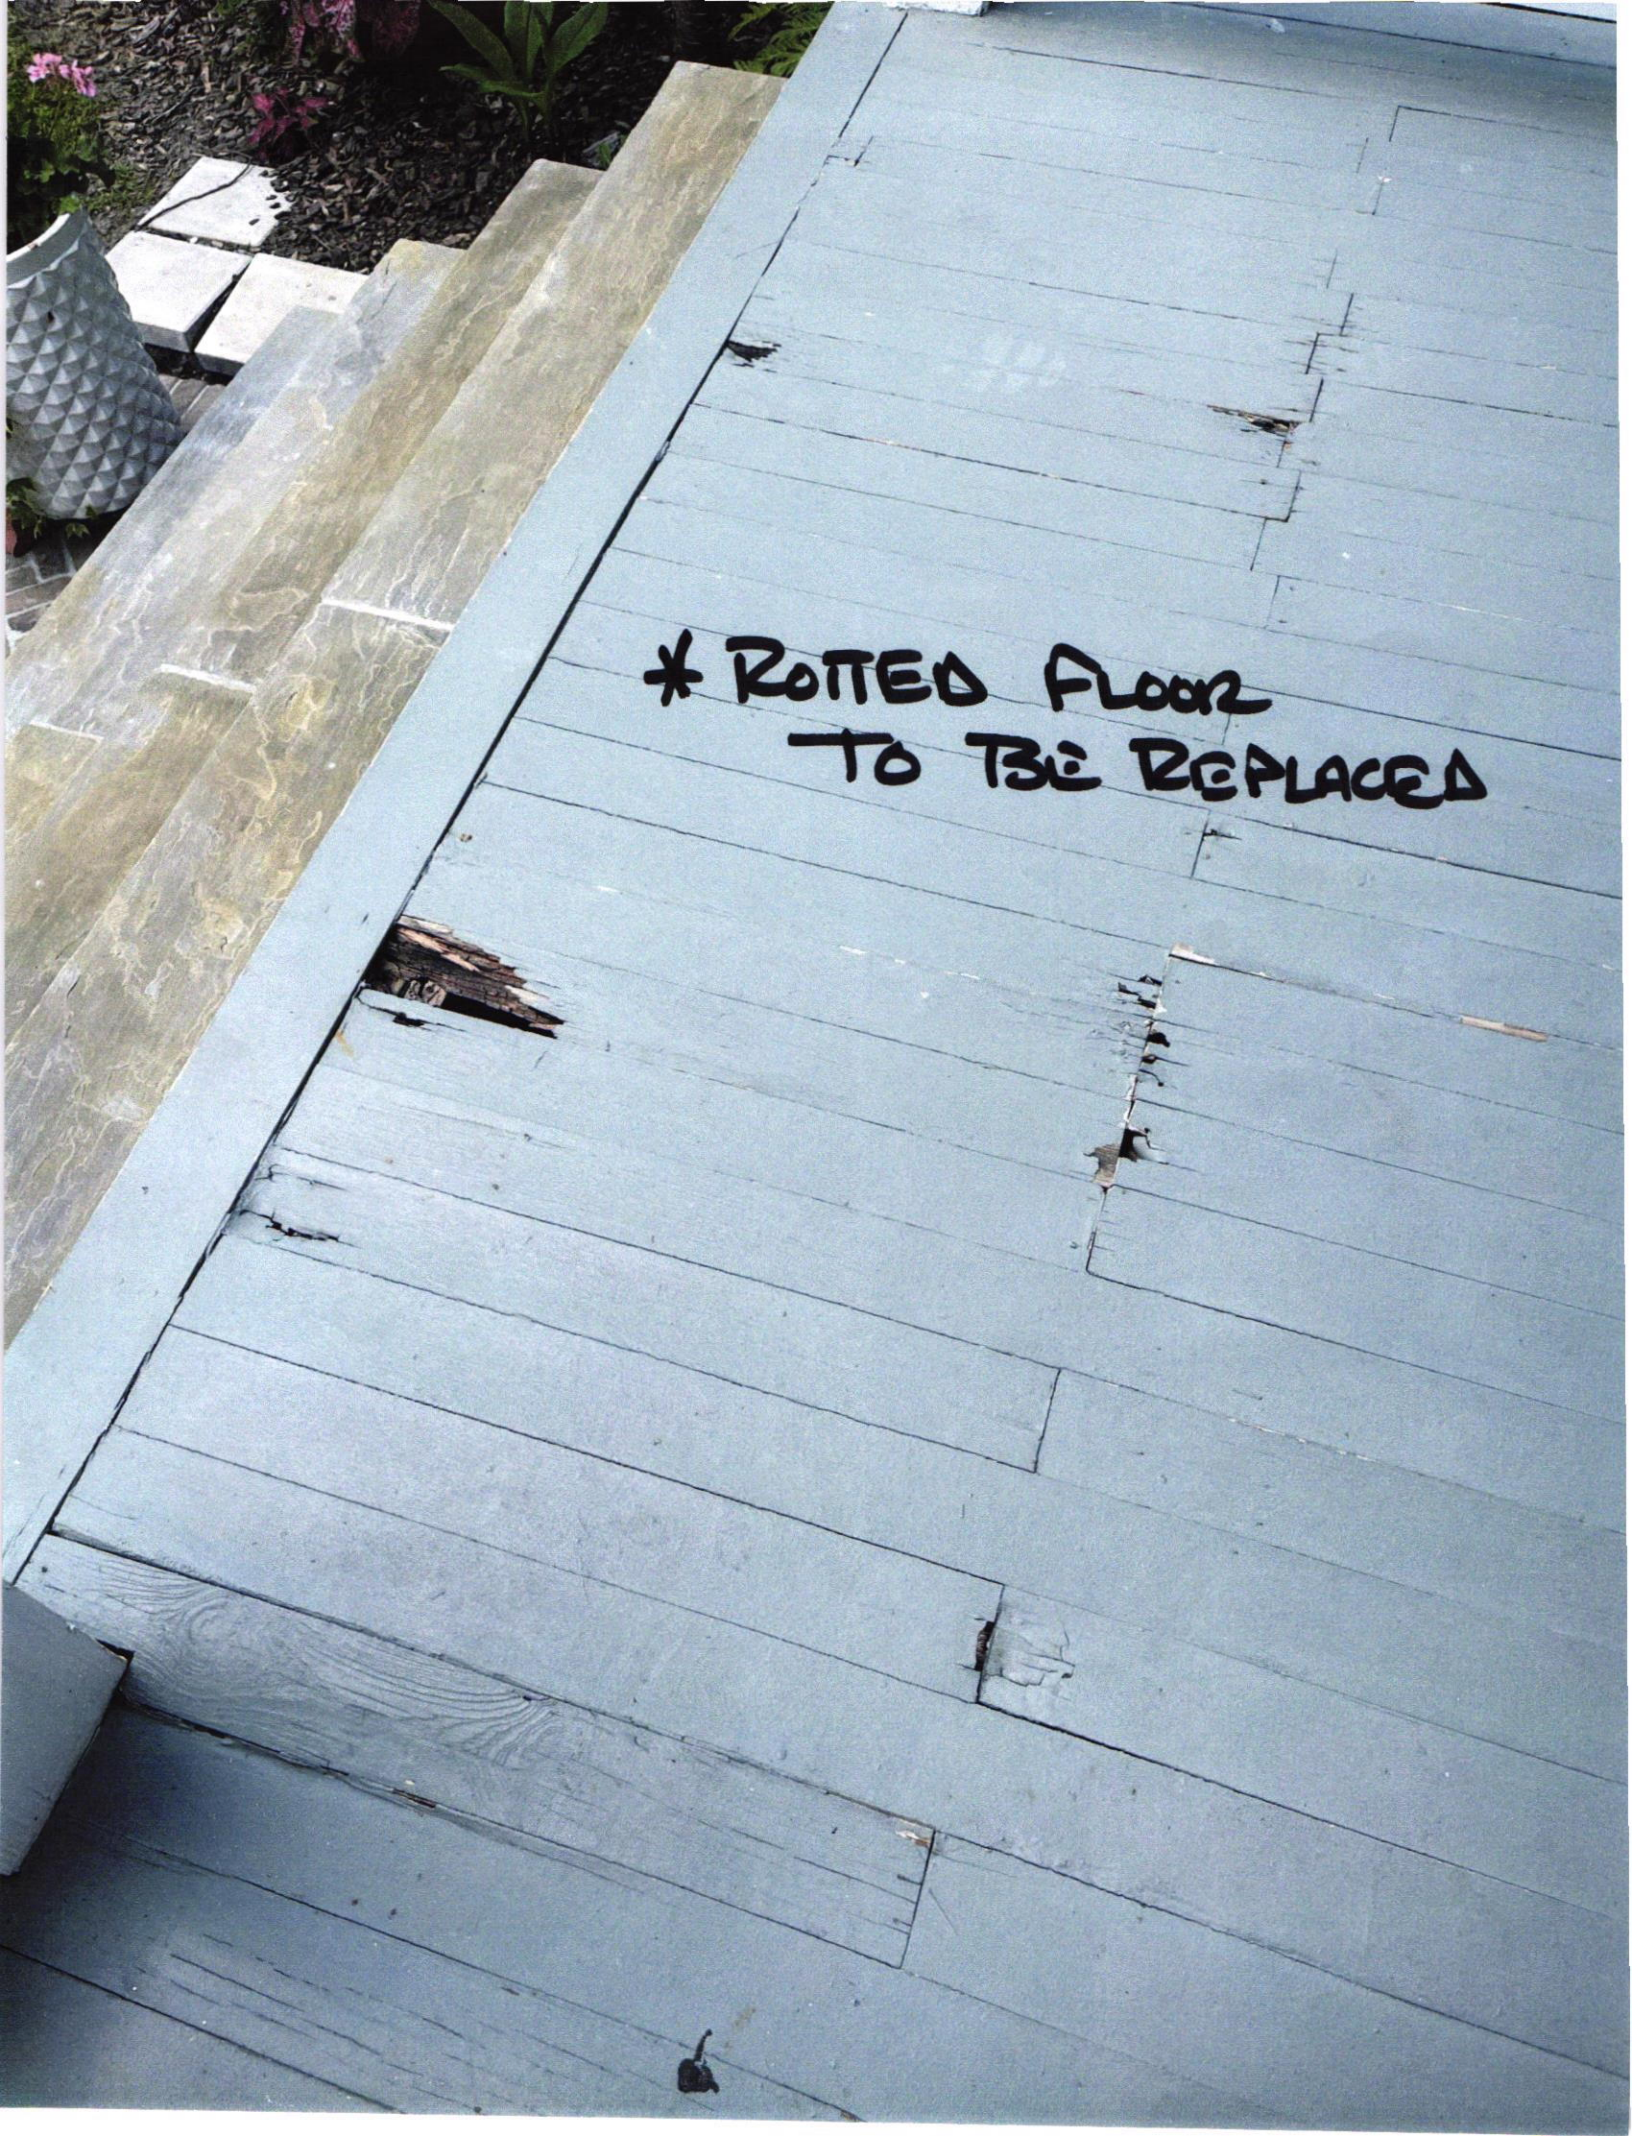
\* NEEDS REPAIRING  
\* ROT

\* ROTTED FLOOR  
TO BE REPLACED

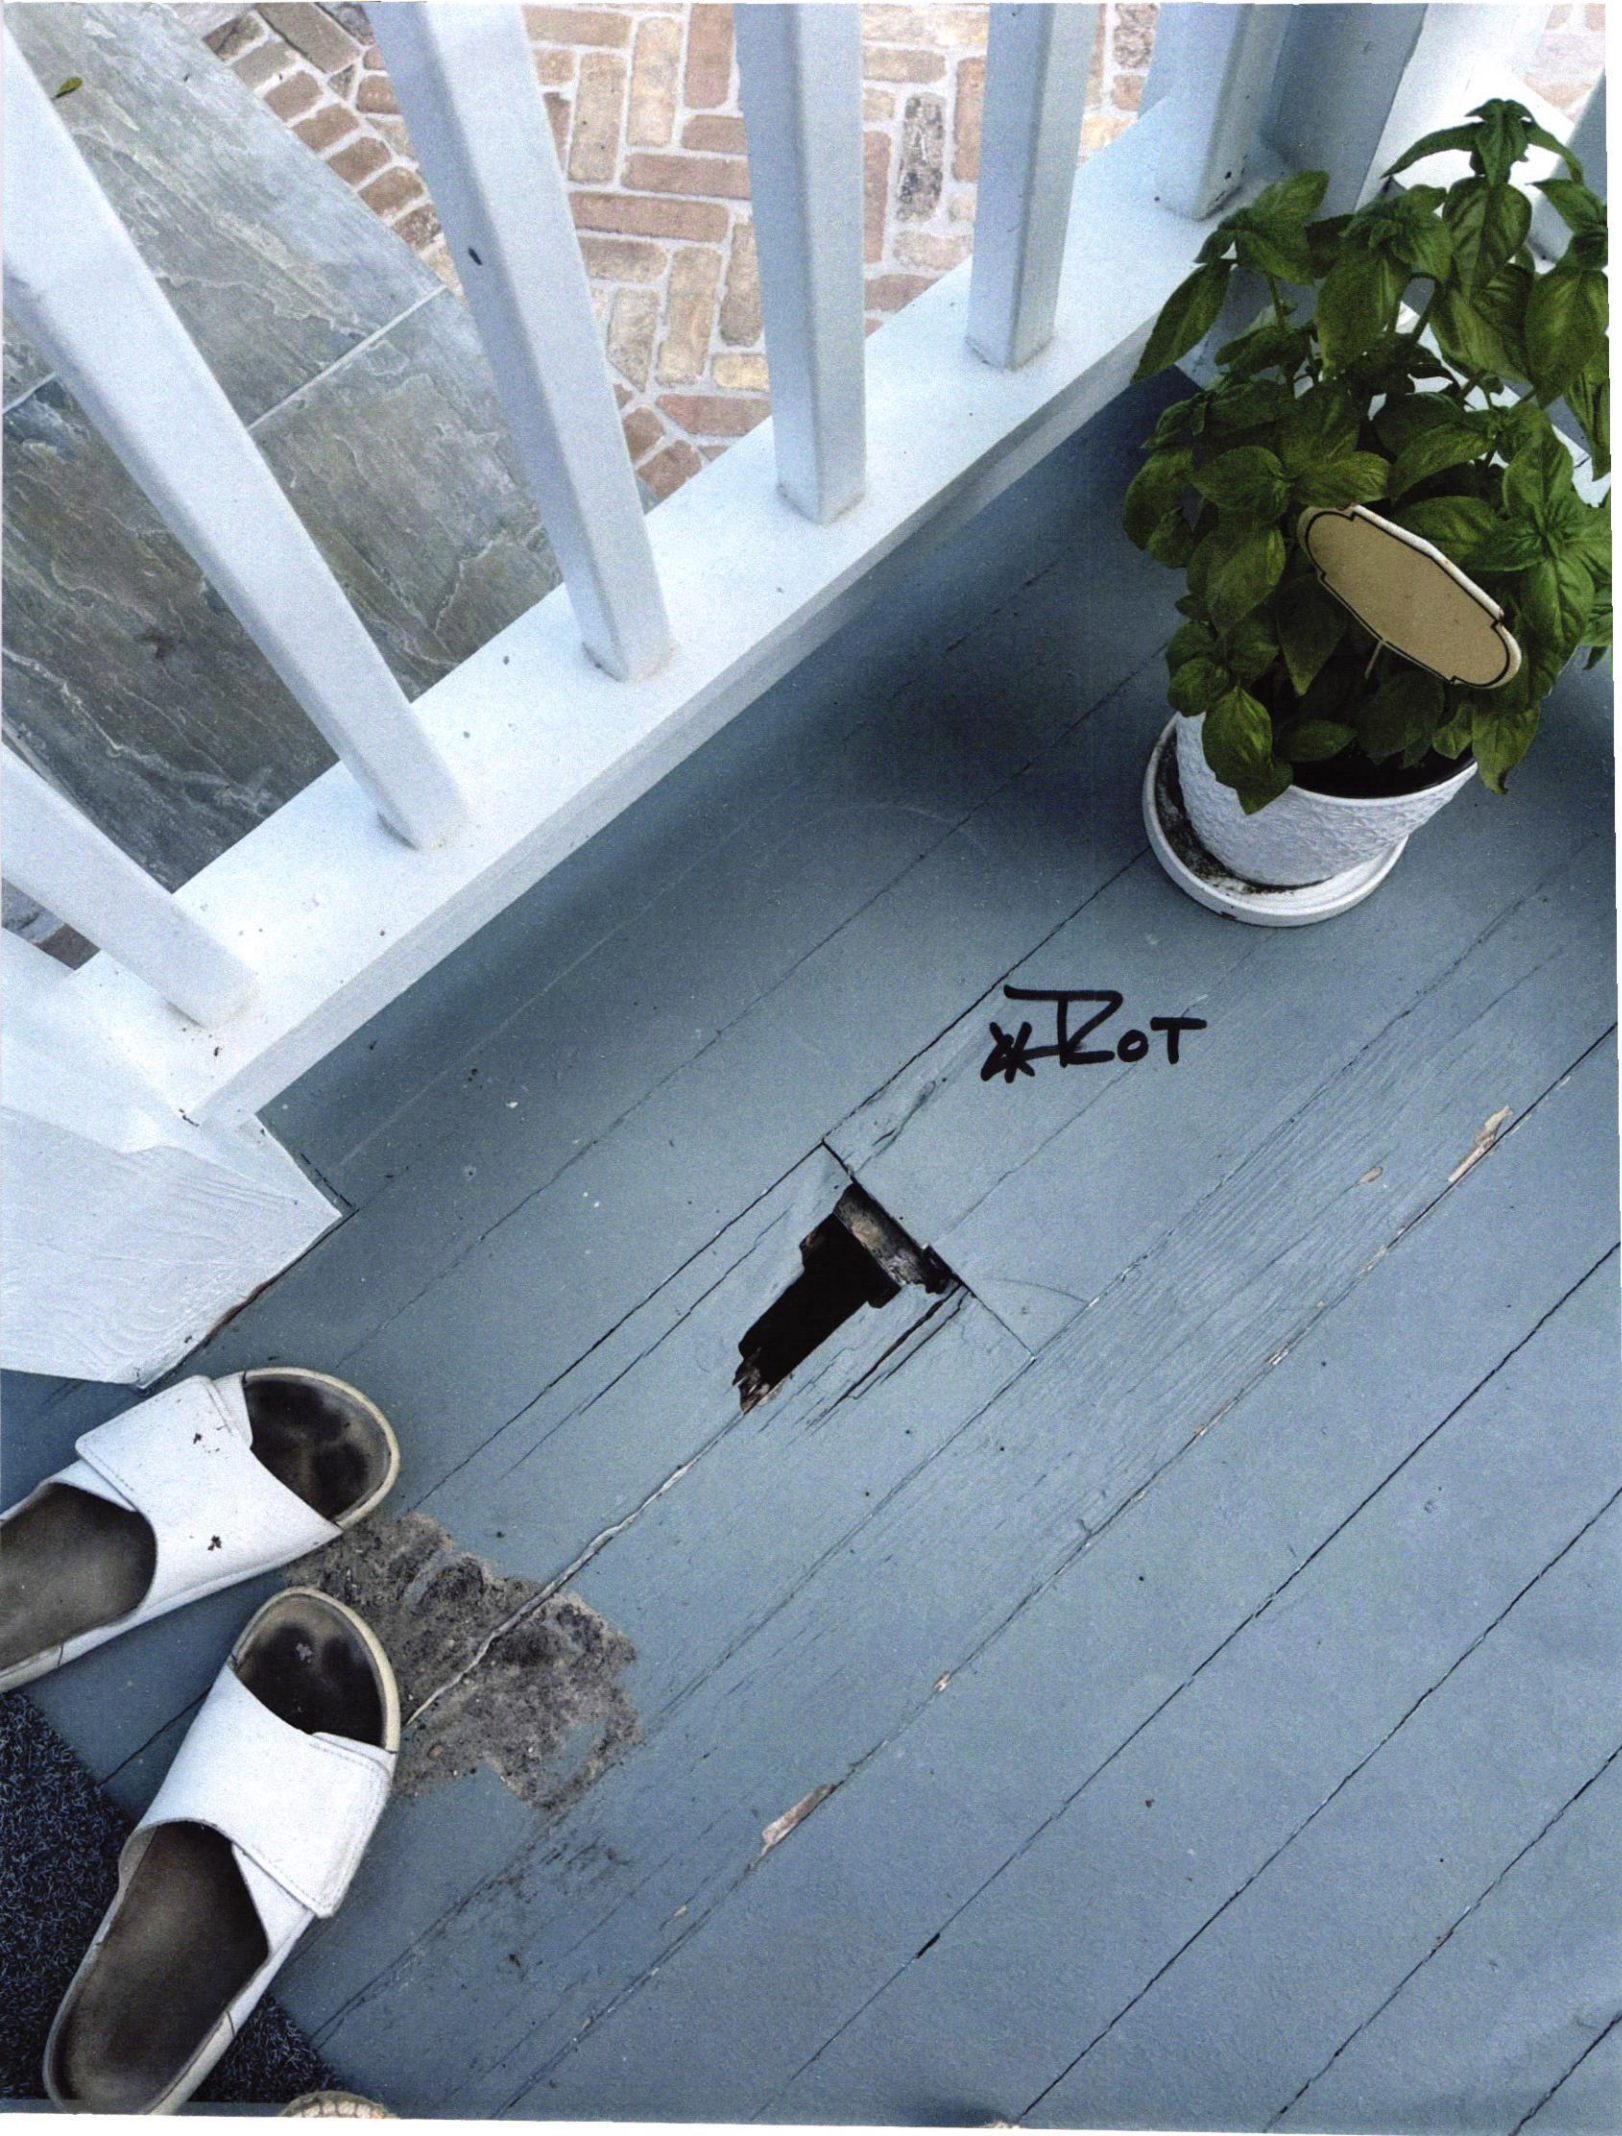
\* ROTTED RAILINGS  
&  
FLOOR

ROT
