**HISTORIC PRESERVATION BOARD**  
**City Hall – 1<sup>st</sup> Floor Board Room, 510 N. Baker Street, Mount Dora, FL**  
**June 28, 2023 at 3:00 PM**

**AGENDA**

**CITY OF  
MOUNT DORA, FLORIDA  
HISTORIC PRESERVATION May  
BOARD  
MINUTES**

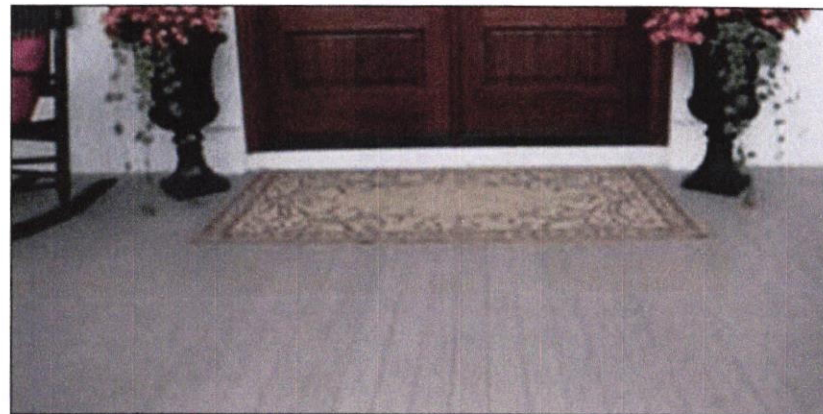
**\*PORCH FLOORING**

**Size:** 1" thick x 3-3/8" wide, including tongue. Installed width is approximately 3-3/16".

**Tongue and groove installation** with a slight crack between boards... just like wood porch flooring! Wood grain surface is almost impossible to distinguish from wood porch decking.

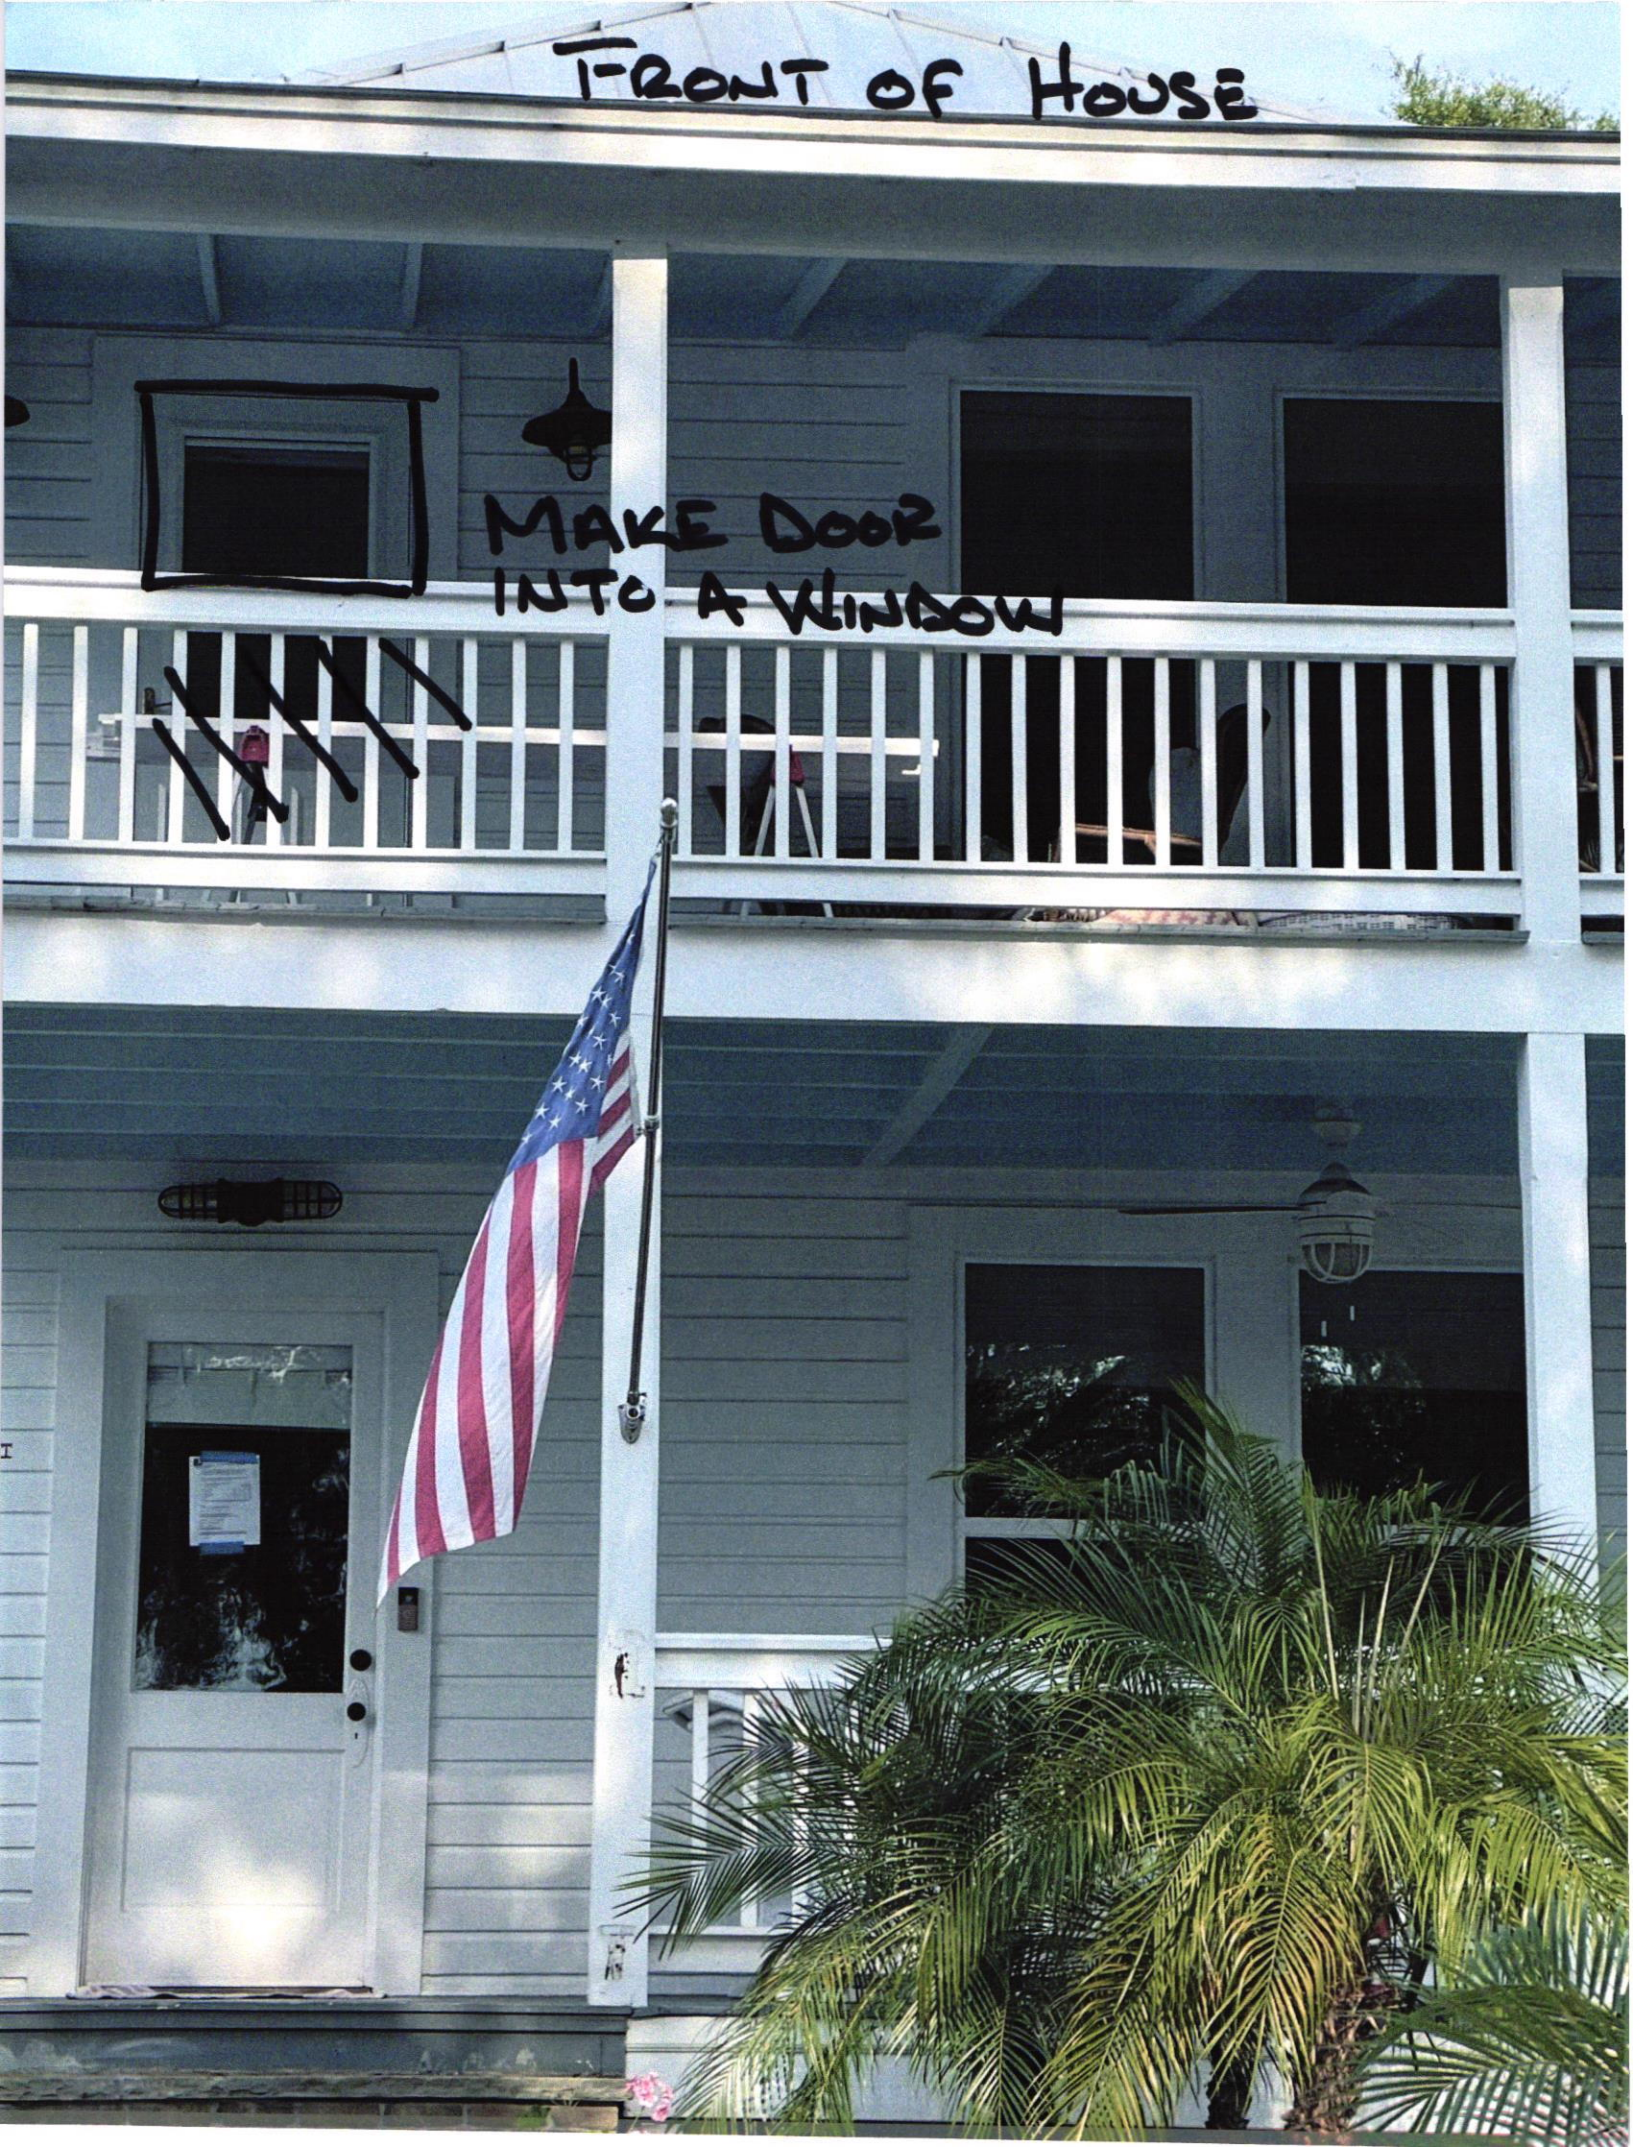
MAKE DOOR  
INTO A WINDOW

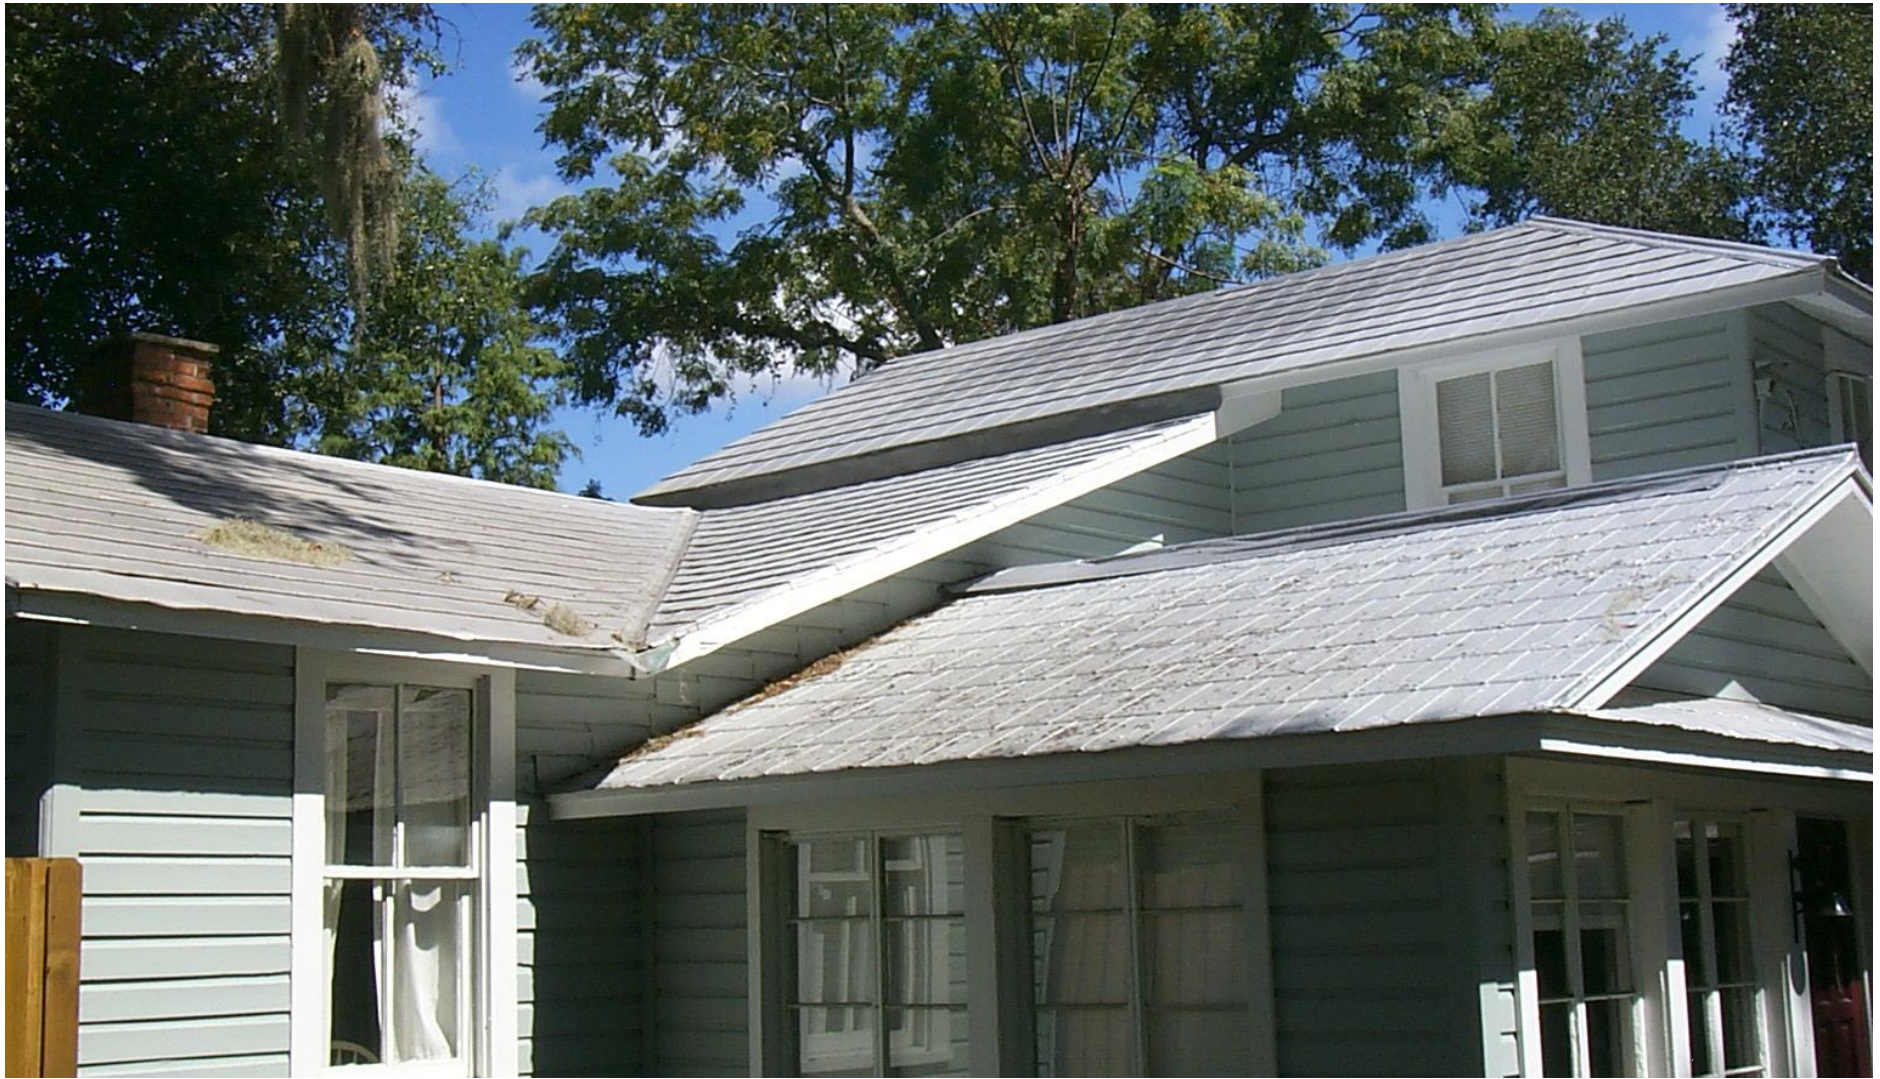
Photo 1 – View of left (west) side of roof area.
