**HISTORIC PRESERVATION BOARD**  
**City Hall – 1<sup>st</sup> Floor Board Room, 510 N. Baker Street, Mount Dora, FL**  
**July 26, 2023 at 3:00 PM**

**RE:** **Tab 1 - Certificate of Appropriateness; 813 E 5<sup>th</sup> Ave (Location); Remove and Replace Four (4) Doors (Request); Hurley Family Partnership (Owner); Sunshine Properties Source, LLC (Applicant).**

**RE:** Tab 2 - Certificate of Appropriateness; 132 W 9<sup>th</sup> Avenue (Location); Remove and Replace Front Door (Request); Deborah M. Crawford (Owner); Paul Thomas, Ro-Mac Building Supply (Applicant).

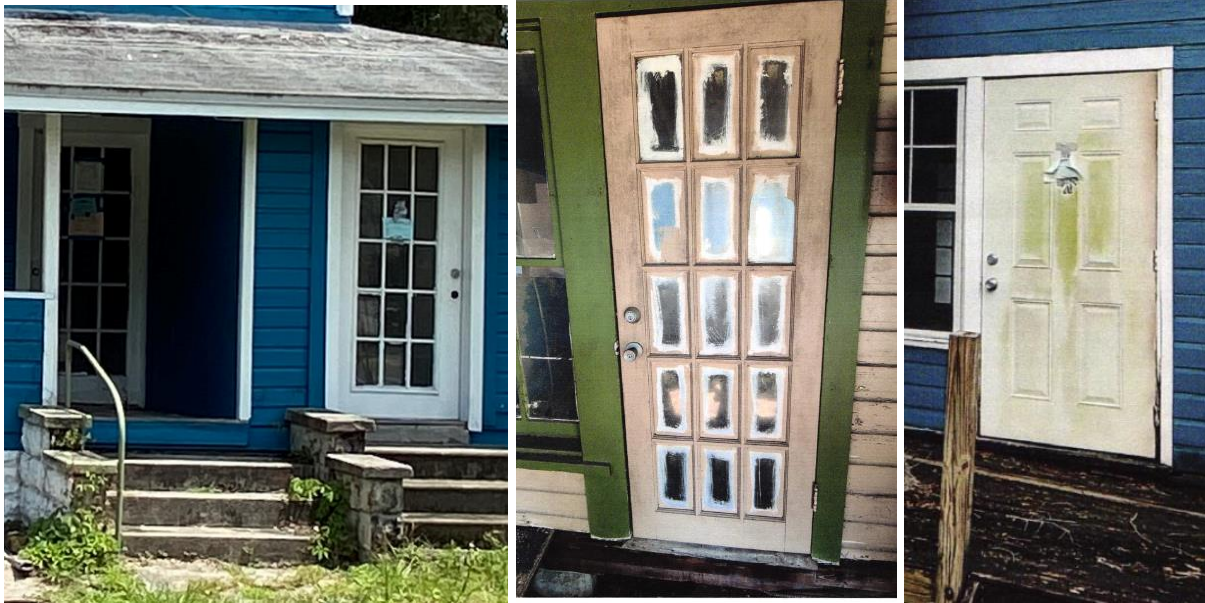
Existing Doors:

The applicant is seeking to remove four (4) doors (three wood and one fiberglass) and replace them with steel doors; and provide a wrought iron handrail for the existing front stairs. The Applicant stated on the application that the doors are in poor condition and there is currently no handrail on the stairs.

The Applicant is seeking to replace all four doors with steel doors replicating the grids on the existing wood windows.

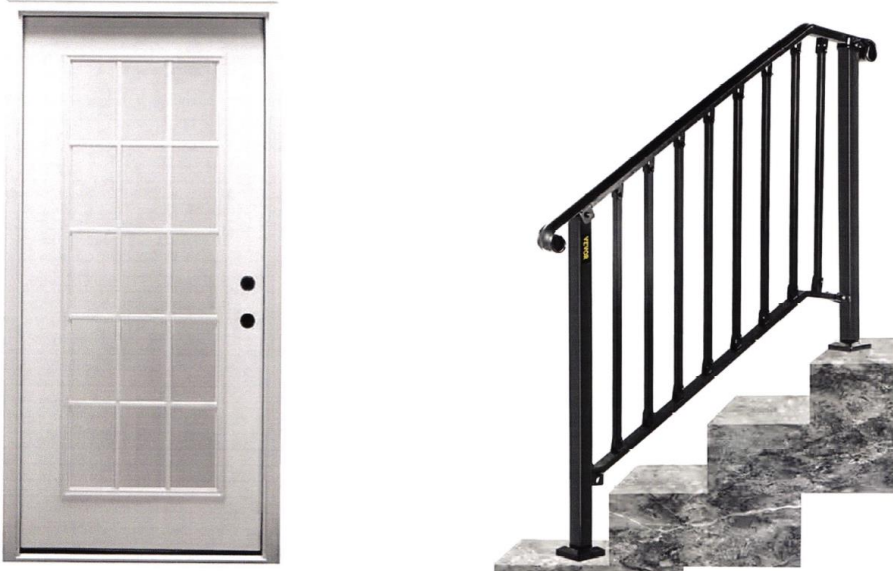
Proposed Door and Wrought Iron Railing:

The railing will need to be compliant with Florida Building Code (e.g. min. 12” extension of railing from last step).

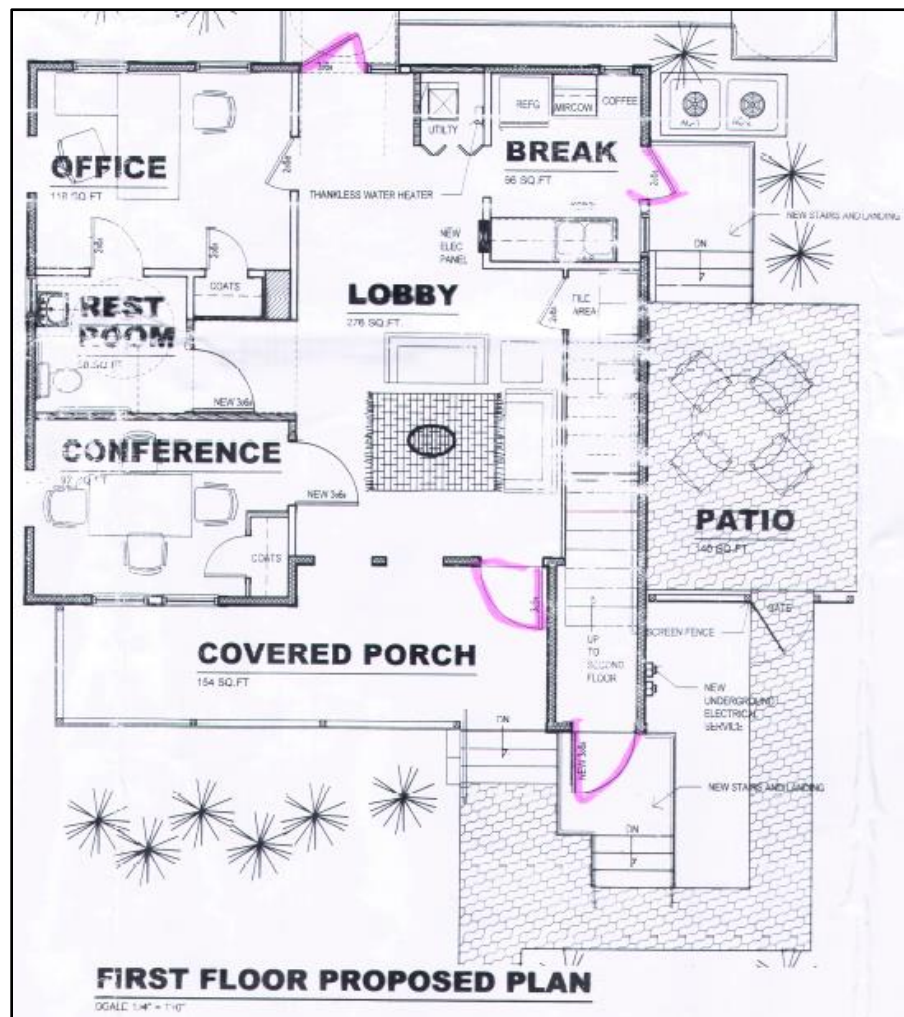
Below are the location of the doors which will be replaced (highlighted in pink):

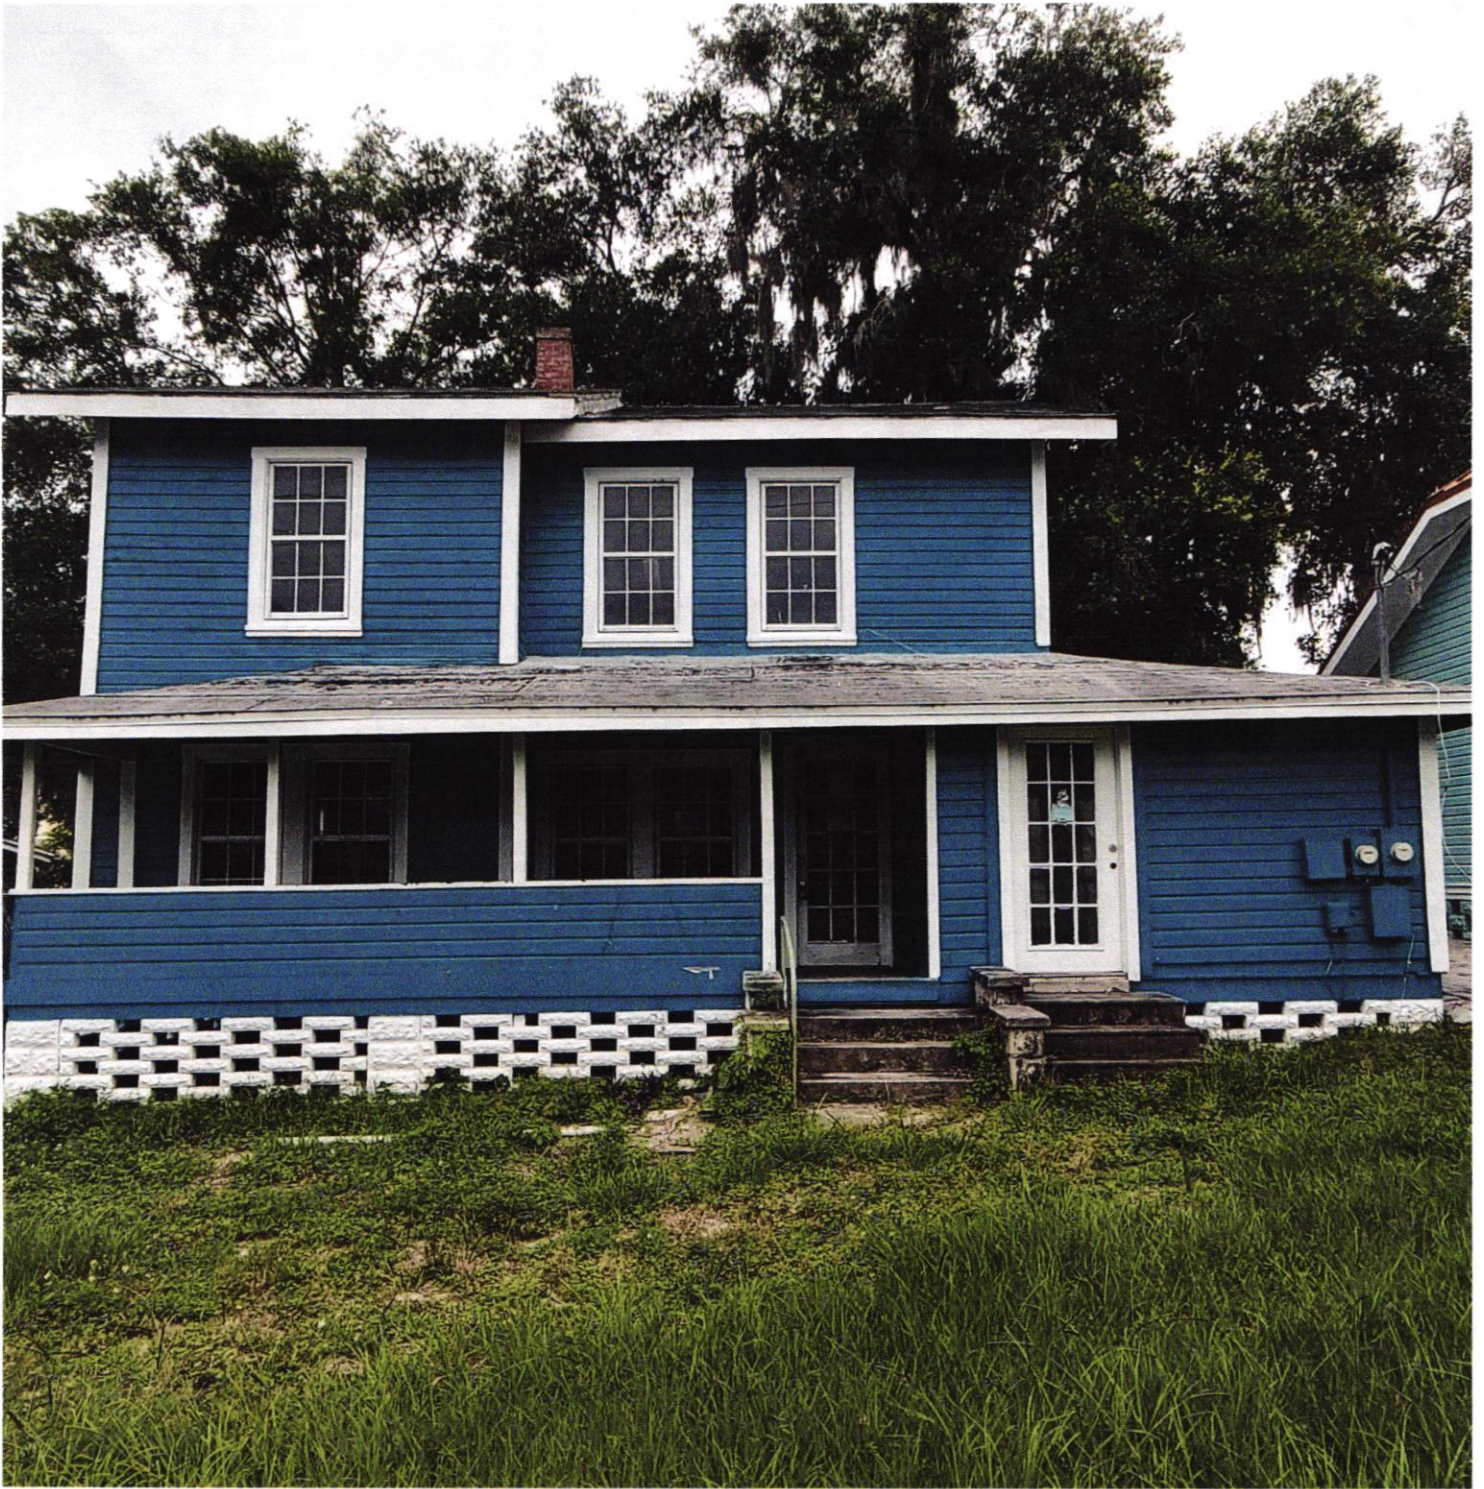
Front of Building

Existing doors - replace w/ steel 15 lite door (new)  
Existing steps - replace w/ wrought iron railing (new)

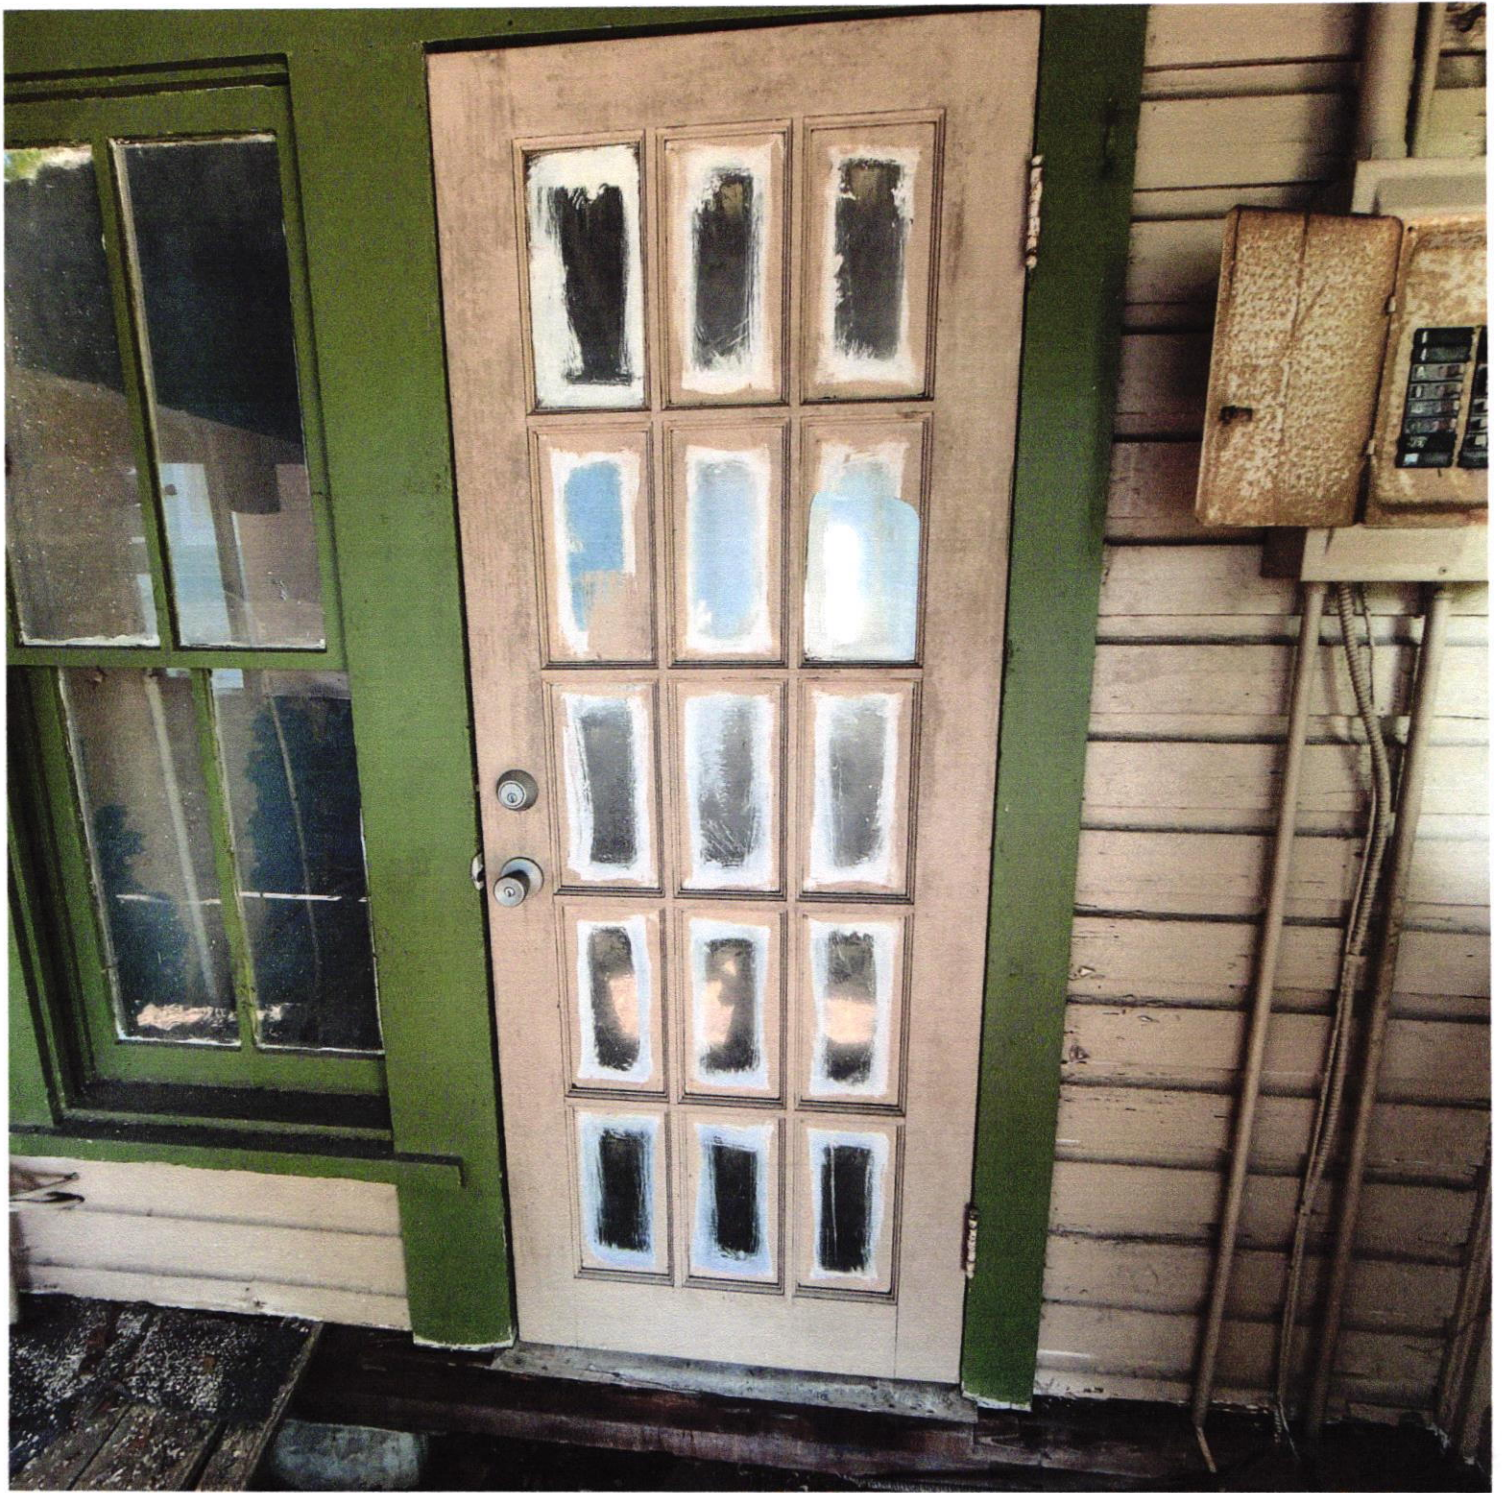
Side of Building

Existing door  
Replace w/ steel 15 lite door (new)

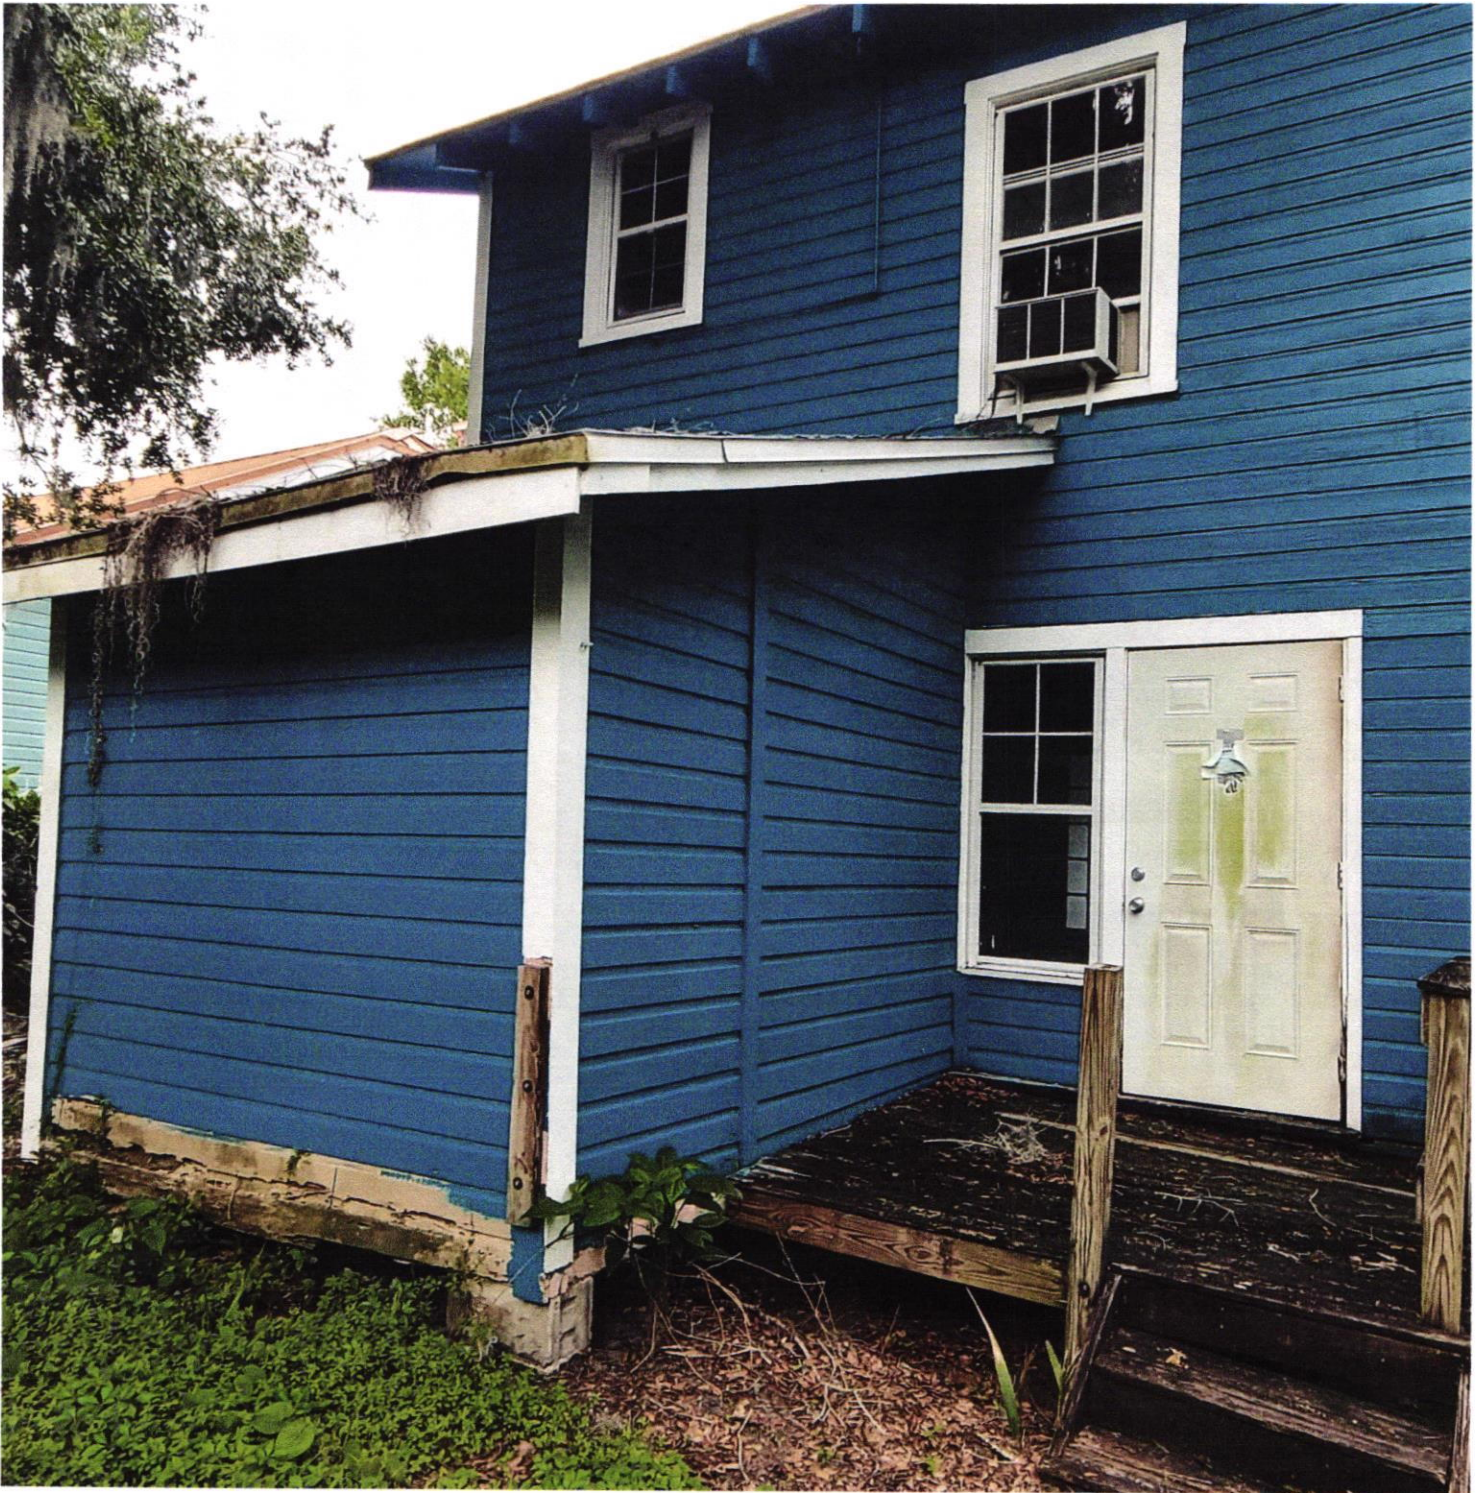
Back of Building

Existing door  
Replace w/ steel 15 lite door (new)

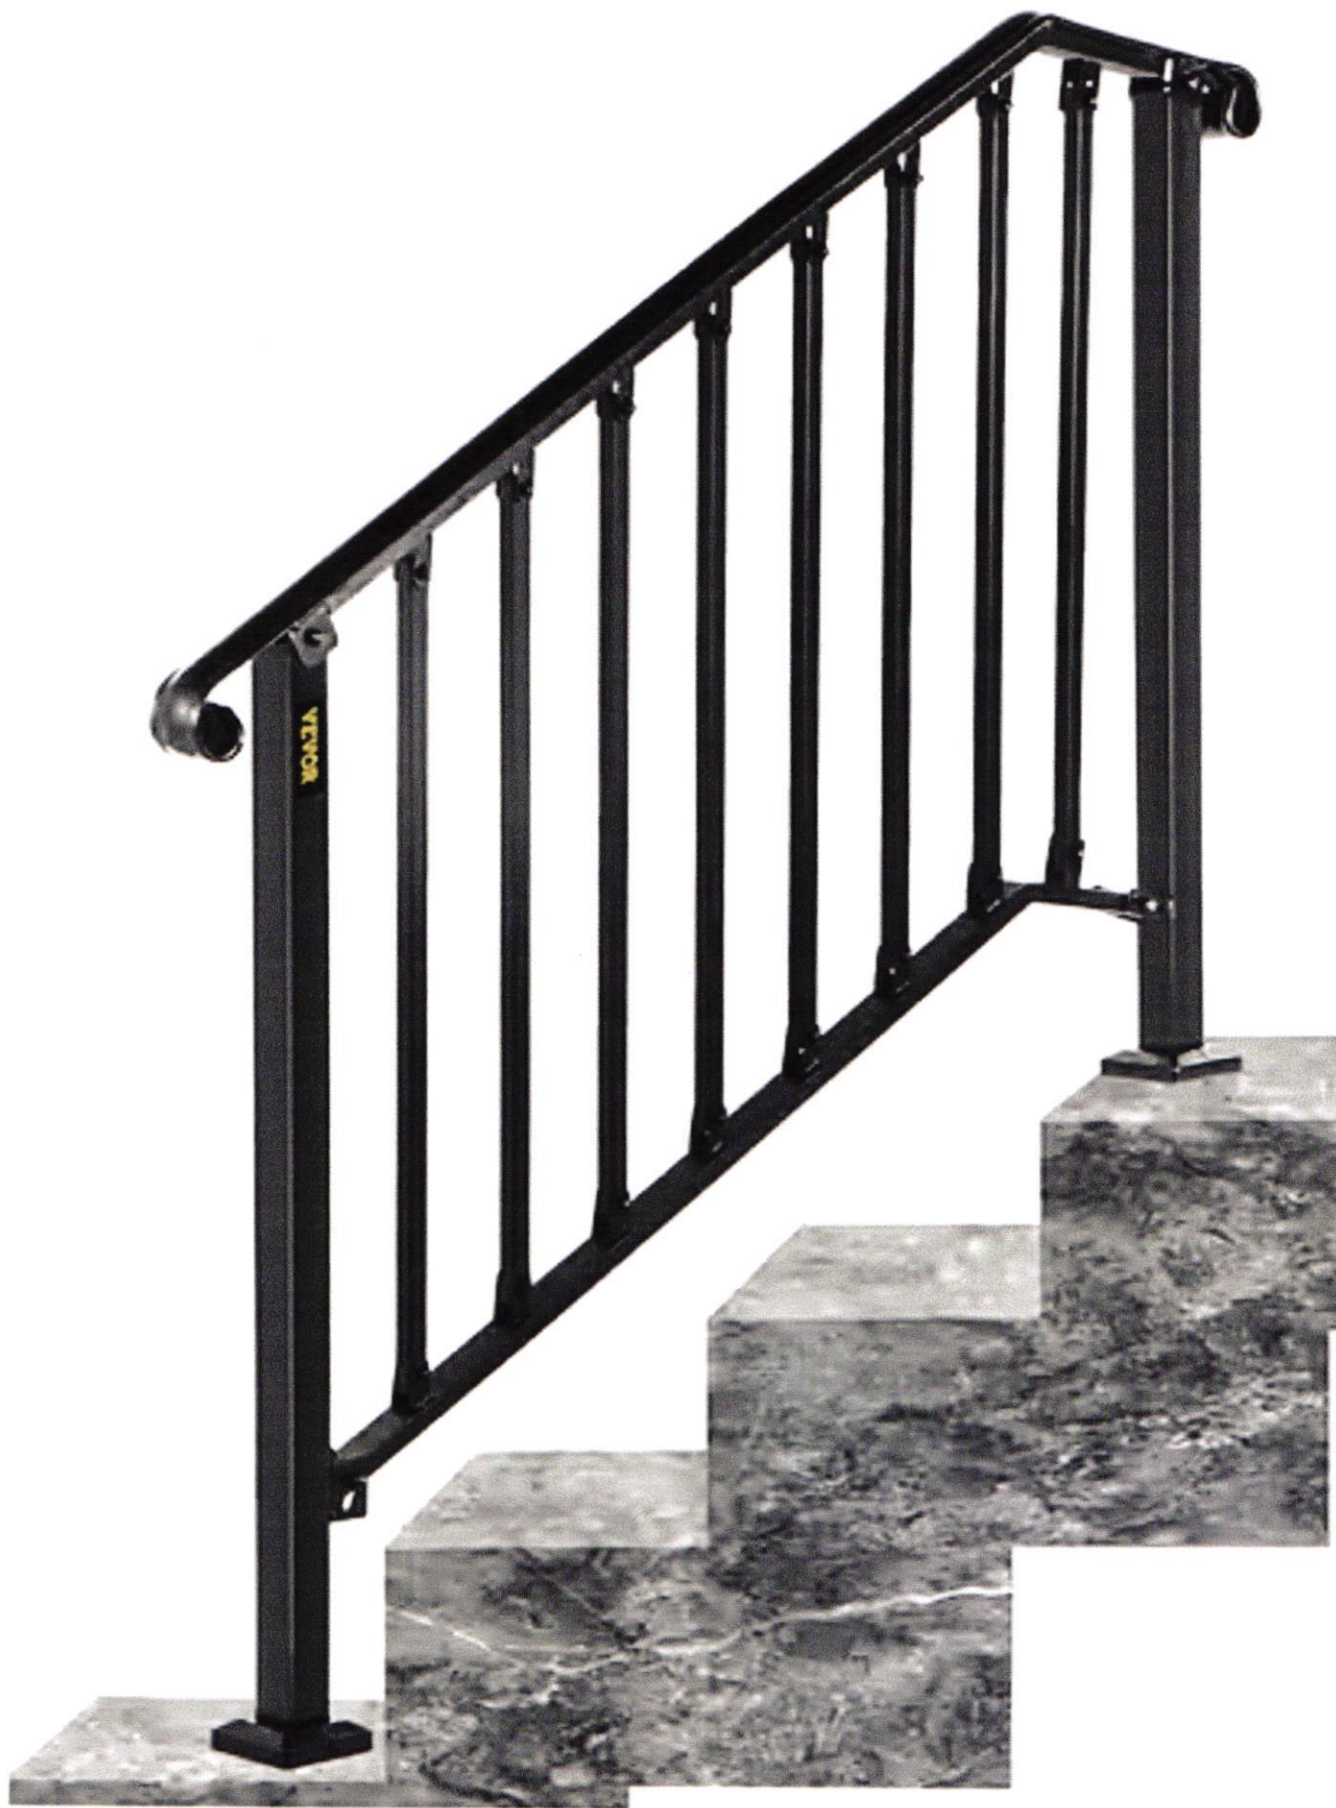
## **VEVOR Handrails for Outdoor Steps, Fit 4 or 5 Steps Outdoor Stair Railing, Picket#4 Wrought Iron Handrail, Flexible Porch Railing, Black Transitional Handrails for Concrete Steps or Wooden Stairs**

- **Flexible for 4 or 5 Steps:** Max Height for Steps: 32"/82 cm; Distance Between Posts: 57"/ 144.7 cm; Upper Post Height: 38"/ 95.2 cm; Lower Post Height: 39.8"/ 99.8 cm. Due to the flexible height, our wrought iron handrail fits your 4 or 5 steps according to the different sizes. It is perfect for helping people keep balance in the rain or winter and prevent skidding.
