HISTORIC PRESERVATION BOARD
City Hall – First Floor Board Room
510 N. Baker Street, Mount Dora, Florida
April 30, 2025 at 3:00 PM

AGENDA

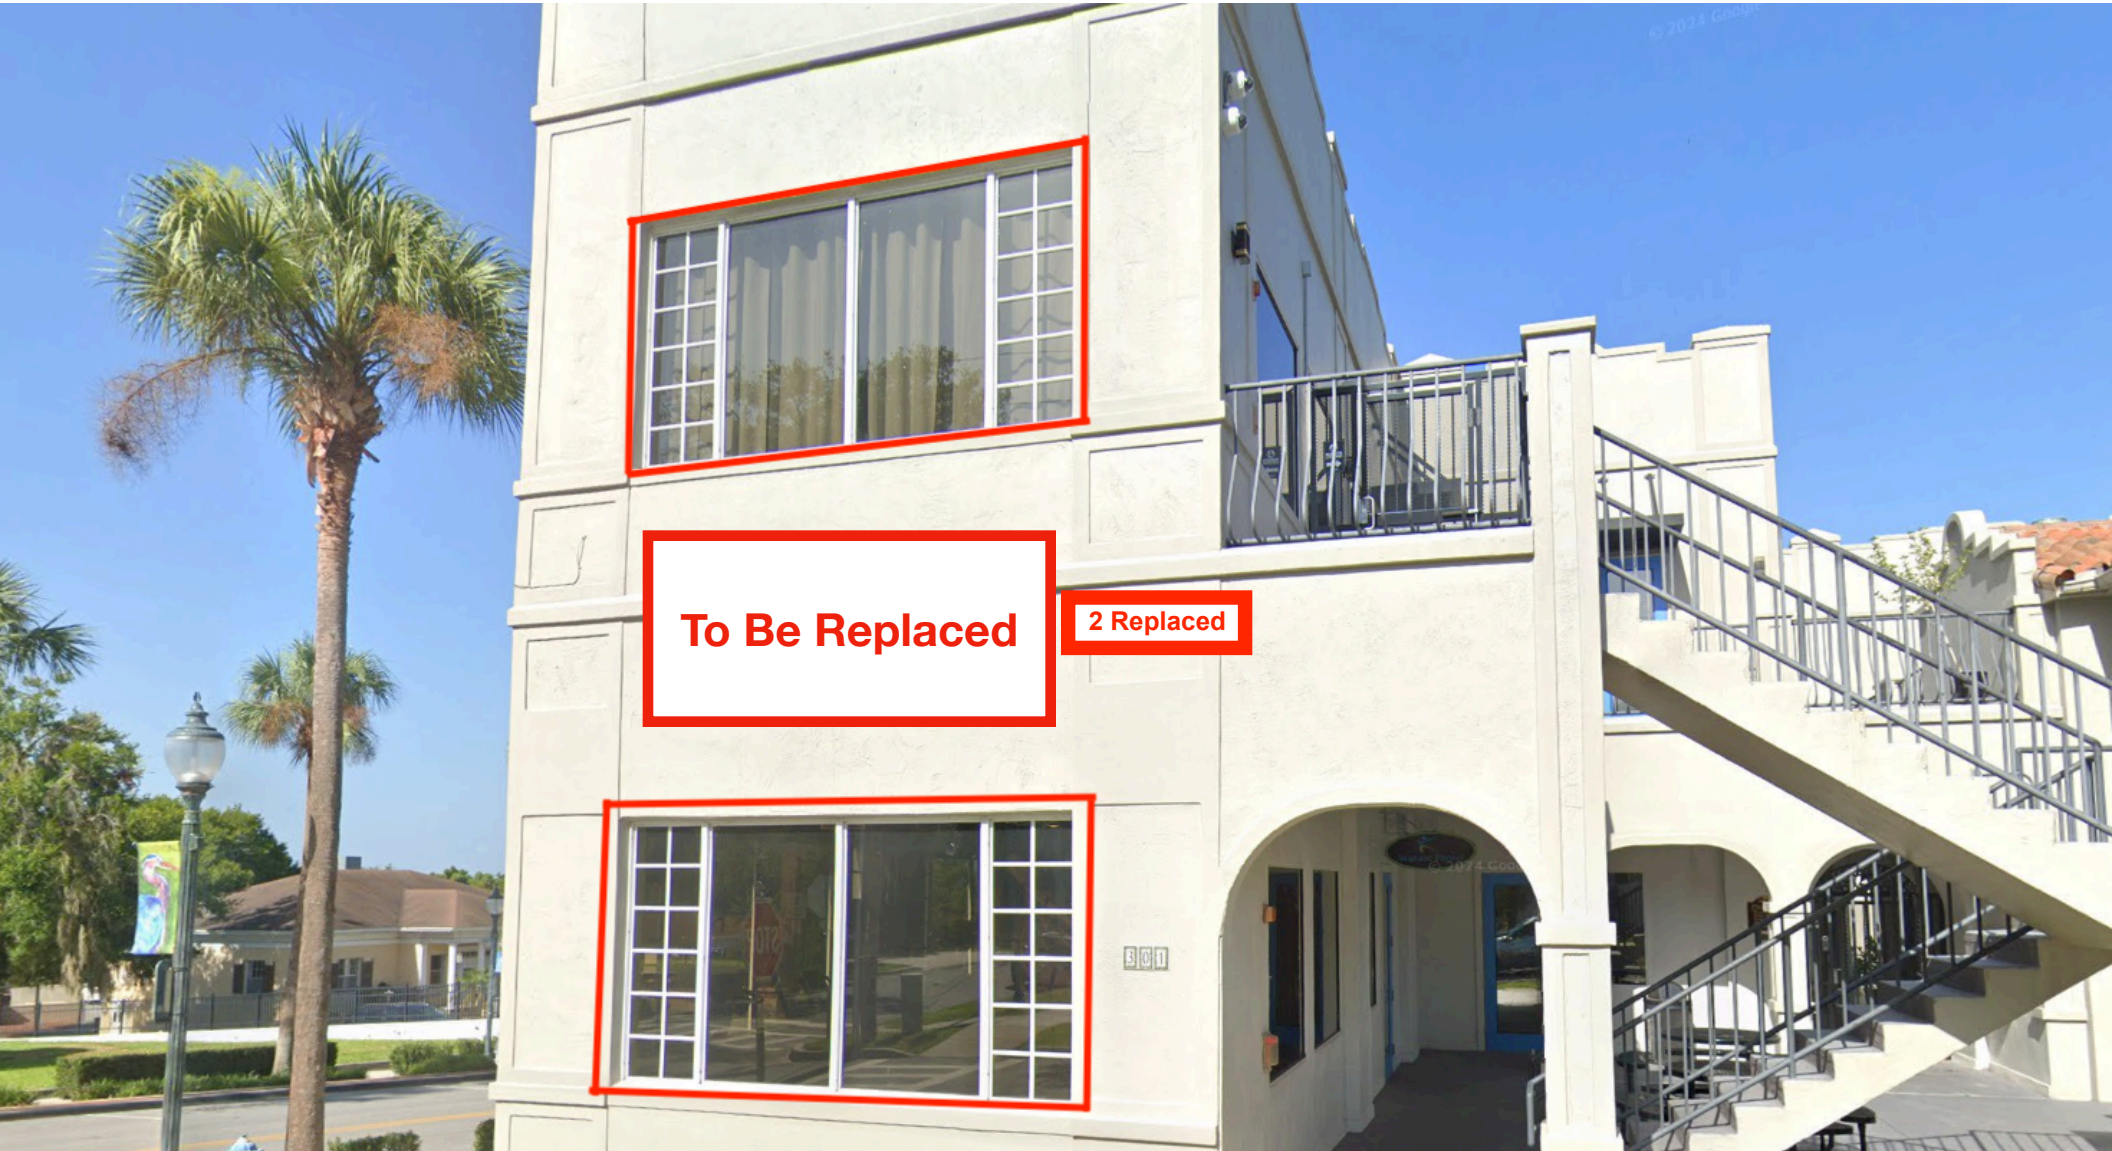
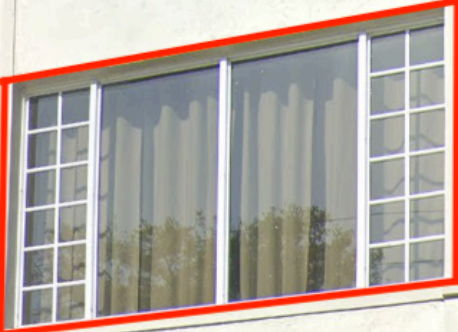
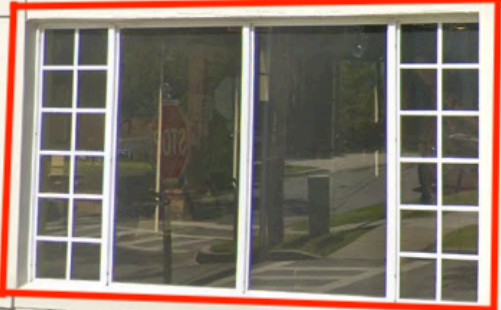
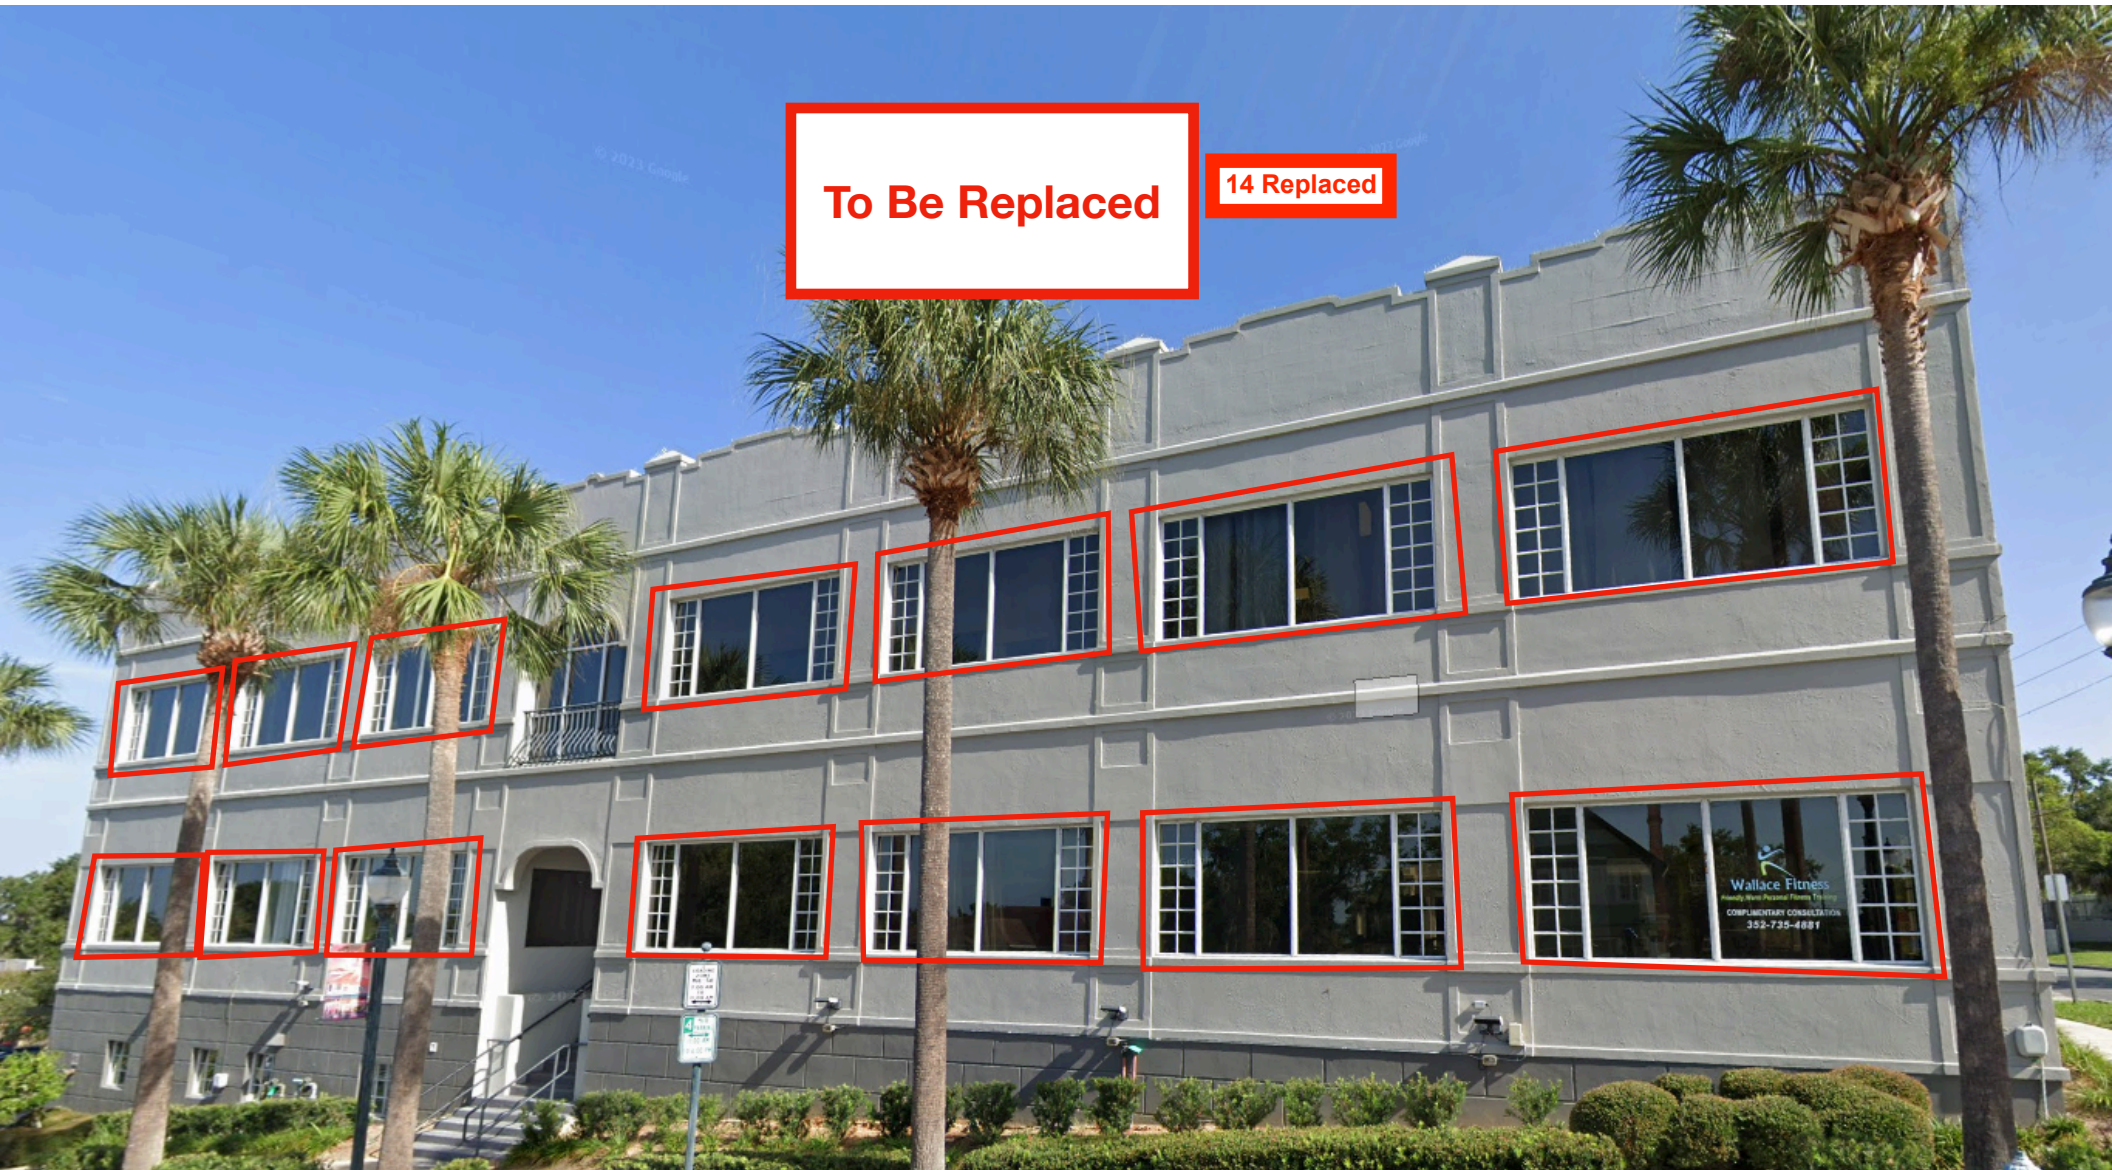
To Be Replaced

2 Replaced

14 Replaced

5 Replaced

6 Replaced

**27 Total
Facade
Windows
Replaced**

The structure was constructed in 1997 and the Applicant is seeking to remove and replace twenty-seven (27) vinyl windows due to the poor condition of the existing windows which are leaking. The replacement windows will be the same material as the existing windows (vinyl) but will not provide a grid pattern.

Reason for Addition / Modification: Existing windows leak badly

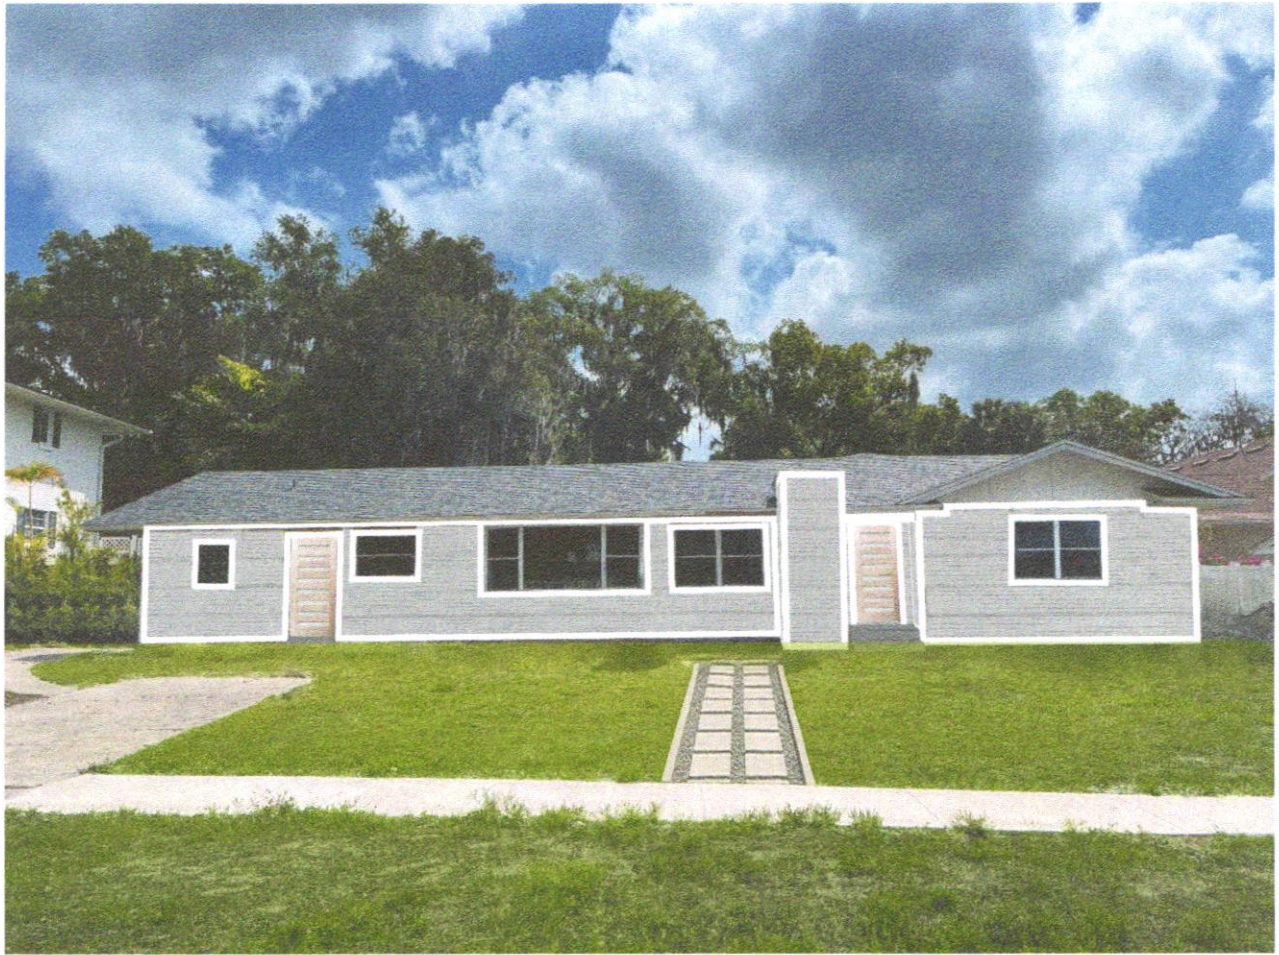
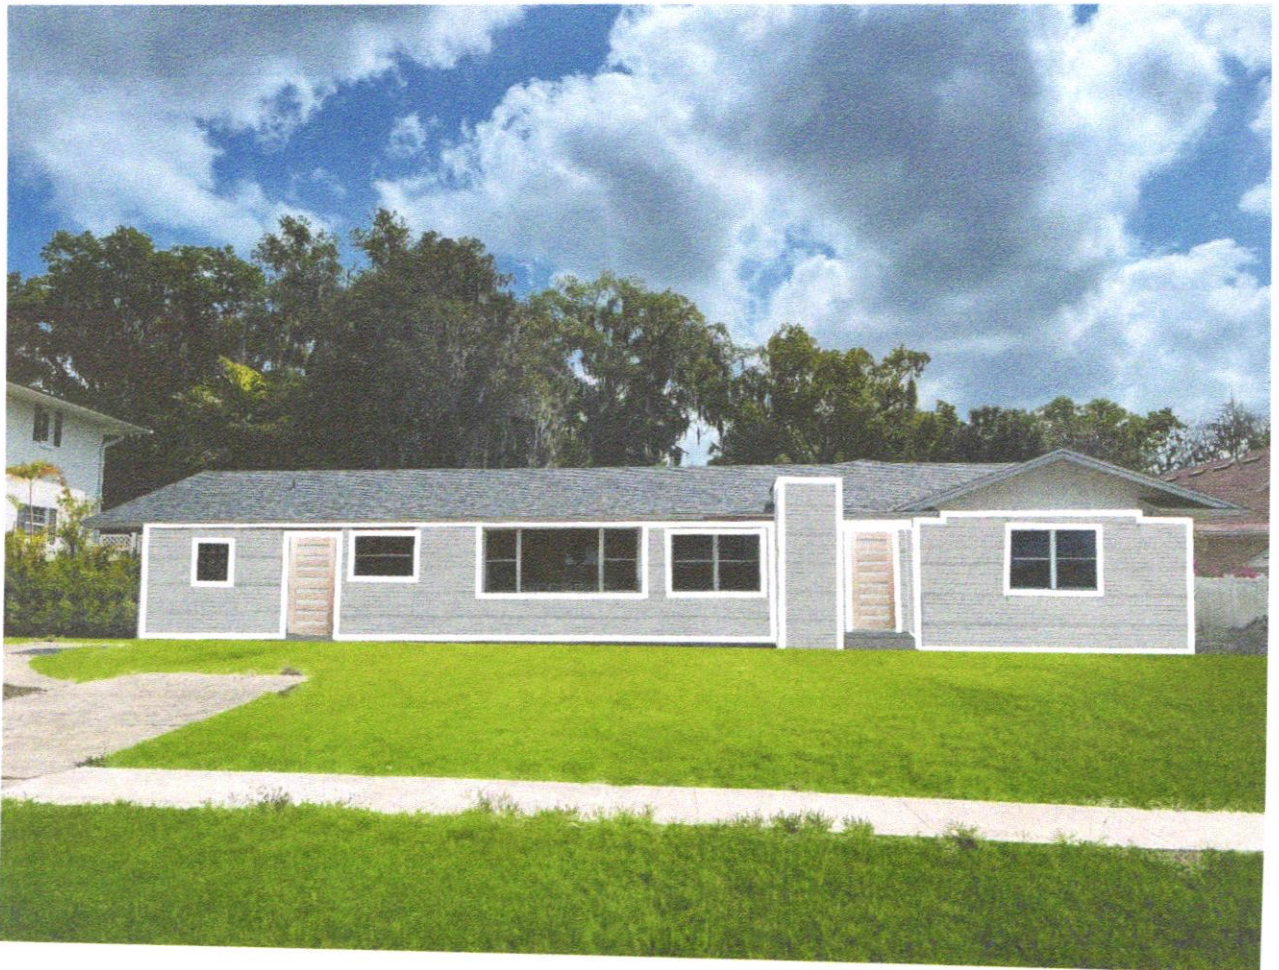
Degrading walls are not structural.

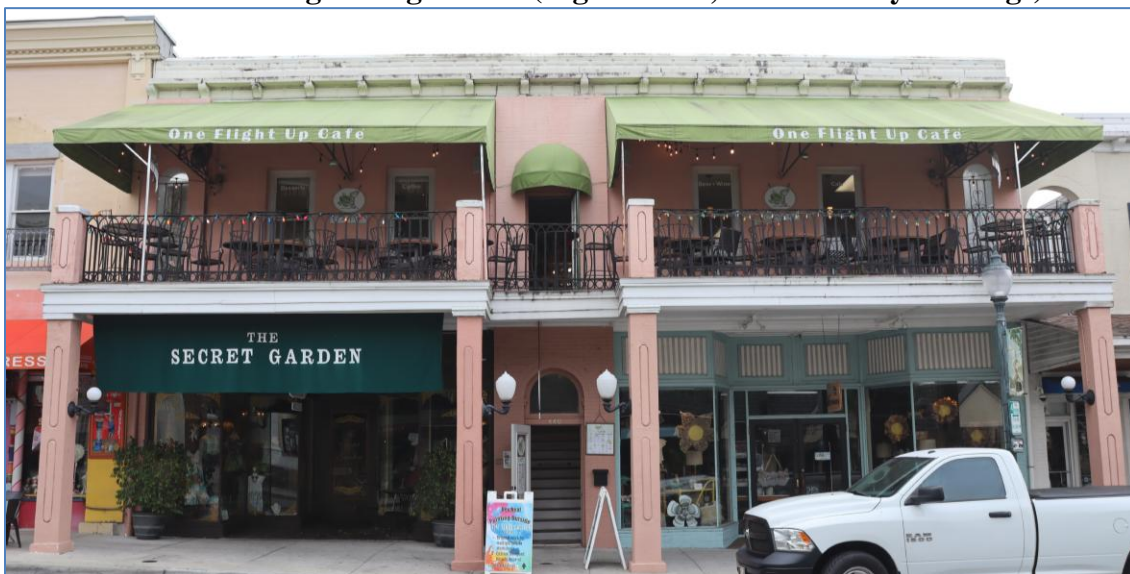
Proposed Awning Configuration

Current Awning Configuration (Light Green, Second Story Awnings)
