HISTORIC PRESERVATION BOARD
City Hall – First Floor Board Room
510 N. Baker Street, Mount Dora, Florida
June 25, 2025 at 3:00 PM

AGENDA

**CITY OF MOUNT DORA
HISTORIC PRESERVATION BOARD
APRIL 30, 2025 MEETING MINUTES**

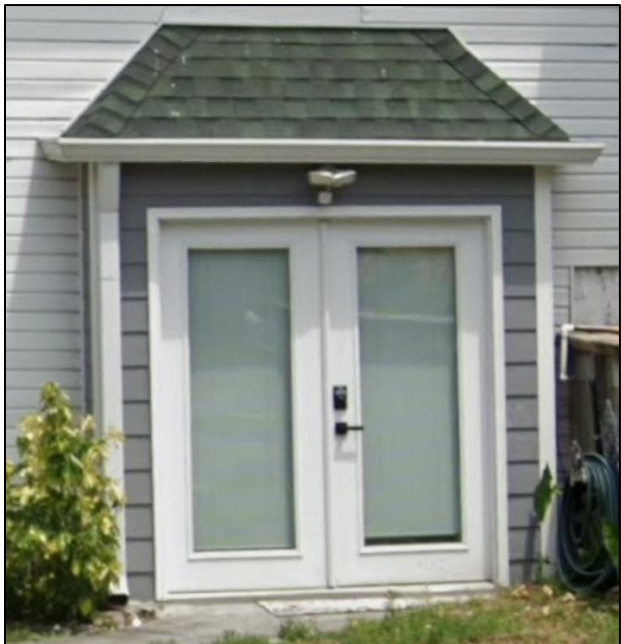
2. Recess the double doors on the front façade 16” so the doors will be in line with the primary façade. The Applicant does not propose any changes to the existing awning.

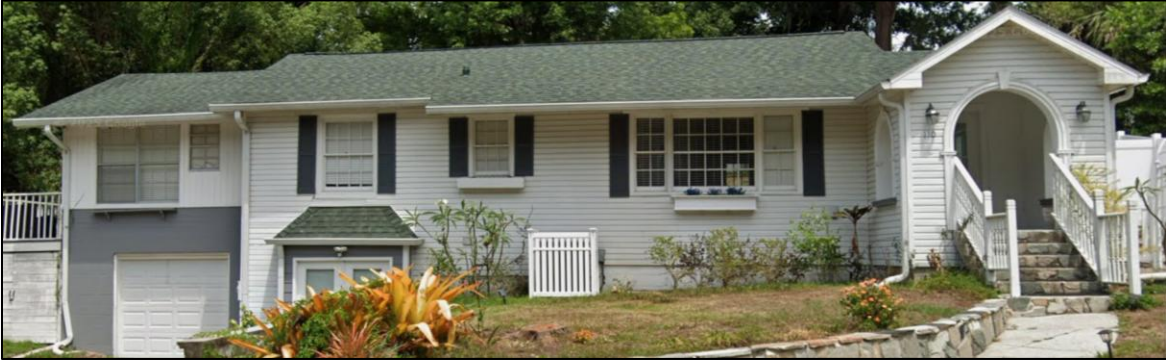
3. Change in color and material of shutters to a natural wood.

Original shutters in Florida are rare. Under Standard 3, unless there is physical or documentary evidence of their existence, shutters should not be mounted. If shutters are found to be appropriate, they should be operable or appear to be operable and measure the full height and one-half the width of the window frame. They should be attached to the window casing rather than the exterior wall. Wood shutters with horizontal louvers are the preferred type. Avoid metal and vinyl.

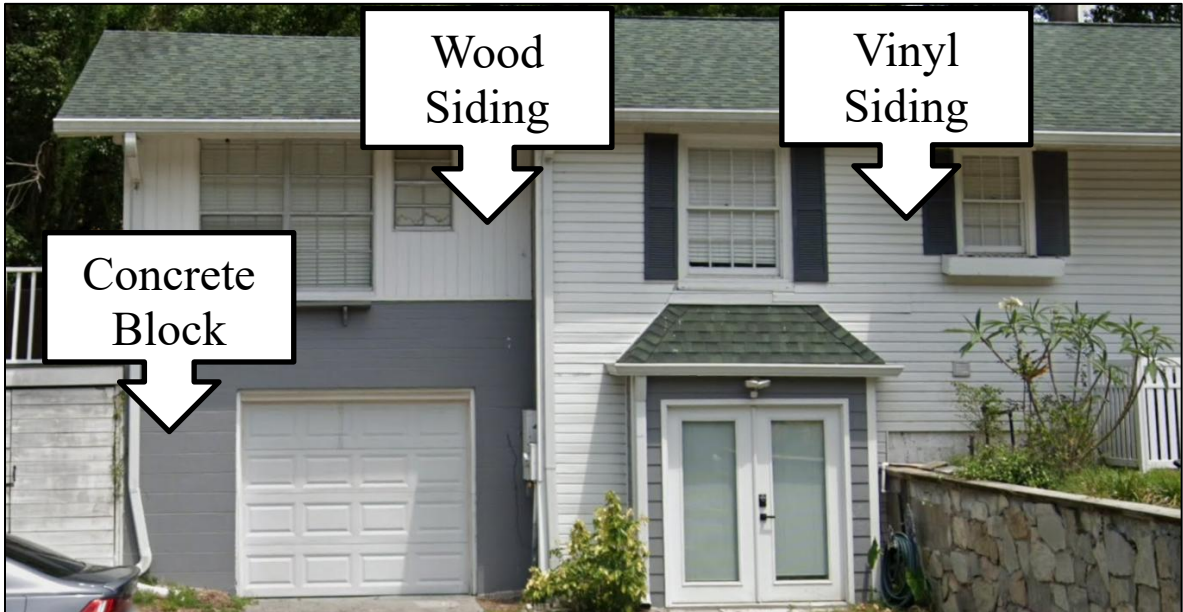
4. Remove the existing vinyl siding and replace with horizontal concrete or composite boards and provide horizontal concrete or composite boards over the existing wood and concrete siding.

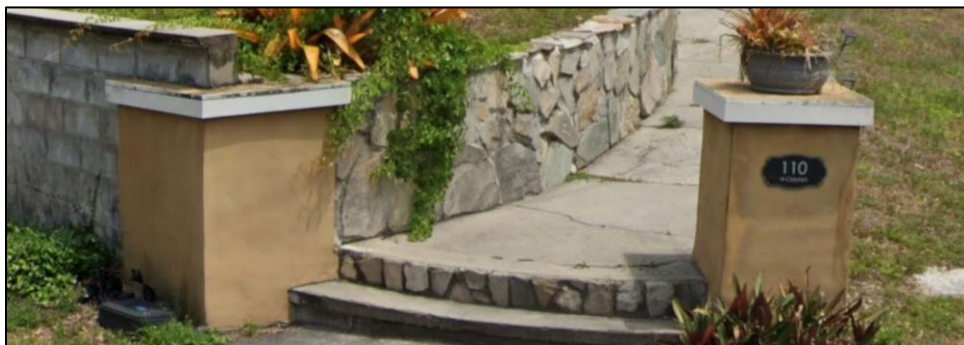
5. Wrap the columns in the same material and color of the residence.

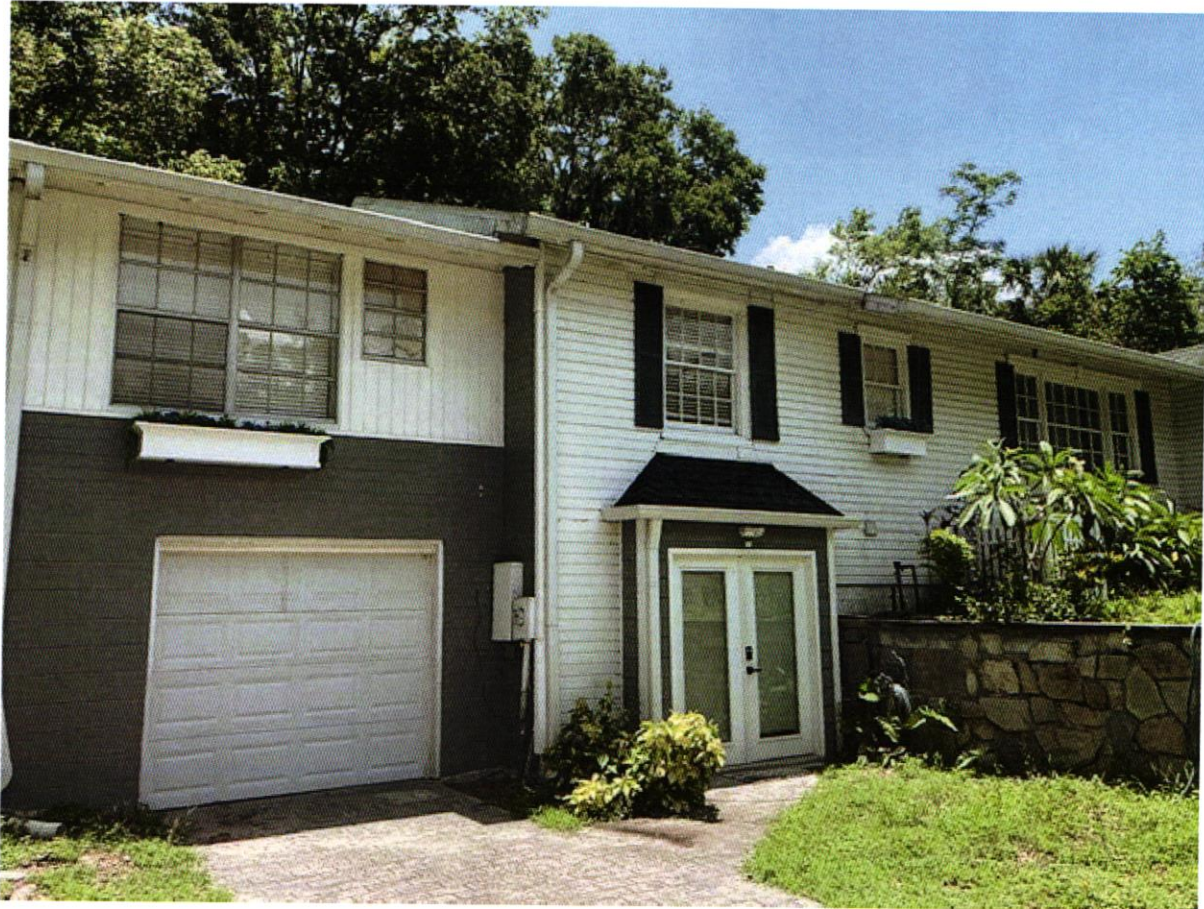
Windows above the double doors and to the right on all wood frame windows. The windows above the garage and on the side are aluminum. The gray block surrounding the garage door and the wood siding above the garage door is requested to be covered with either a cement or composite siding. The siding will be placed horizontally to mirror the look of the current vinyl siding and painted white. The request also includes the replacement of the vinyl siding with the same material for a consistent look to the home.

First, replacement of front and side windows. Current windows are a mix of wood frames and aluminum frames. The proposed renovation will replace the mix of windows with consistent and updated white frame/grid style windows (pictures of type of window proposed). Sizing will vary of course but quality and grid style type will be consistent as well as approval to meet Florida code/requirements of Mount Dora's Building Department. The reason for this modification is due to the current poor conditions of the windows and lack of energy efficiency.

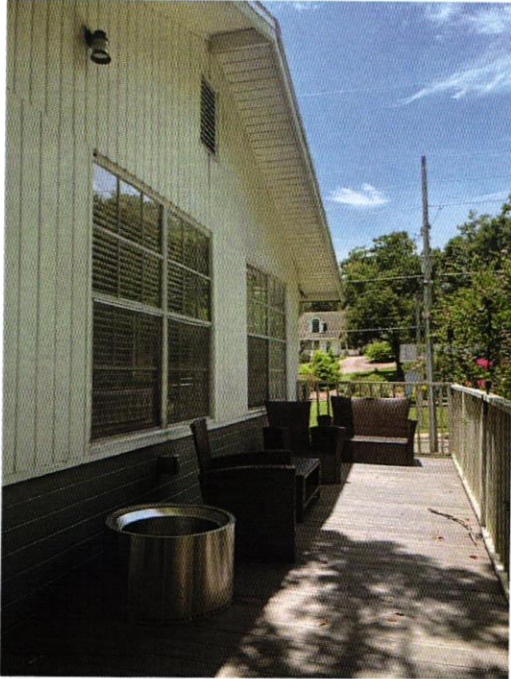
Picture of the side of the home, with the aluminum windows, wood siding, and concrete block. The request is to replace these windows as well and update the siding to a horizontal cement or composite board, painted white.

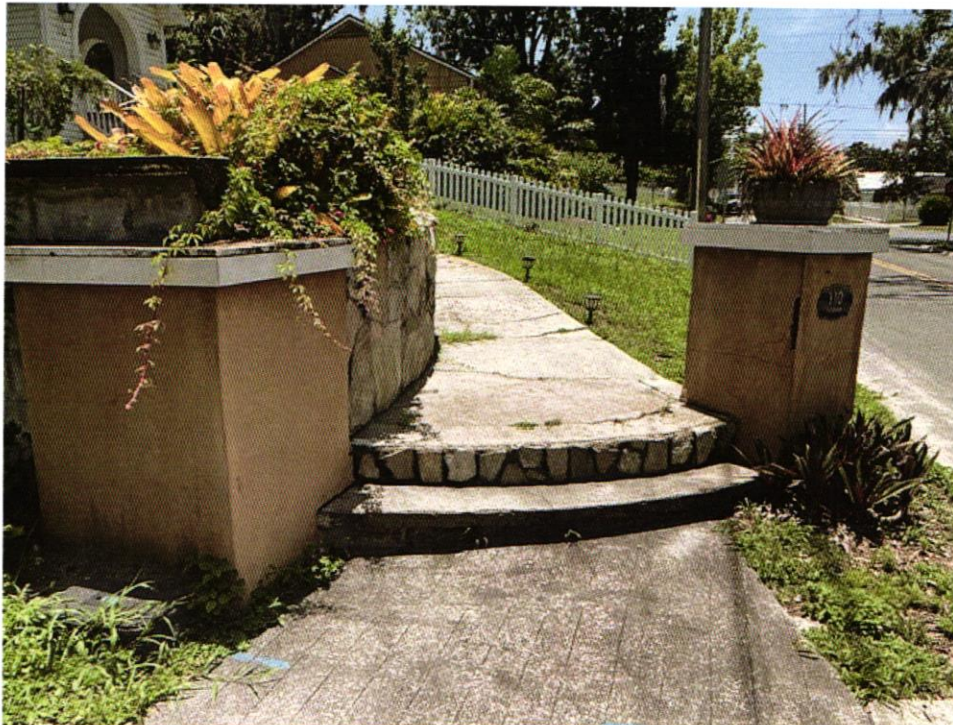
The picture above is the two columns discussed. These would be wrapped in the same material as the house siding and painted white.

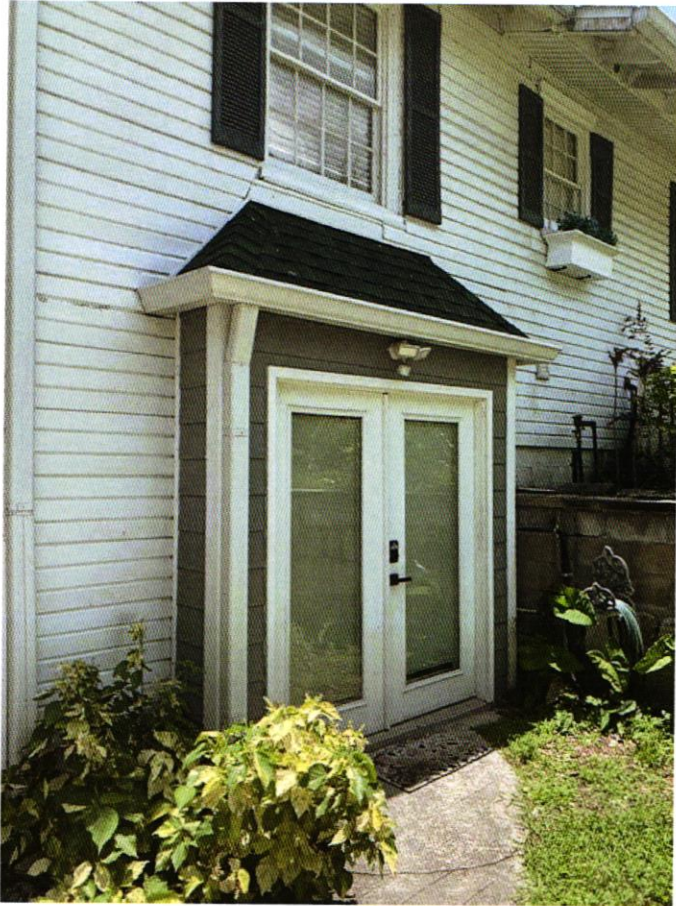
Image of the double doors. The request is to shift these doors to be inline of the white siding but retain the roof cap.

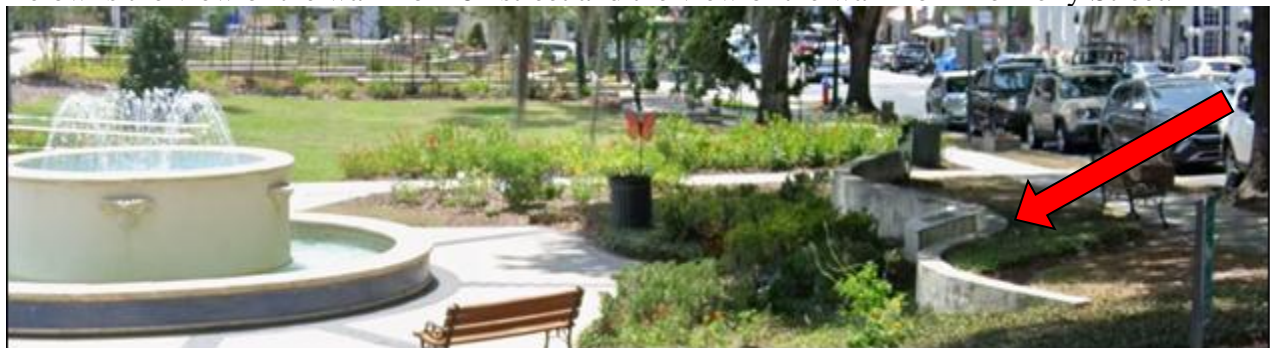
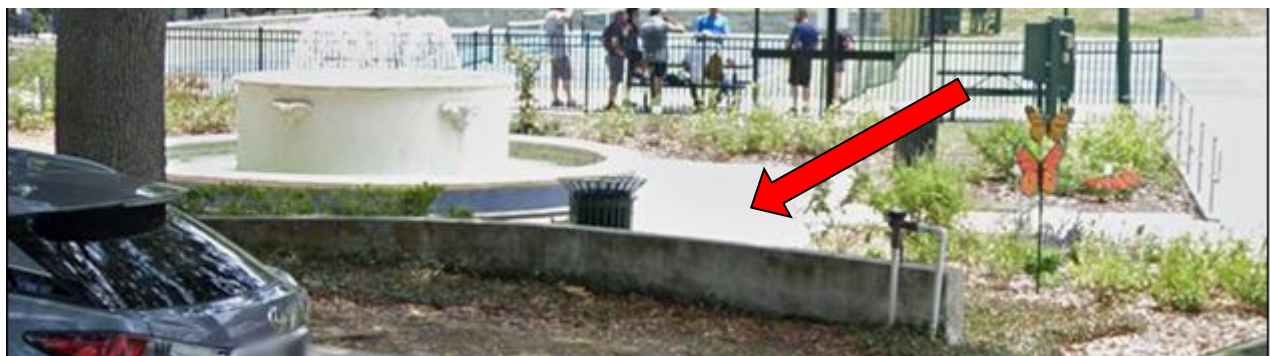
Below is the view of the wall from 6th street and the view of the wall from Donnelly Street.

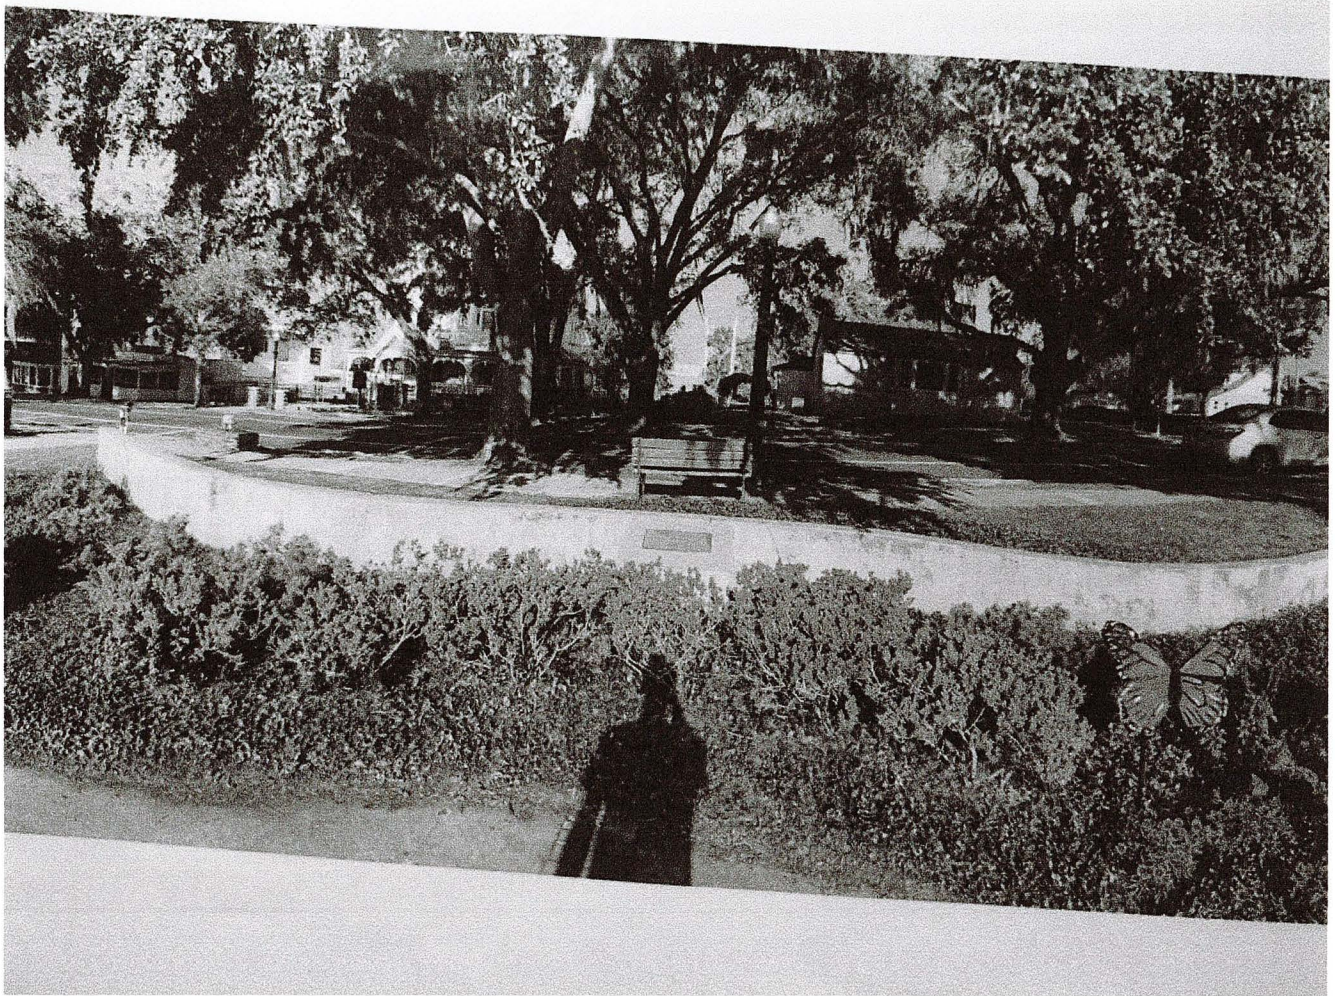
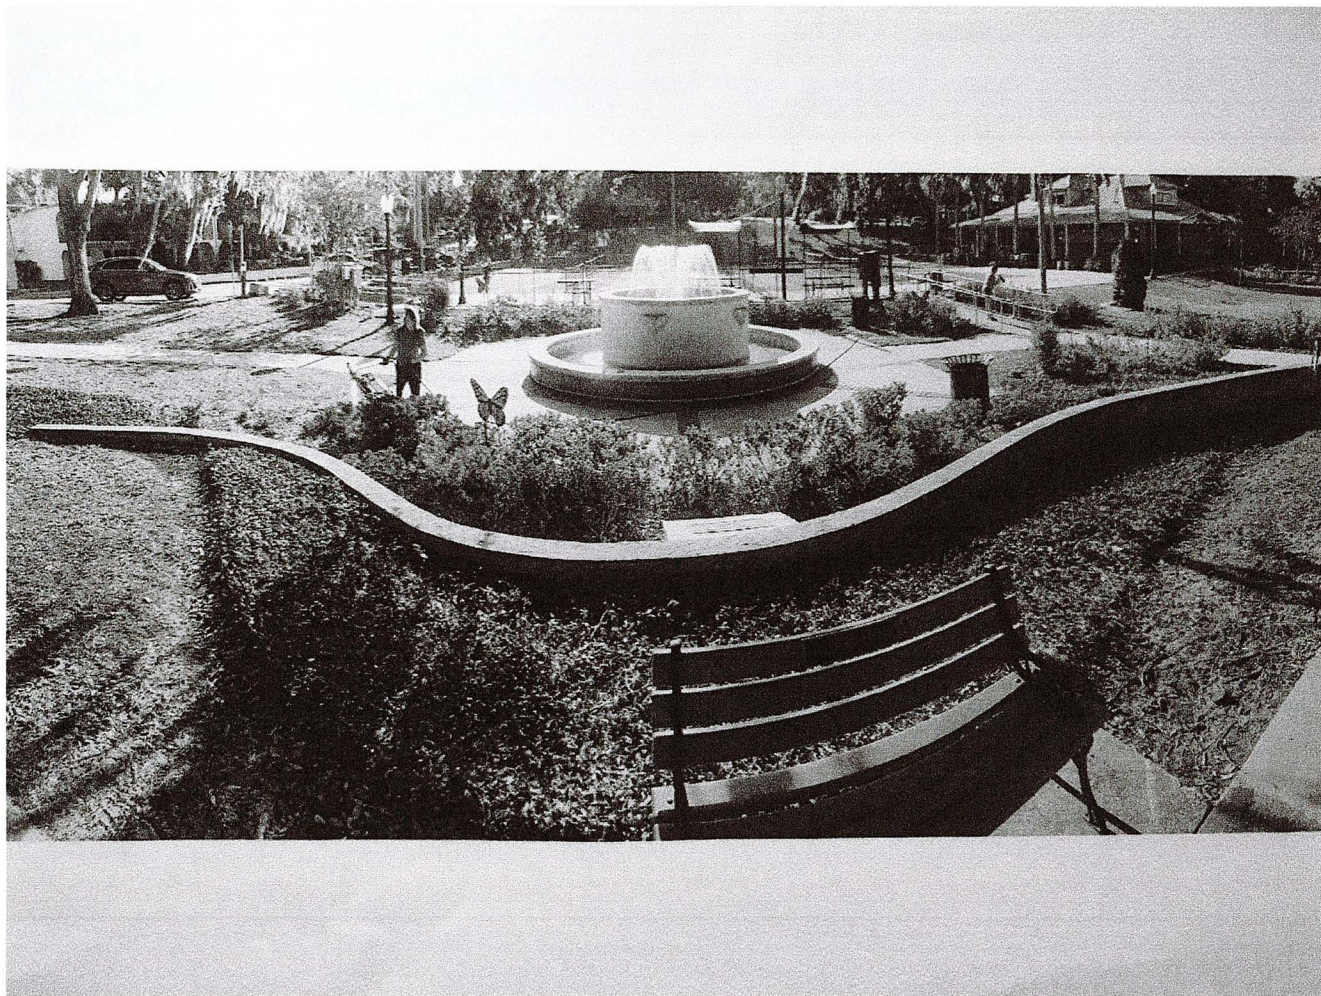
See photos below of the current condition of the wall we want to update.

The length of the wall is 46.5 feet with an average height of 3 ft including top makes the total square footage approximately 139.5' to paint.

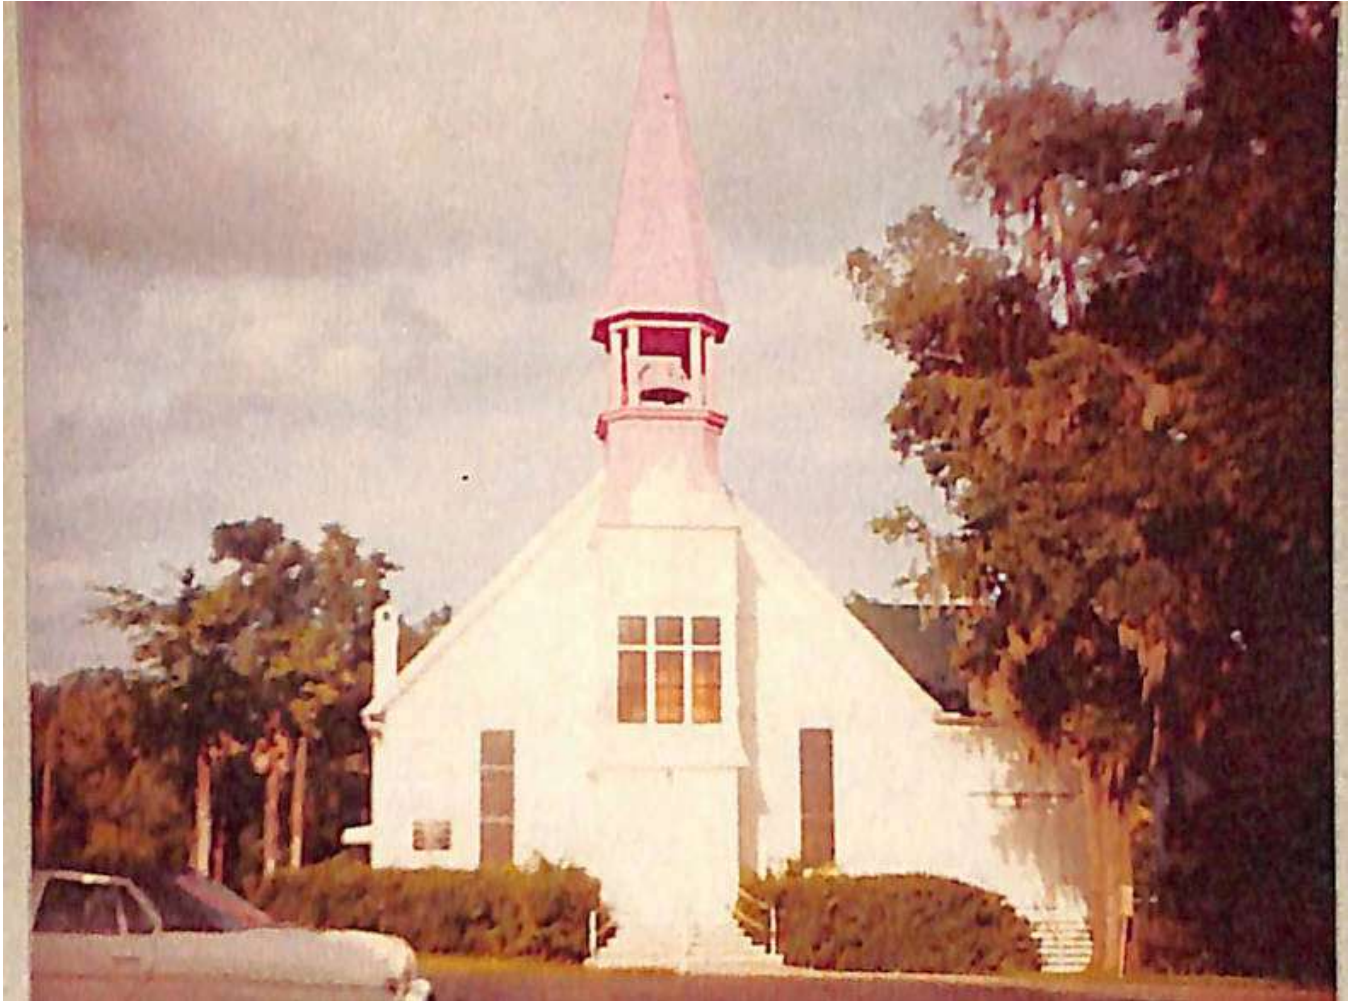
Congregational Church Partially Painted Pink

The Congregational Church on Donnelly Street and Seventh Avenue was featured in the movie; it is pictured in the process of being painted pink for the filming.

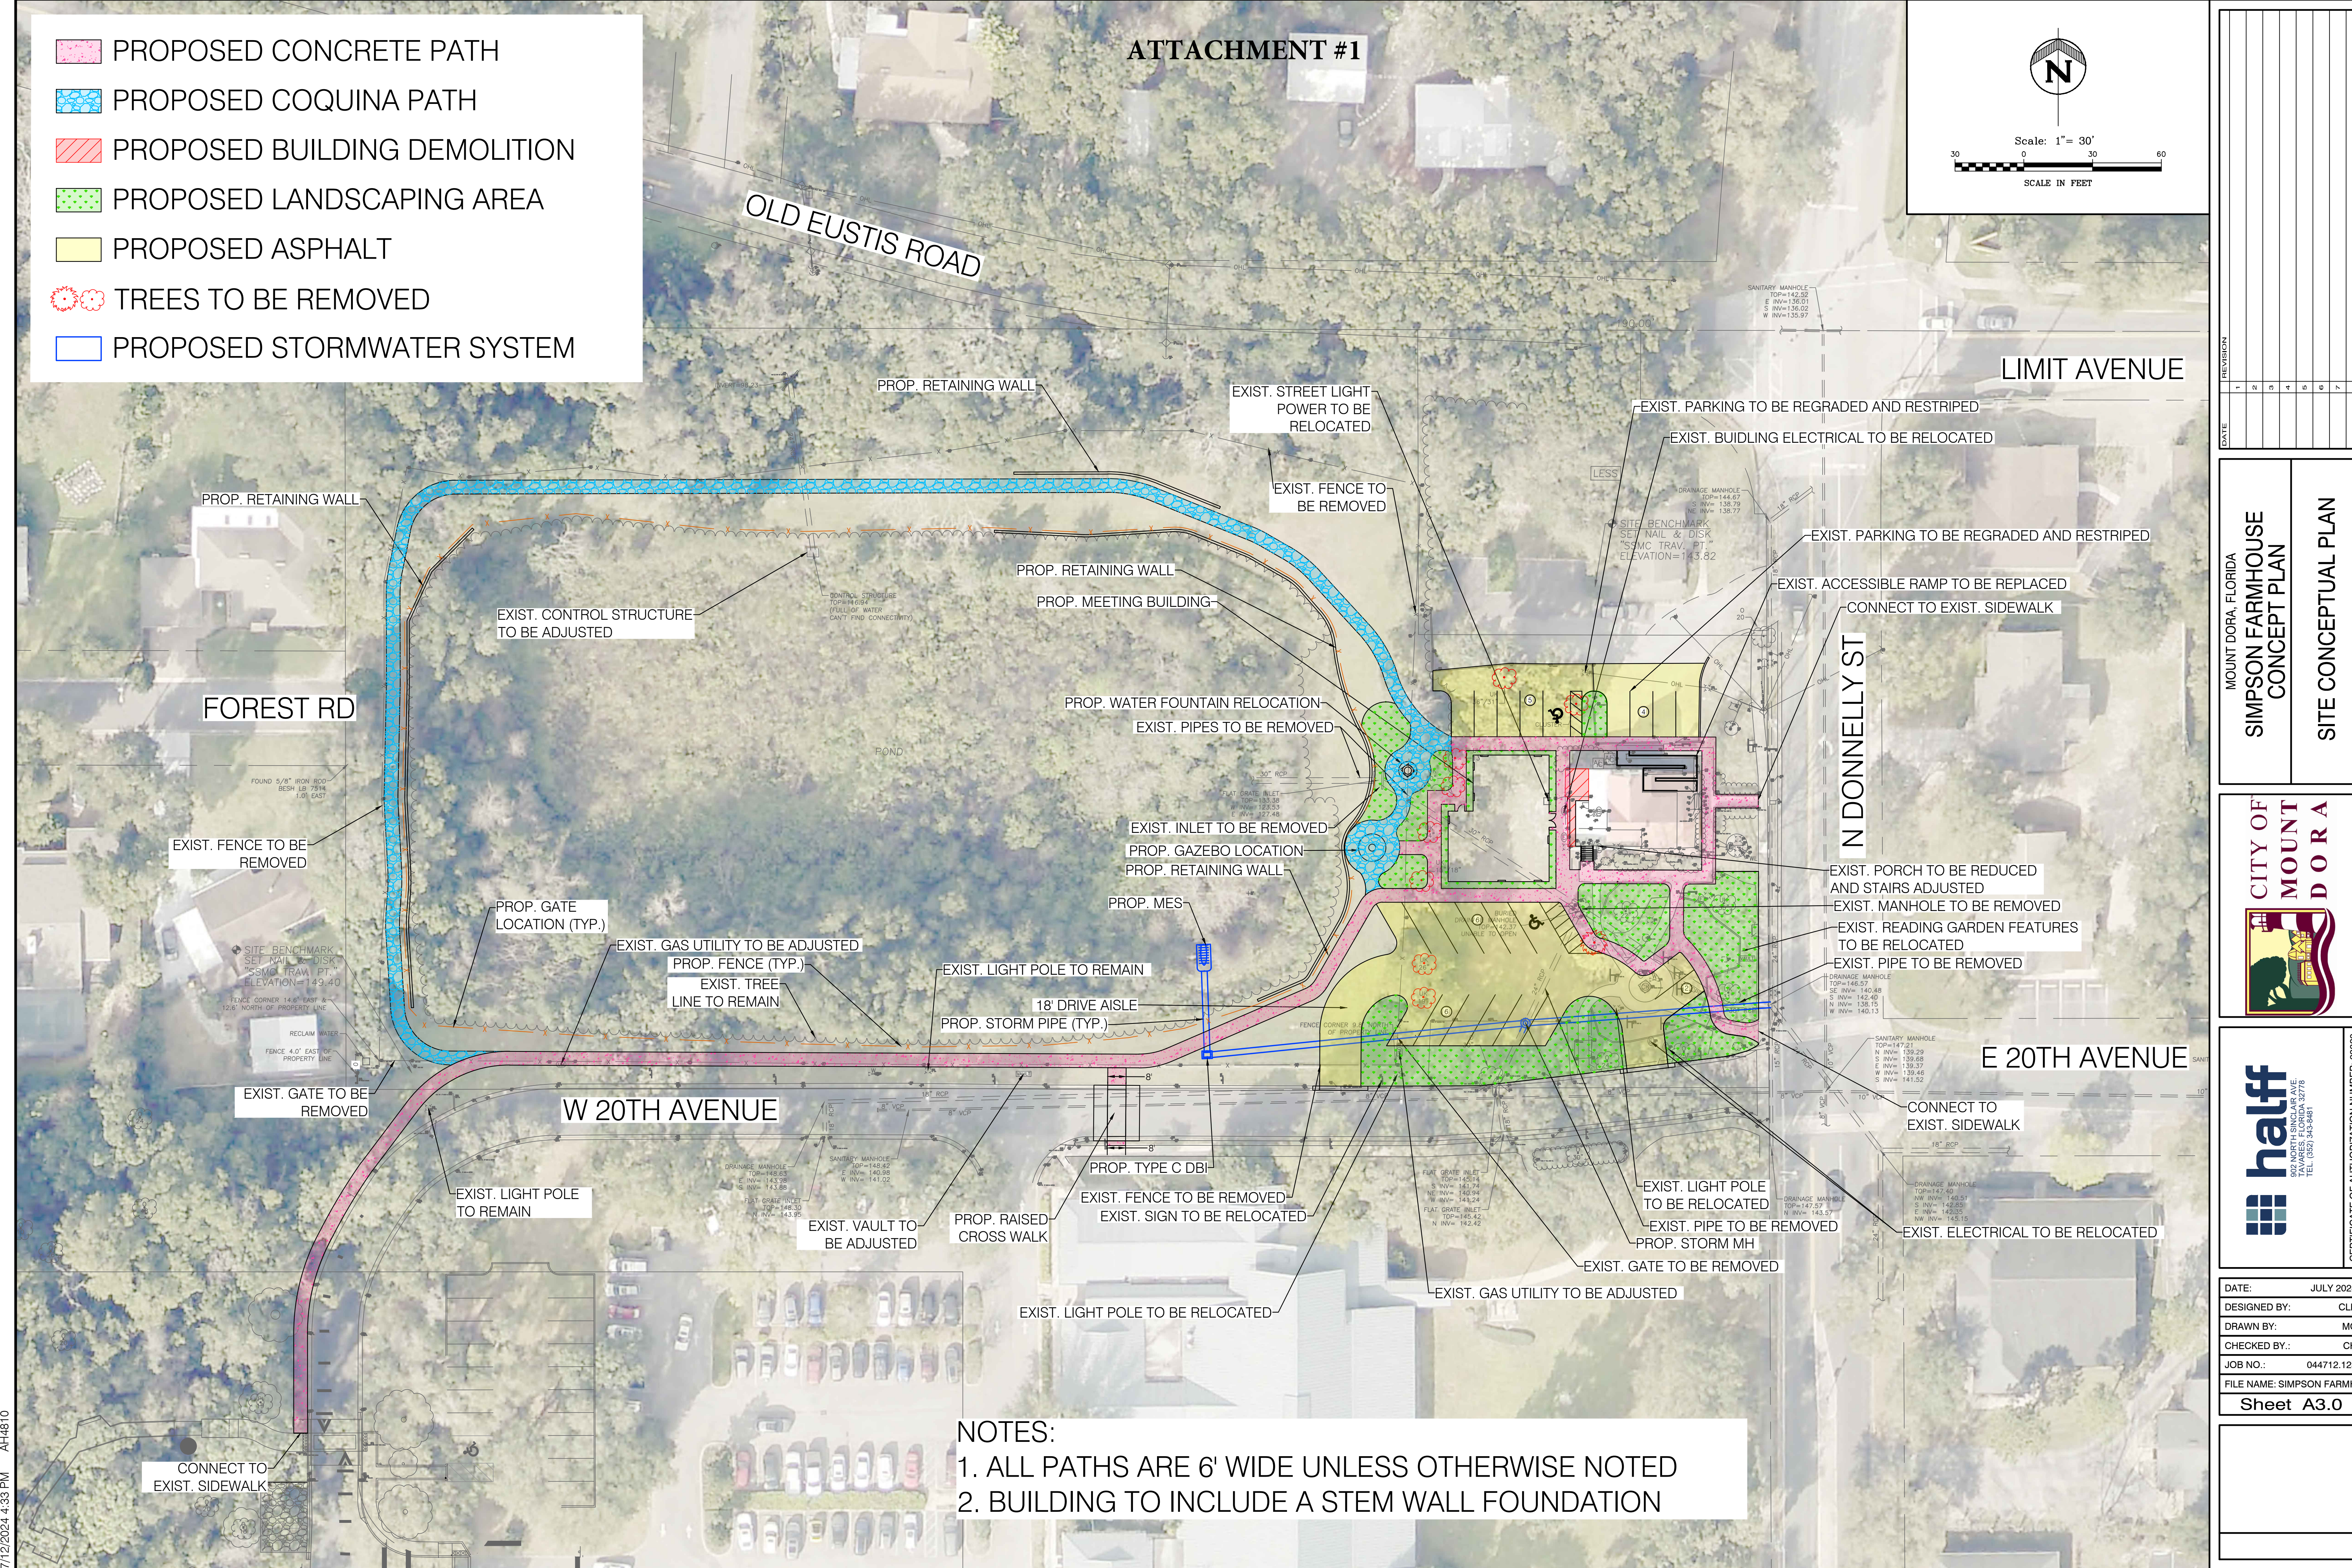
MOUNT DORA, FLORIDA
SIMPSON FARMHOUSE
 CONCEPT PLAN
SITE CONCEPTUAL PLAN

- PROPOSED CONCRETE PATH
- PROPOSED COQUINA PATH
- PROPOSED BUILDING DEMOLITION
- PROPOSED LANDSCAPING AREA
- PROPOSED ASPHALT
- TREES TO BE REMOVED
- PROPOSED STORMWATER SYSTEM

NOTES:
 1. ALL PATHS ARE 6' WIDE UNLESS OTHERWISE NOTED
 2. BUILDING TO INCLUDE A STEM WALL FOUNDATION

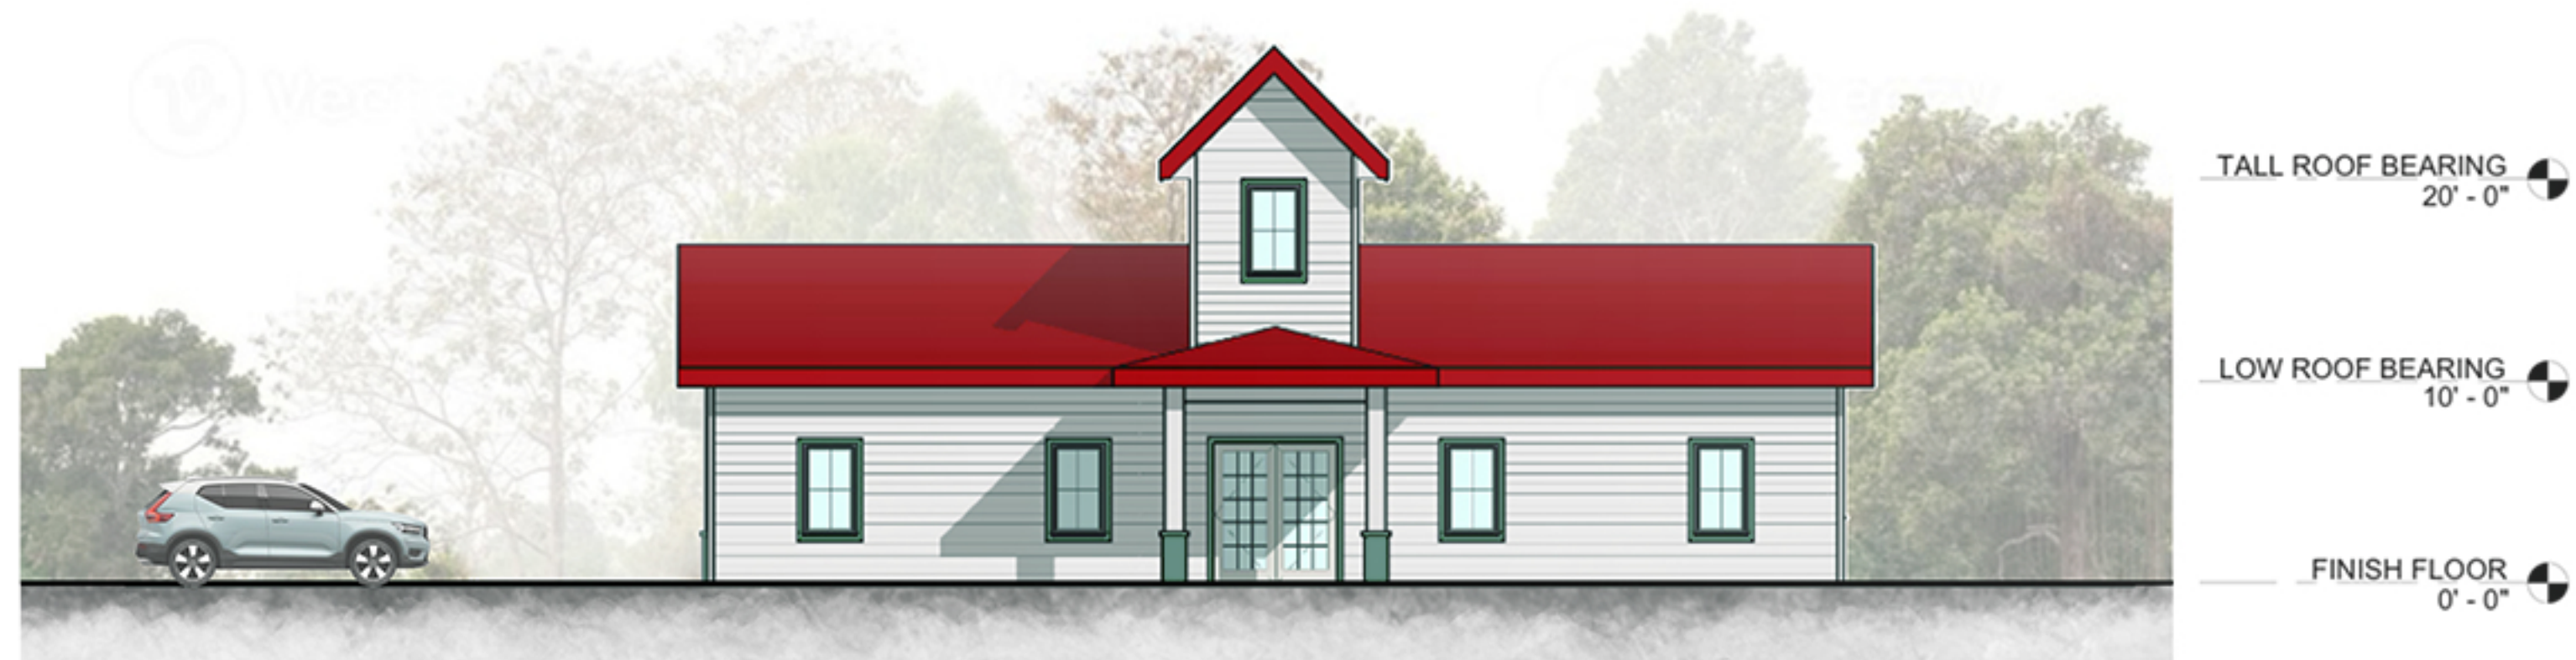
OVERALL EAST ELEVATION

1/8" = 1'-0"

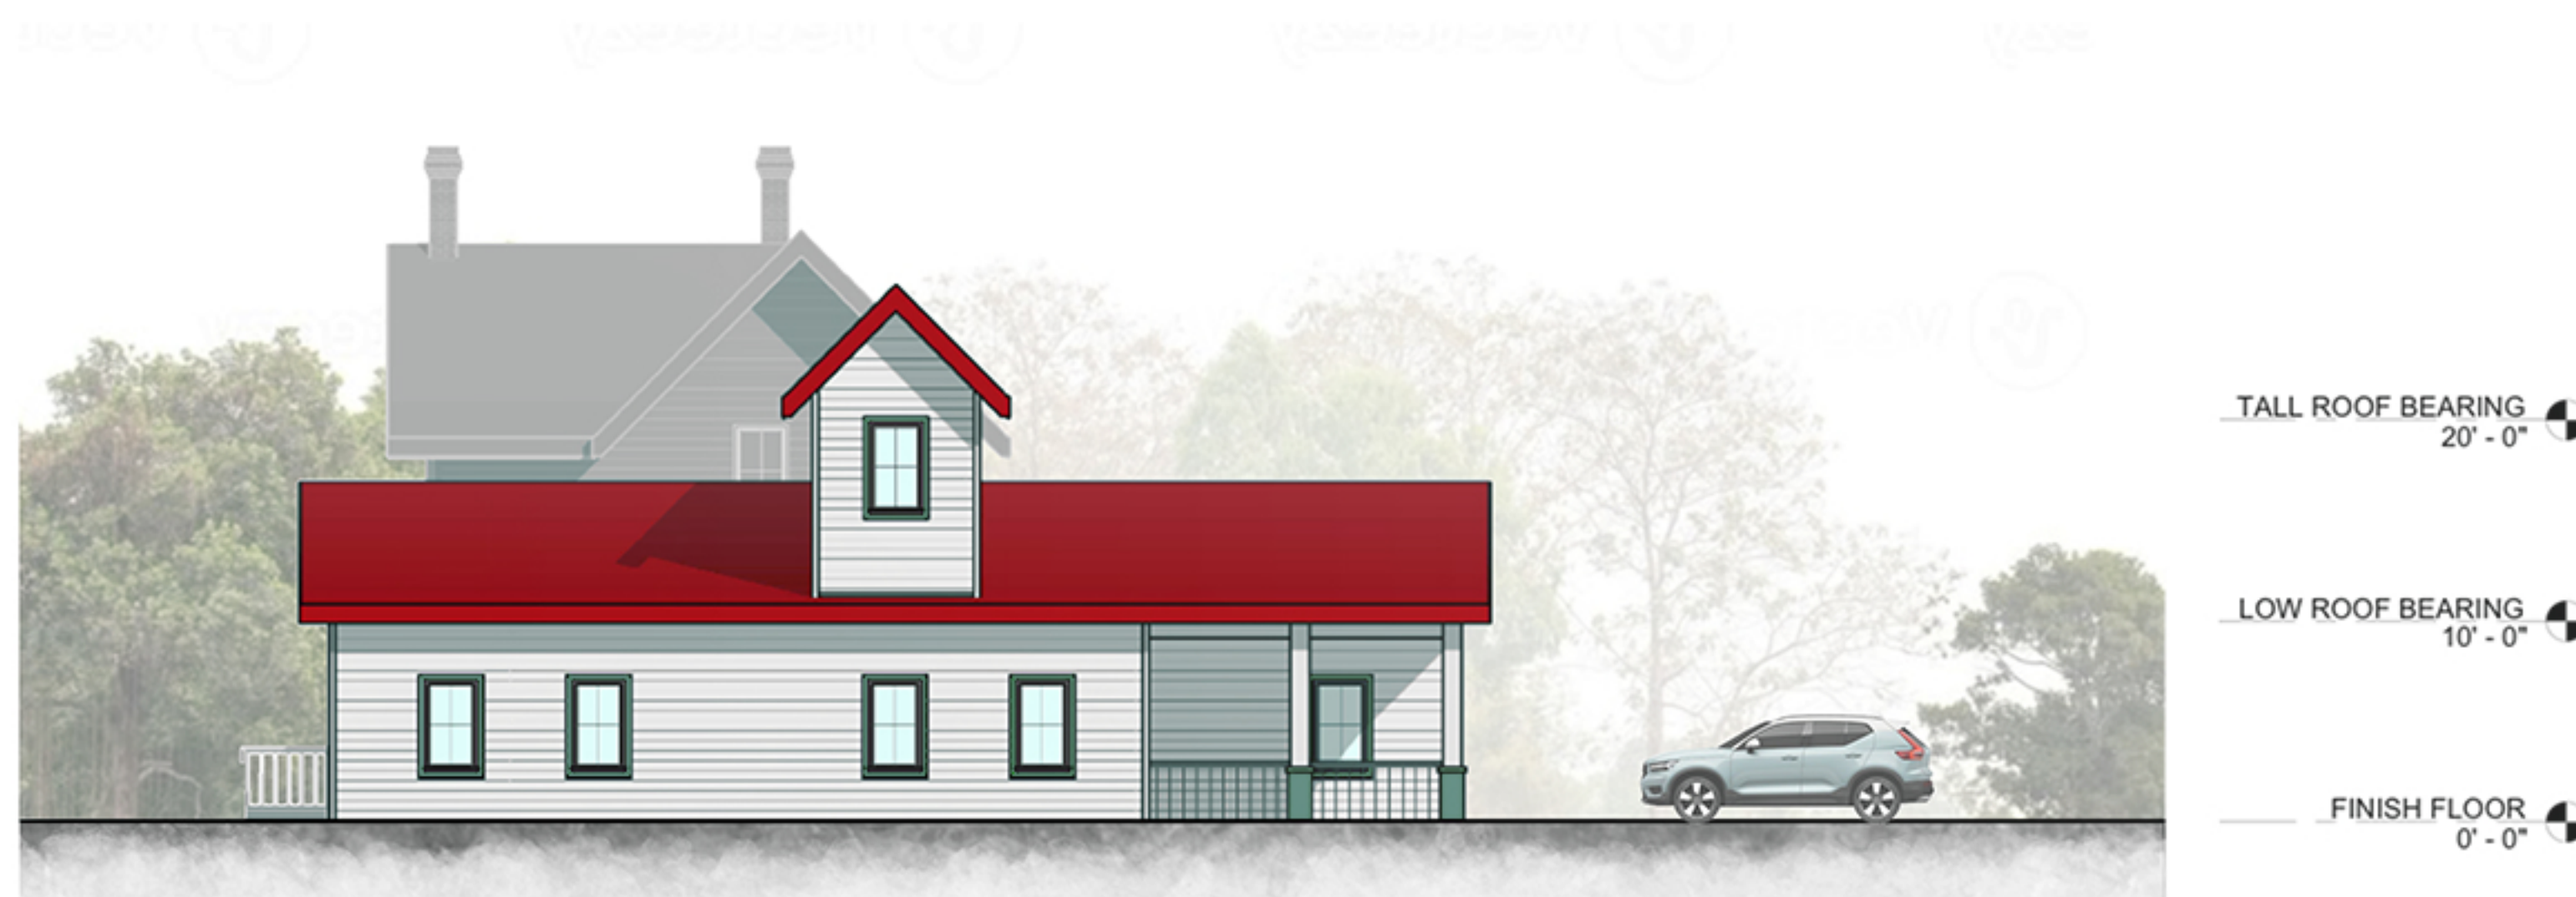
OVERALL WEST ELEVATION

1/8" = 1'-0"

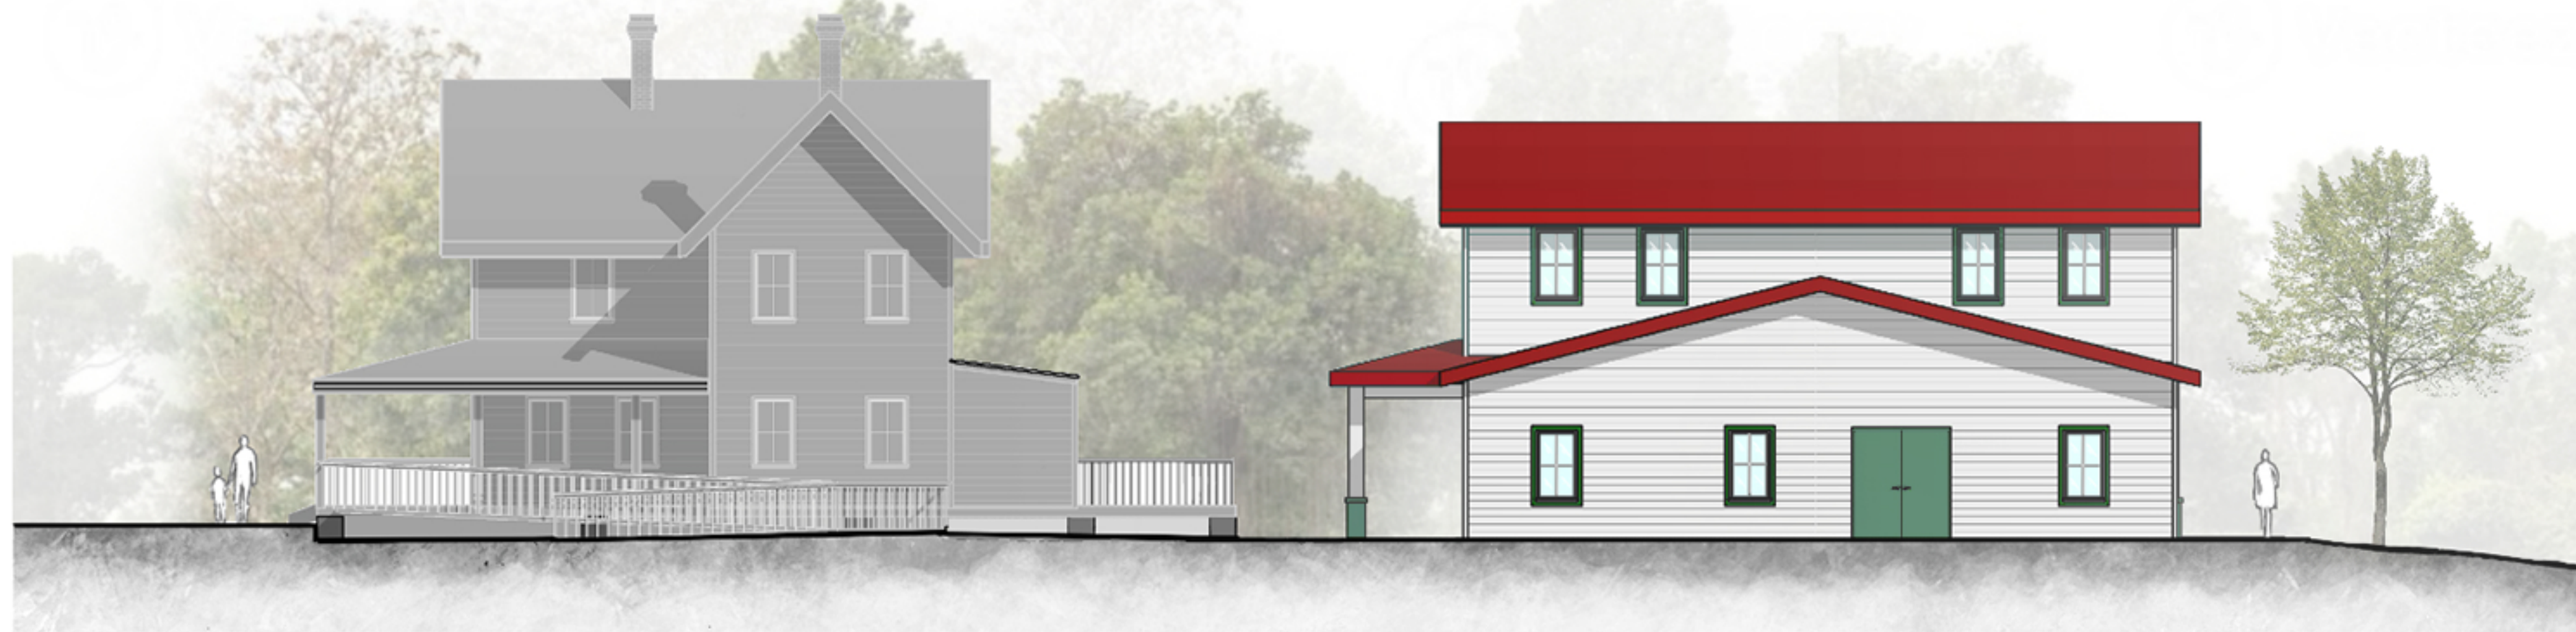
OVERALL NORTH ELEVATION

1/8" = 1' - 0"

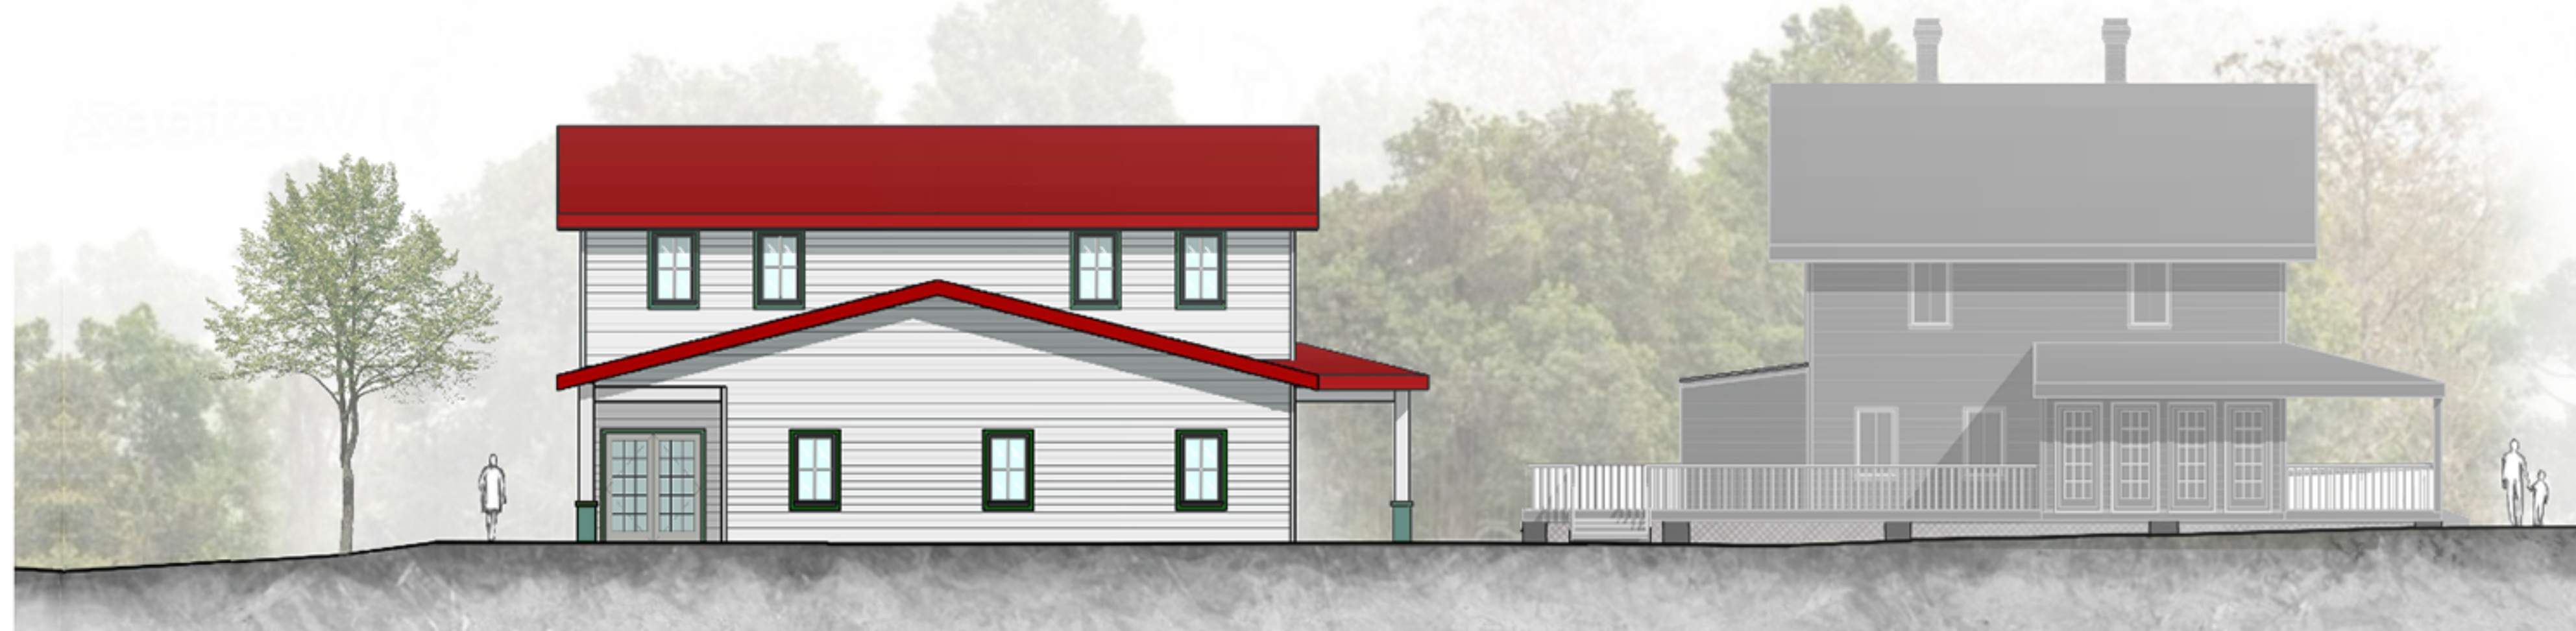
OVERALL SOUTH ELEVATION

1/8" = 1' - 0"
