HISTORIC PRESERVATION BOARD
City Hall – First Floor Board Room
510 N. Baker Street, Mount Dora, Florida
June 25, 2025 at 3:00 PM

AGENDA

**CITY OF MOUNT DORA
HISTORIC PRESERVATION BOARD
APRIL 30, 2025 MEETING MINUTES**

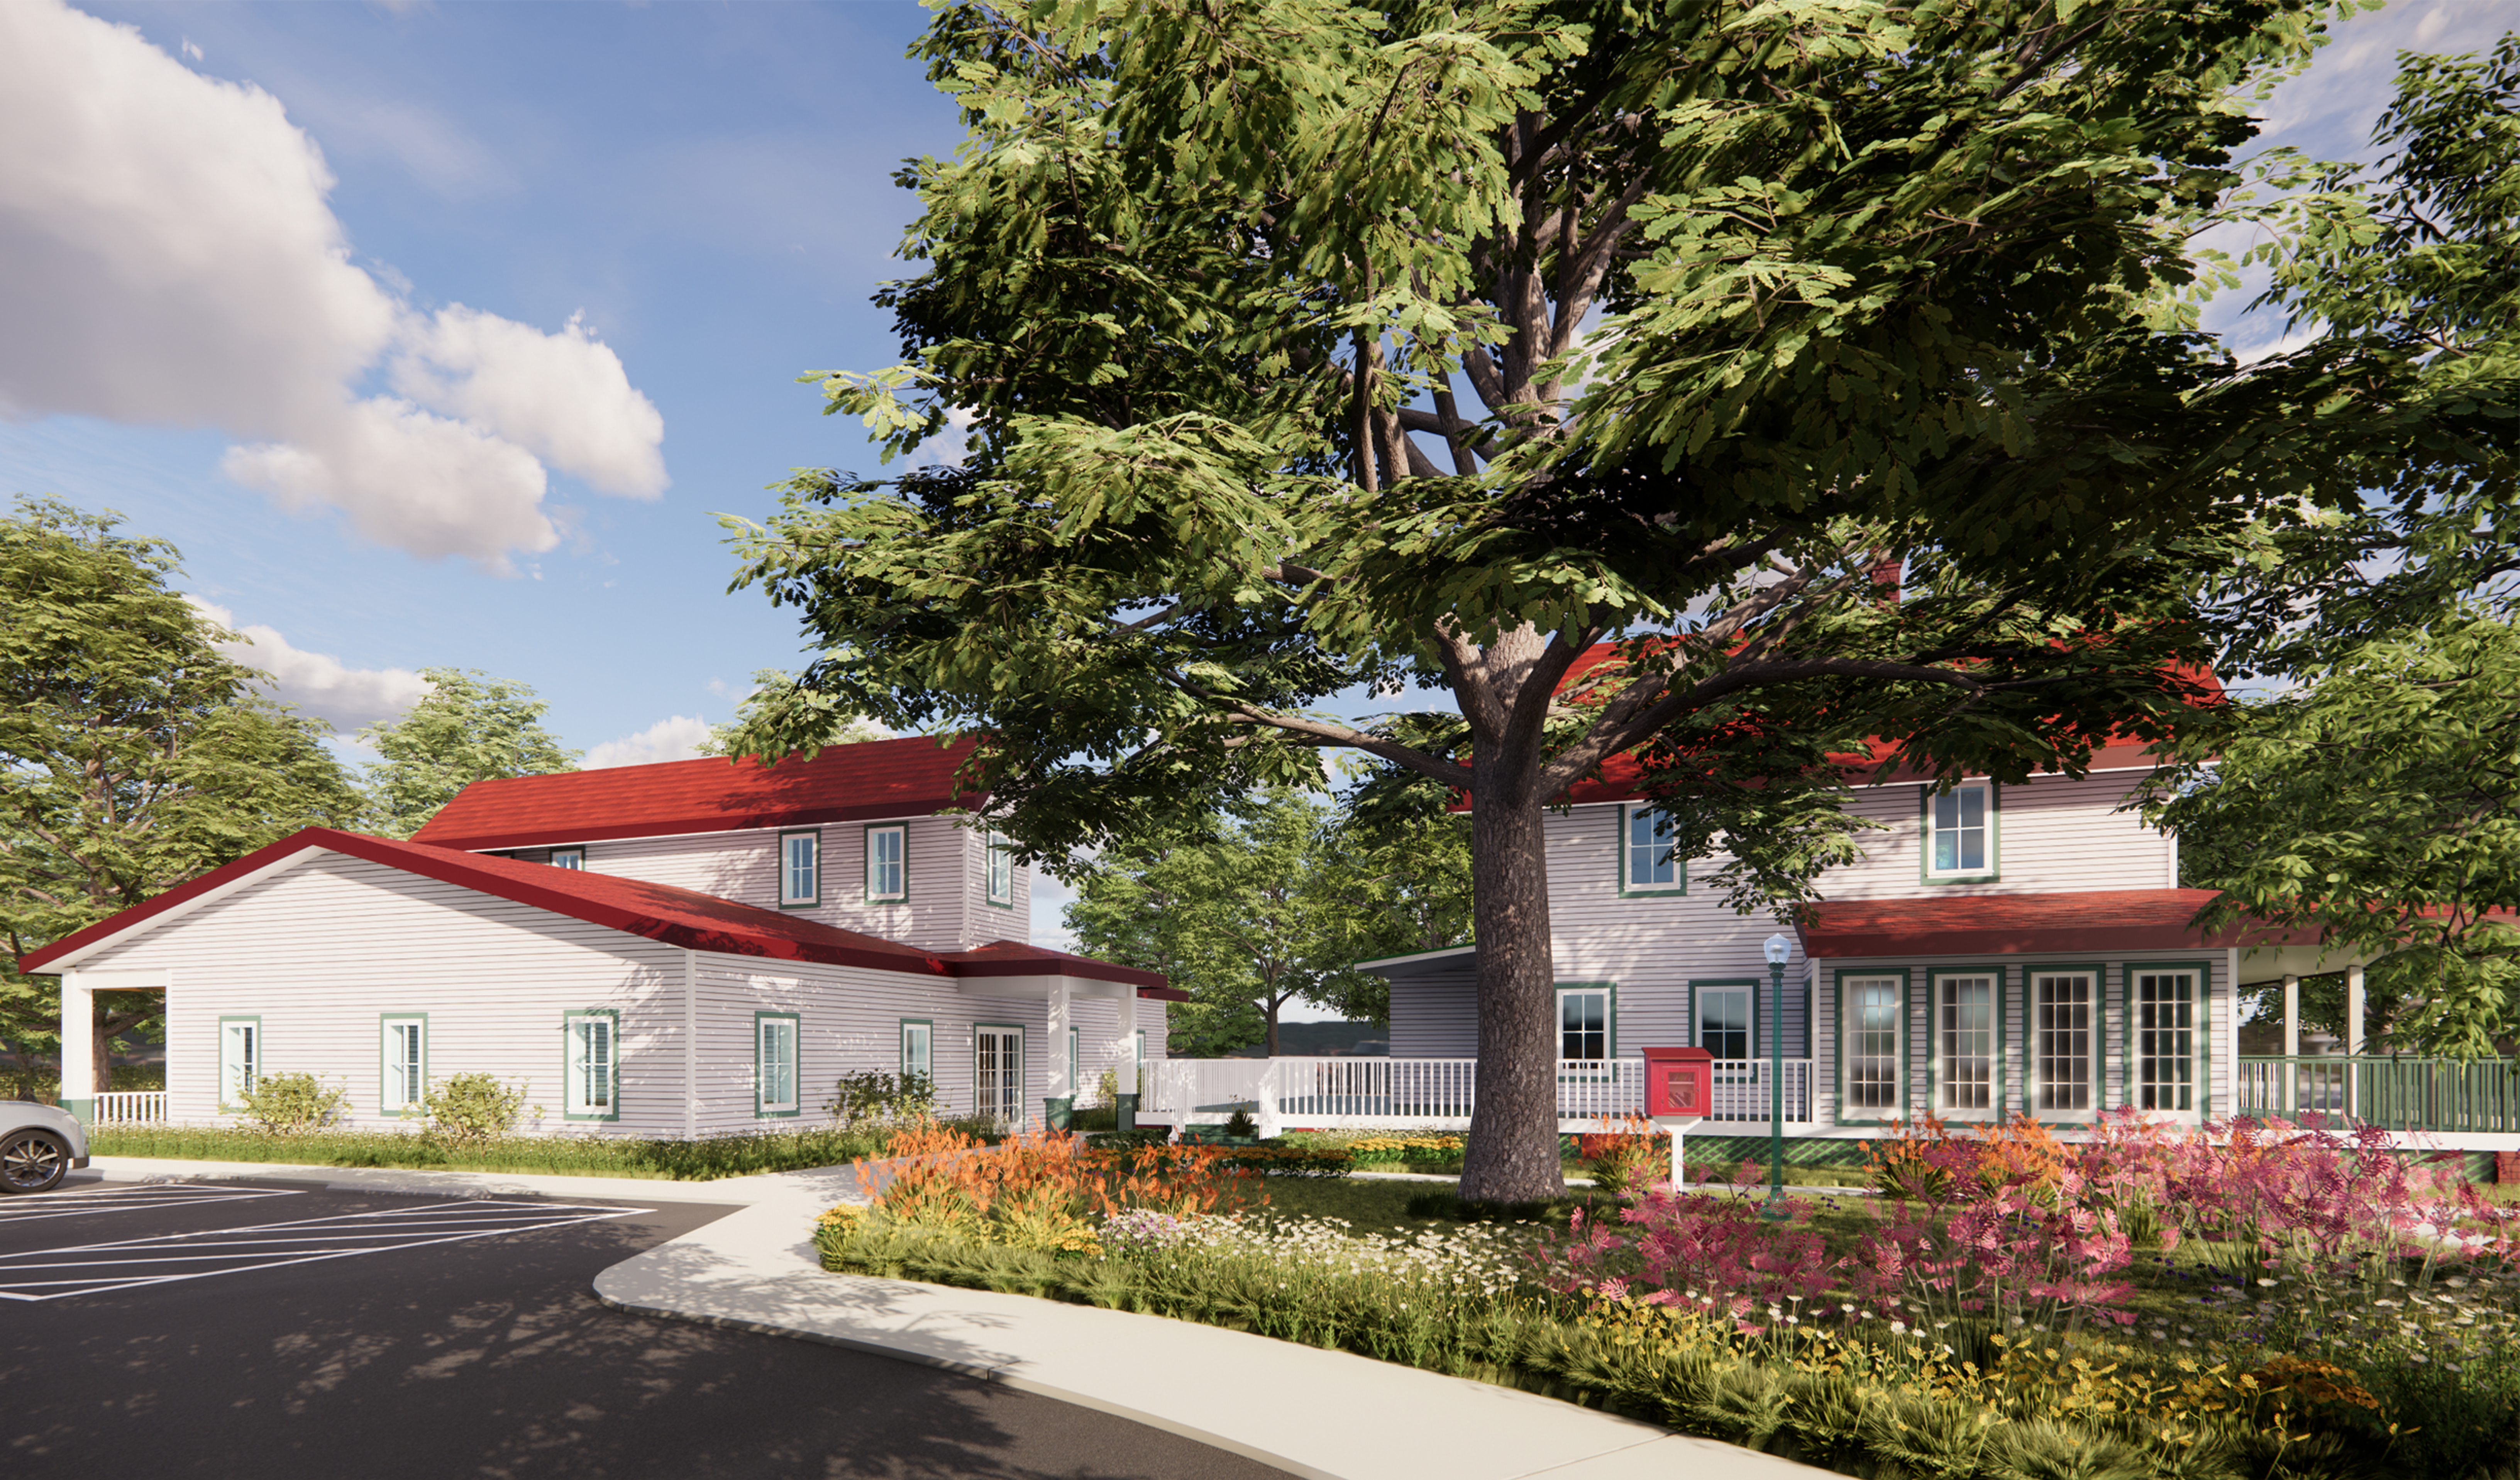
Exterior Render

Library Simpson Farmhouse Expansion

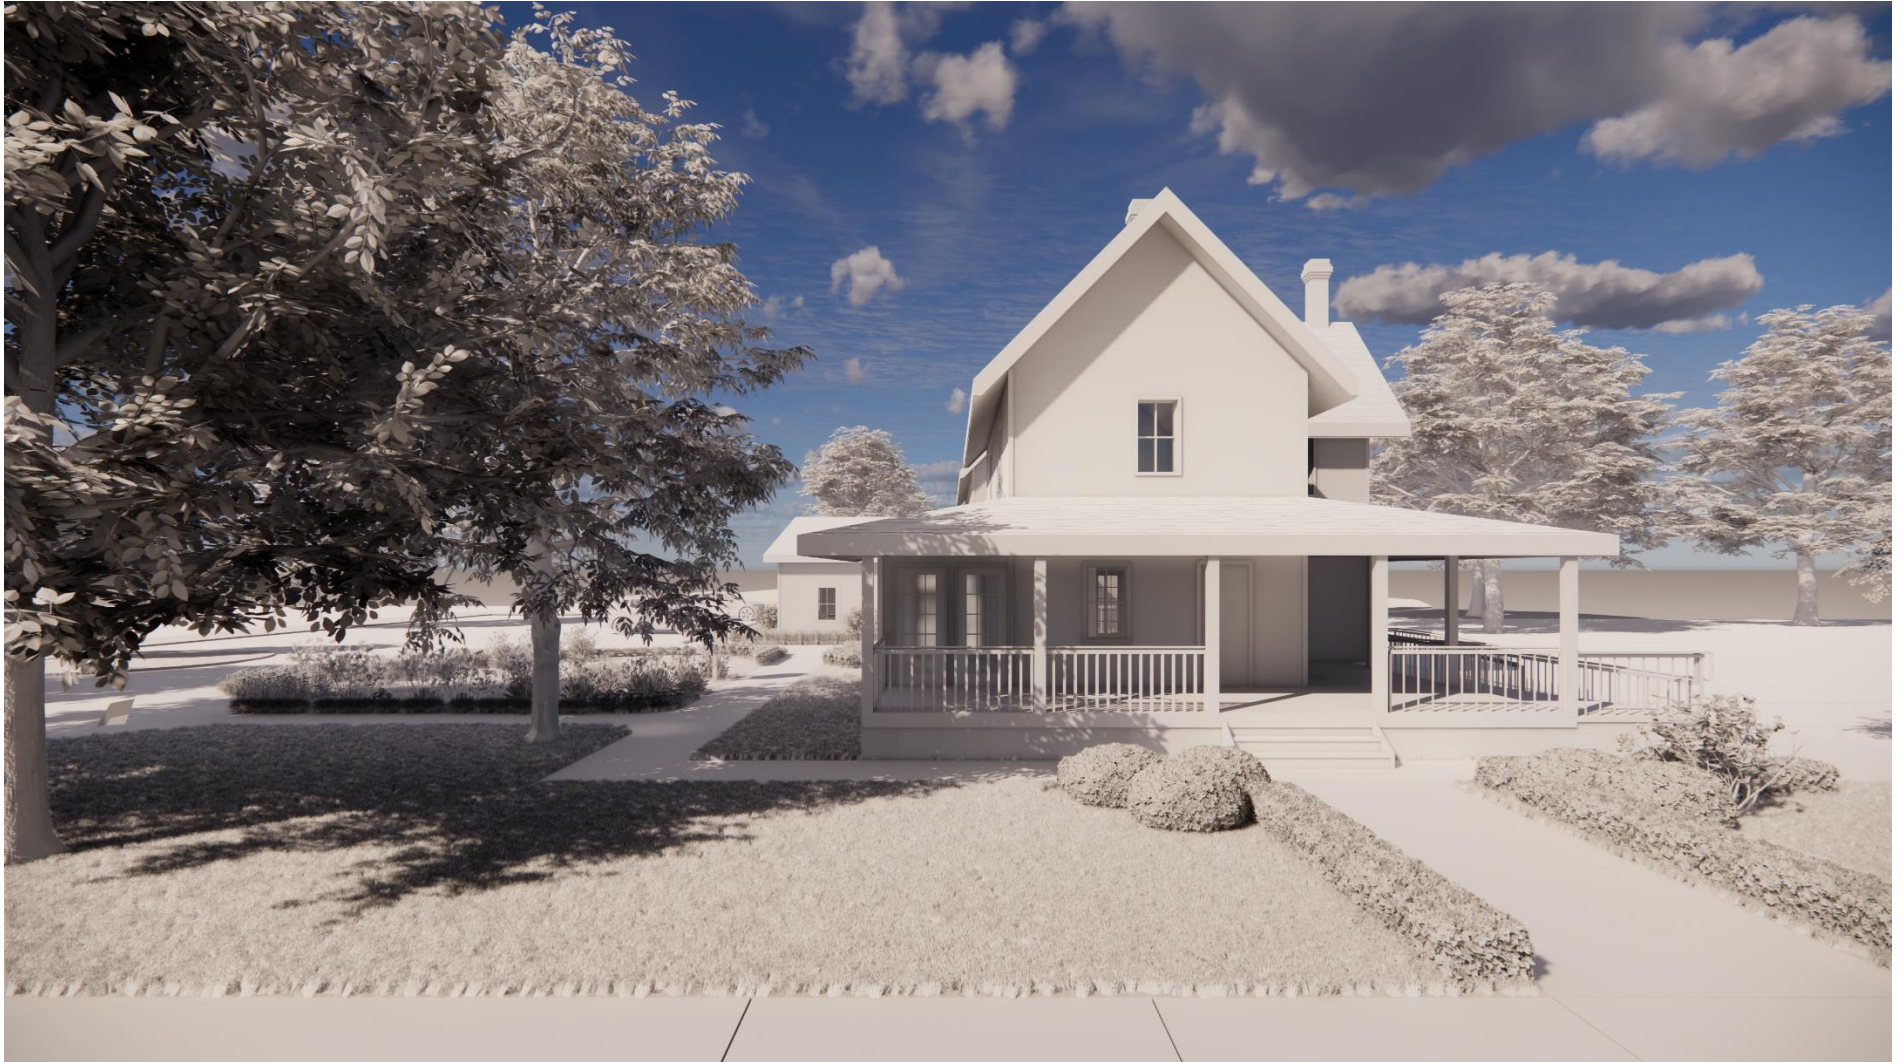
Perspective West from Donnelly Street

Simpson Farmhouse
