**HISTORIC PRESERVATION BOARD**  
**City Hall – First Floor Board Room**  
**510 N. Baker Street, Mount Dora, Florida**  
**July 30, 2025 at 3:00 PM**

**AGENDA**

**DATE:** July 30, 2025  
**TO:** Historic Preservation Board  
**FROM:** Michele Janiszewski, AICP, Senior Planner  
**RE:** **Tab 2 - Certificate of Appropriateness; 625 N Tremain Street (Location); Porch and Foundation Modifications (Proposed Work); Leah C Germain (Owner); Vedder Construction (Applicant).**

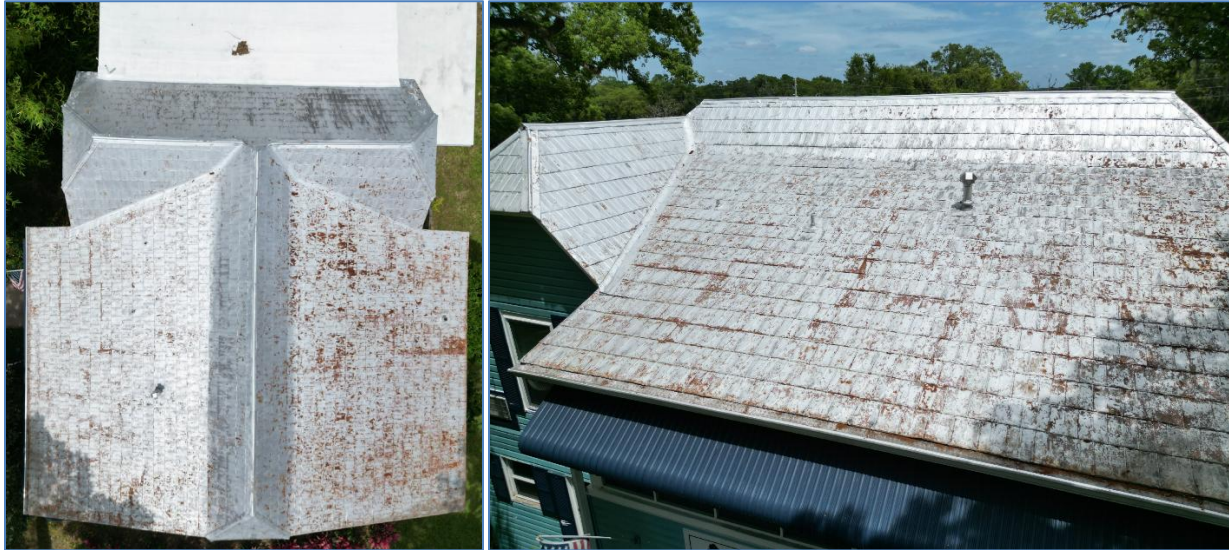
The Applicant is requesting to remove the existing metal shingles and replace them with asphalt shingles in antique silver. The Application states that the roof needs to be replaced due to its age.

<b>Roofing System to be Installed:</b>		
<b>Structure:</b>		Retail Roofing Garage

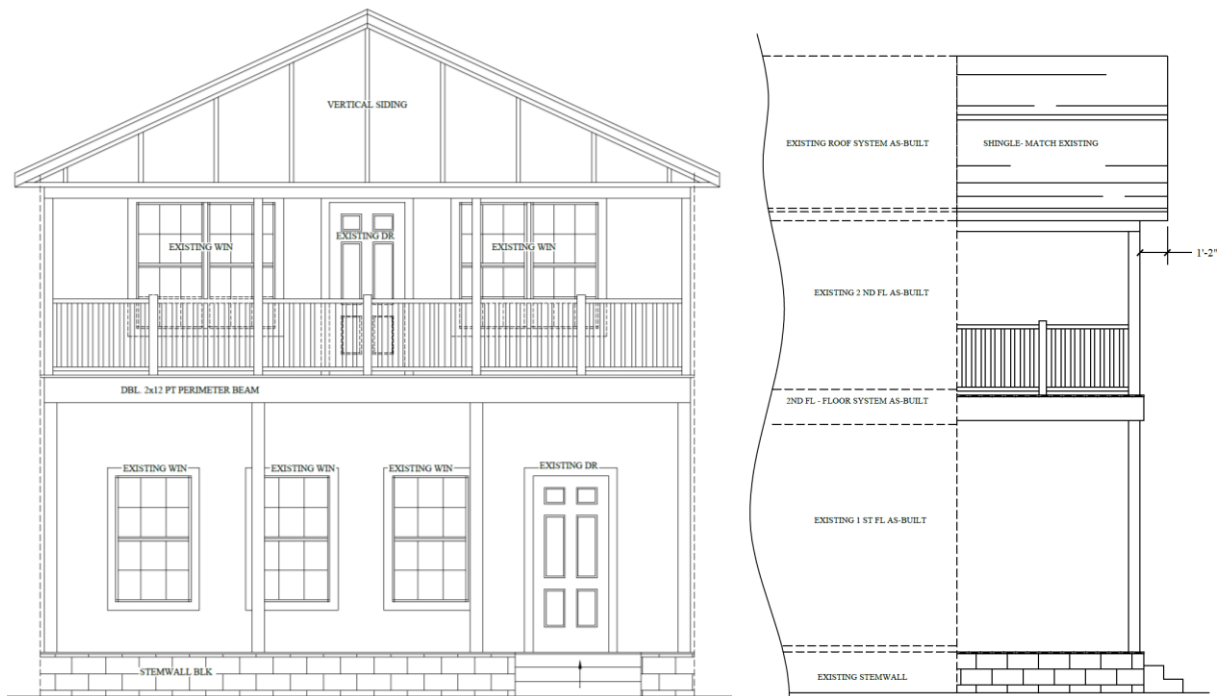
The Applicant is seeking to renovate the second story patio on the rear of the house and finish the ground level patio with a new foundation. The Application indicates that the upper deck patio has been damaged by water.

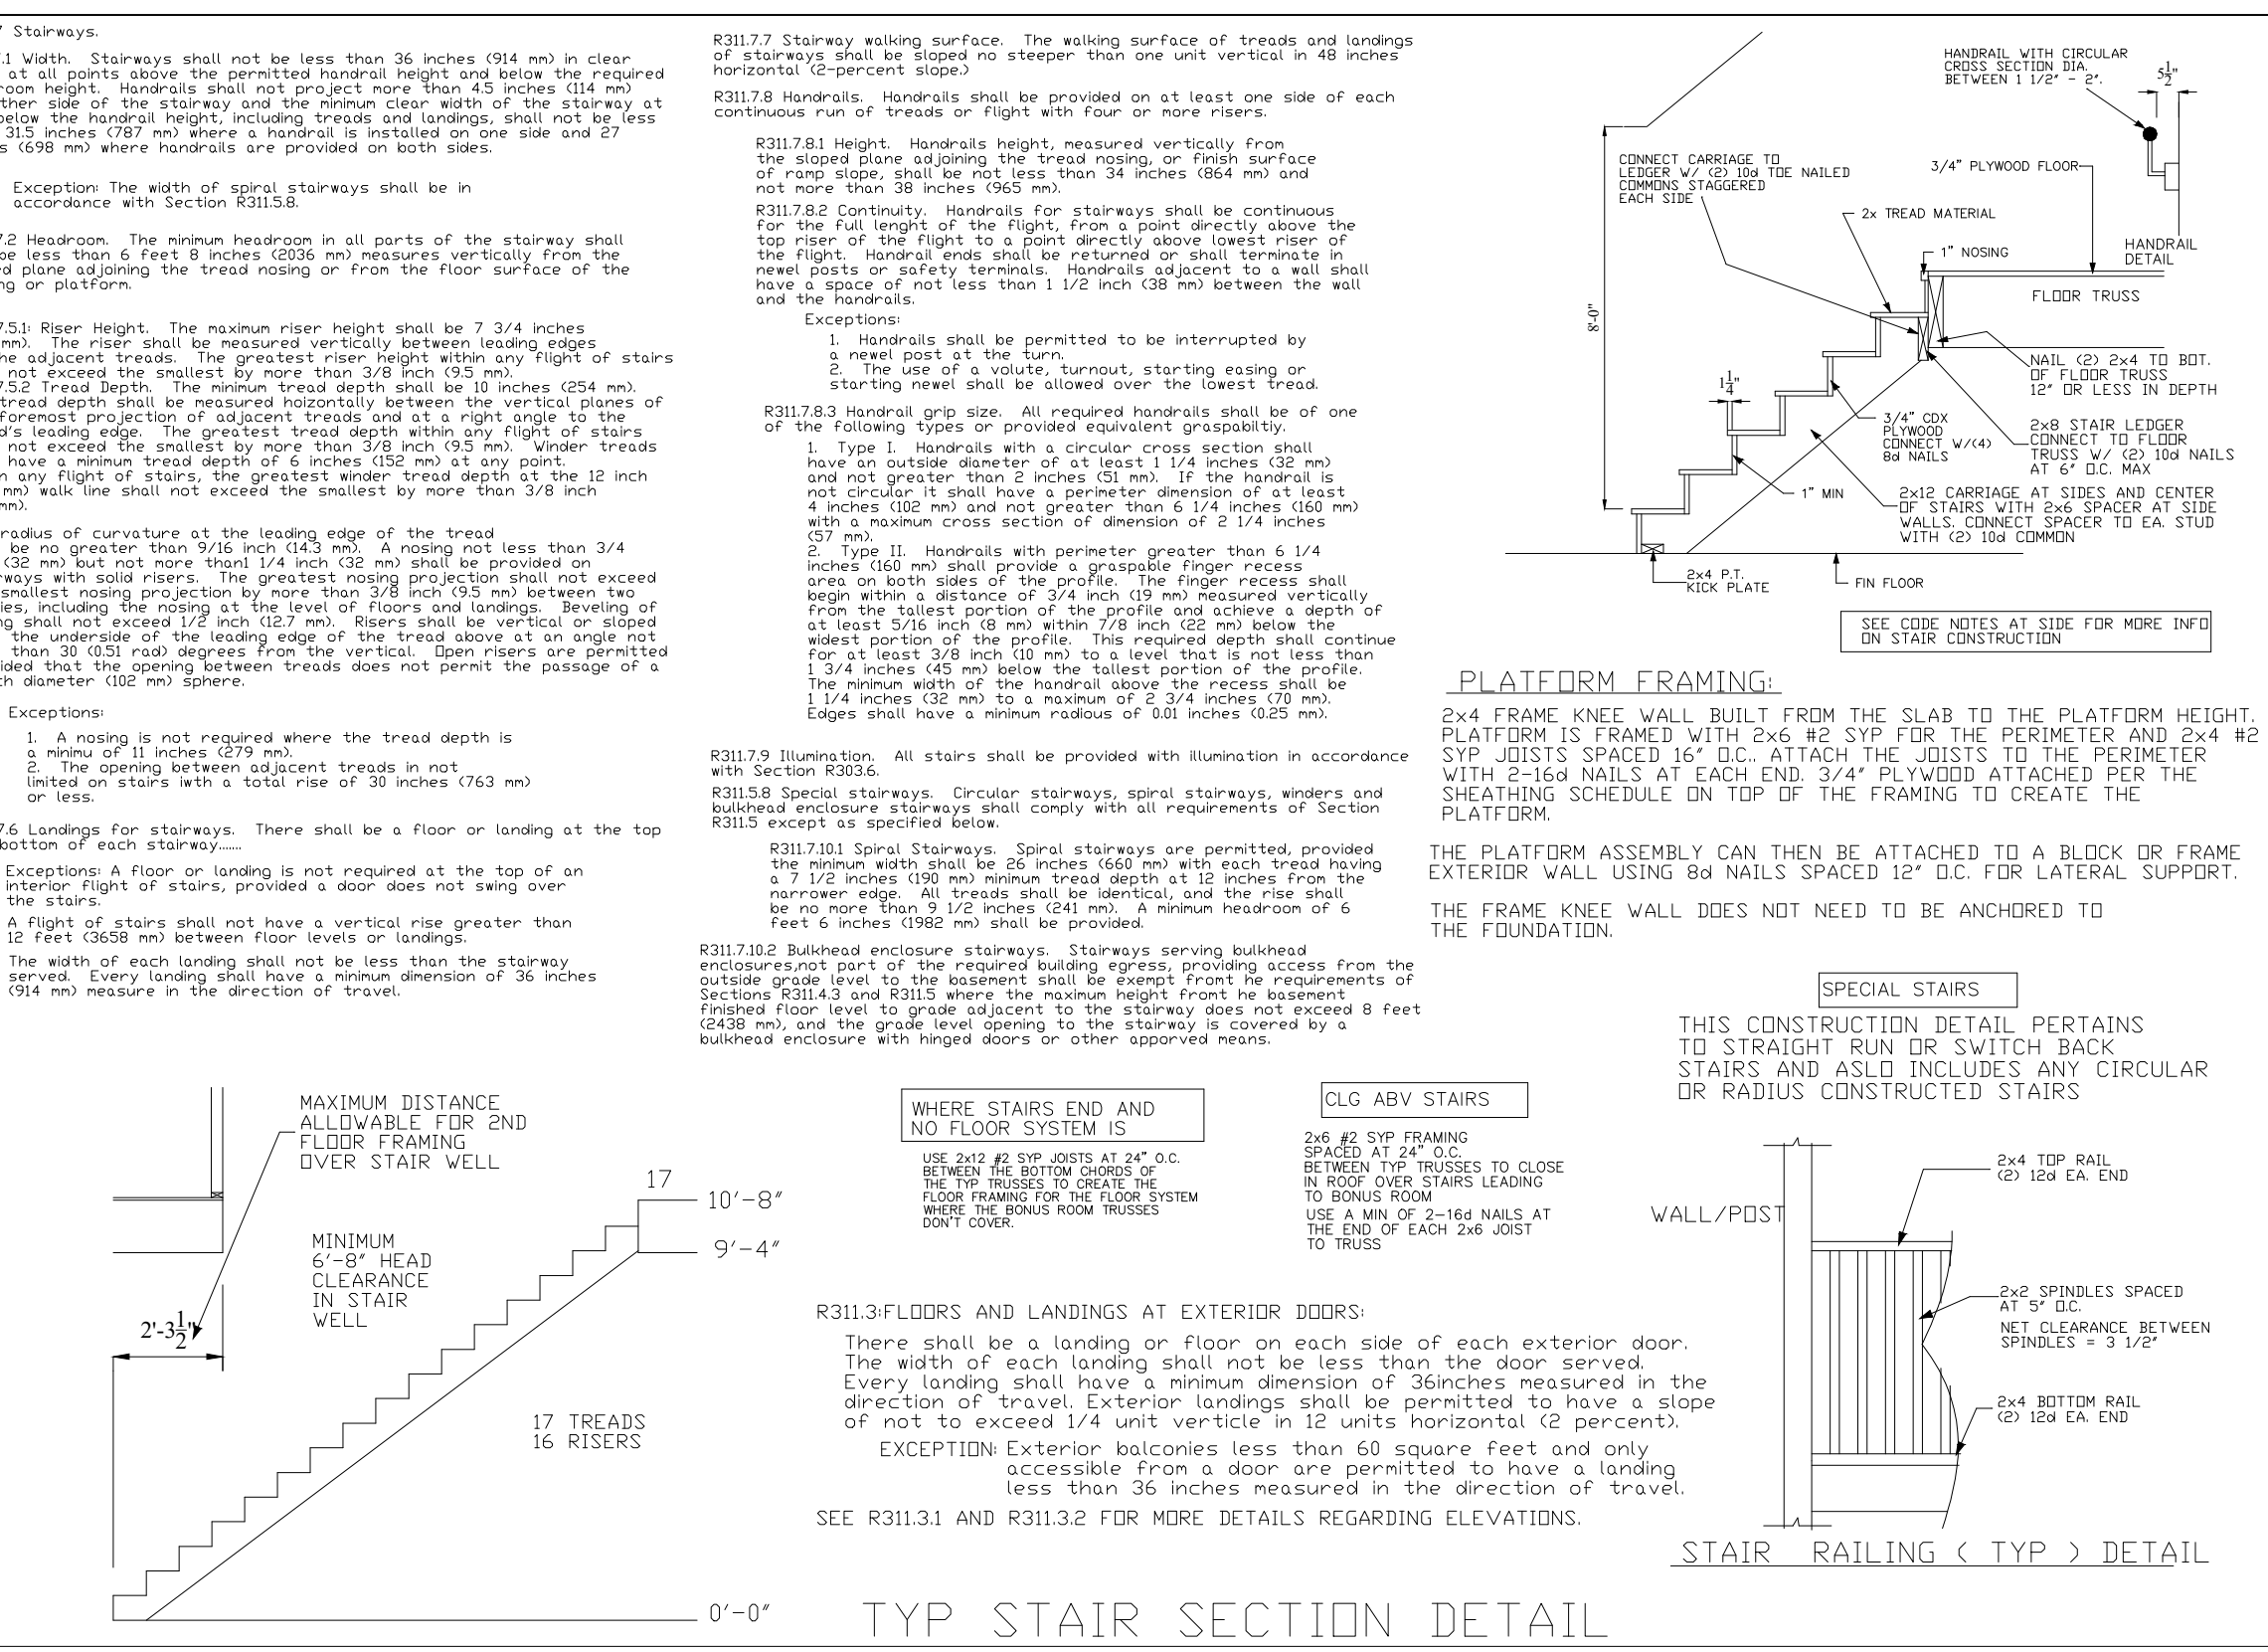
PLATFORM FRAMING:

2x4 FRAME KNEE WALL BUILT FROM THE SLAB TO THE PLATFORM HEIGHT. PLATFORM IS FRAMED WITH 2x6 #2 SYP FOR THE PERIMETER AND 2x4 #2 SYP JOISTS SPACED 16" O.C. ATTACH THE JOISTS TO THE PERIMETER WITH 2-16d NAILS AT EACH END. 3/4" PLYWOOD ATTACHED PER THE SHEATHING SCHEDULE ON TOP OF THE FRAMING TO CREATE THE PLATFORM.  
THE PLATFORM ASSEMBLY CAN THEN BE ATTACHED TO A BLOCK OR FRAME EXTERIOR WALL USING 8d NAILS SPACED 16" O.C. FOR LATERAL SUPPORT.

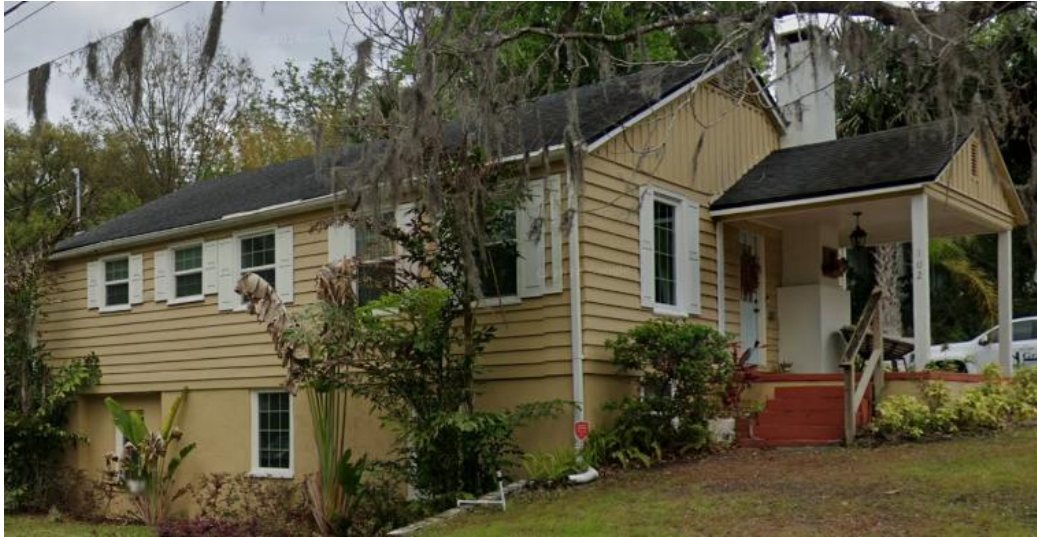
Existing Condition  
of the Western  
Façade

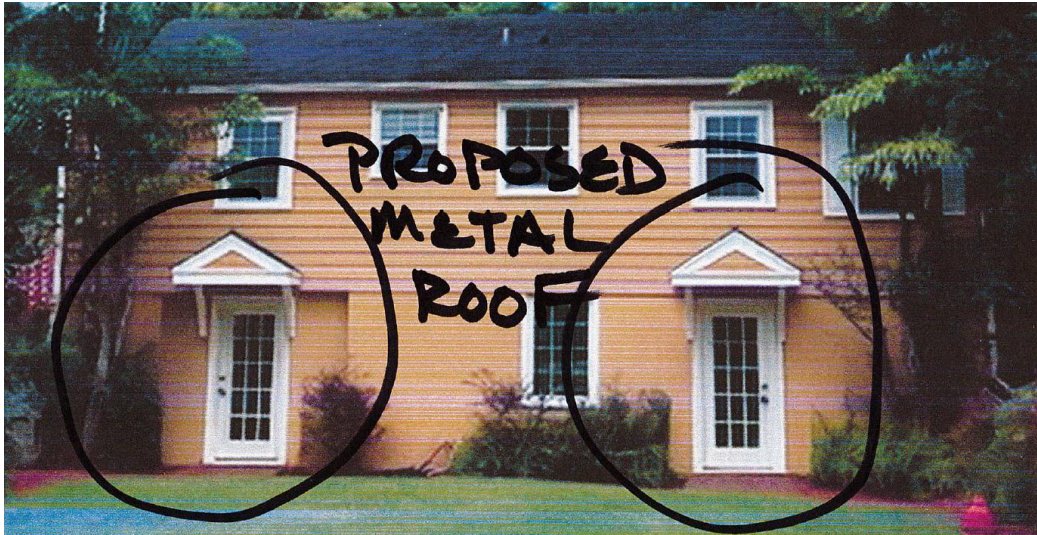
Elevation  
Depicting the  
Proposed  
Word on the  
Western  
Façade

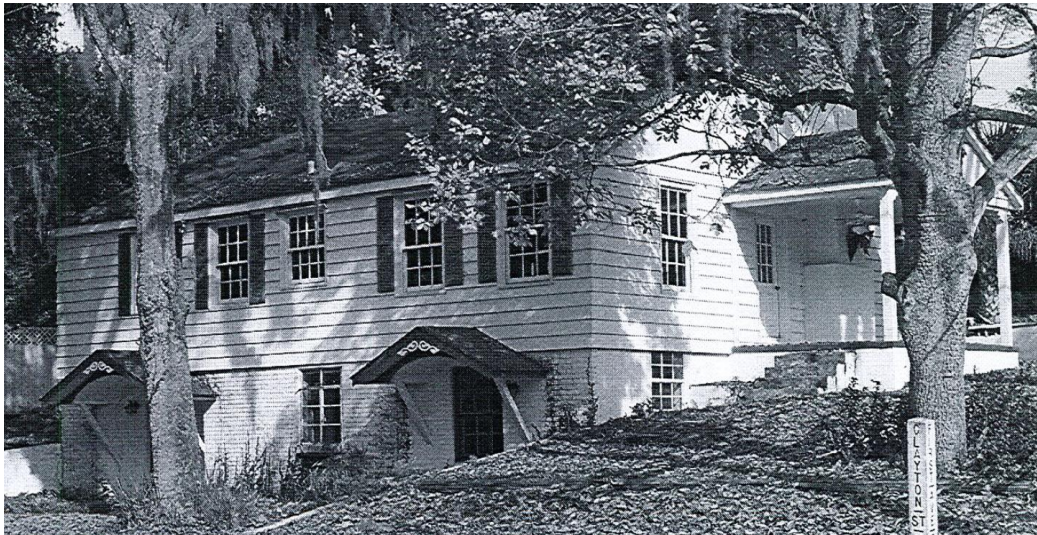
Western  
Façade of the  
residence from  
the 2008 Site  
File

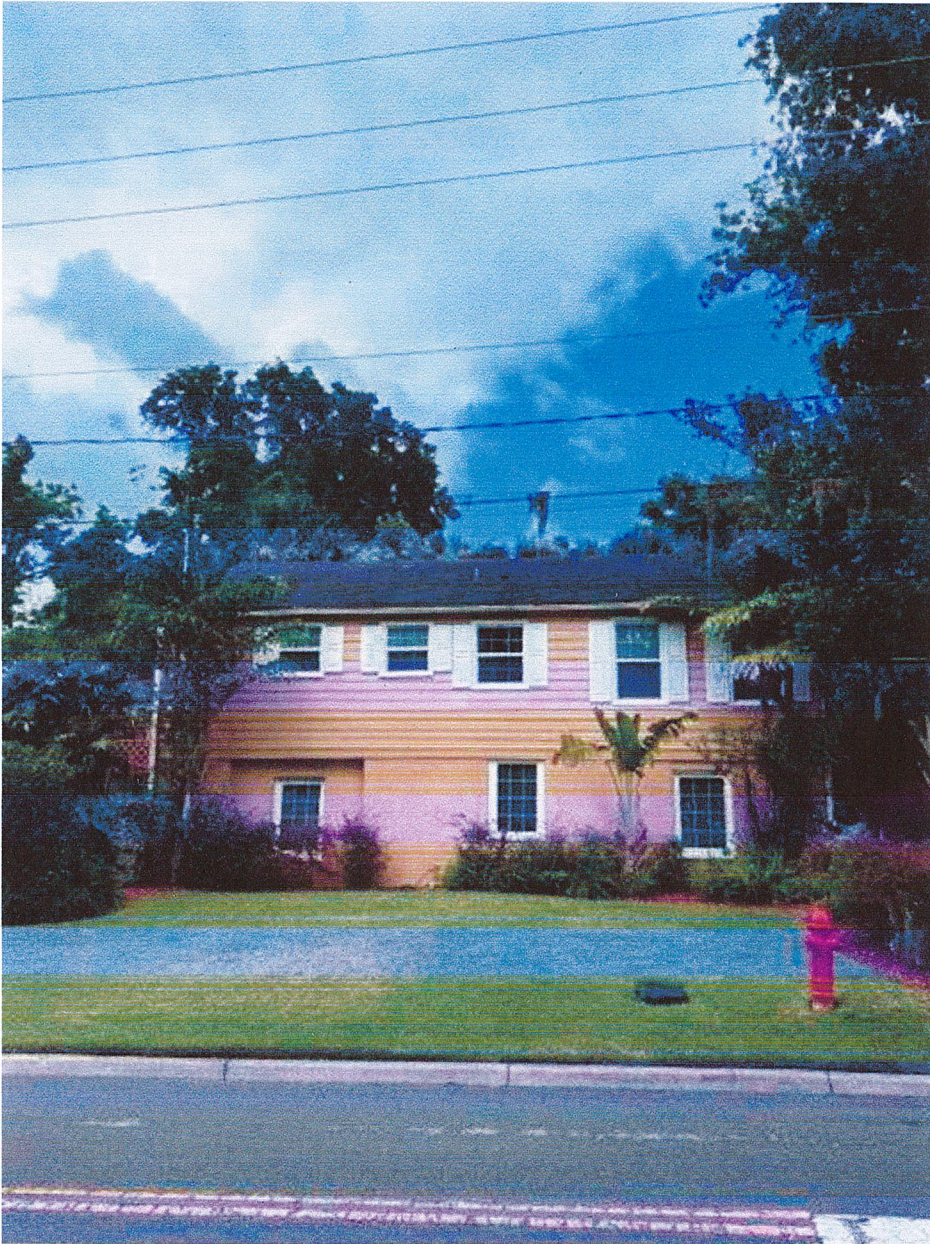
CLAYTON VIEW

The following images provide "before" and "after" views. Please note that the "after" image is AI generated, and shows one door in a different position than the current window. This proposal includes two doors in the **same location as the existing windows**.

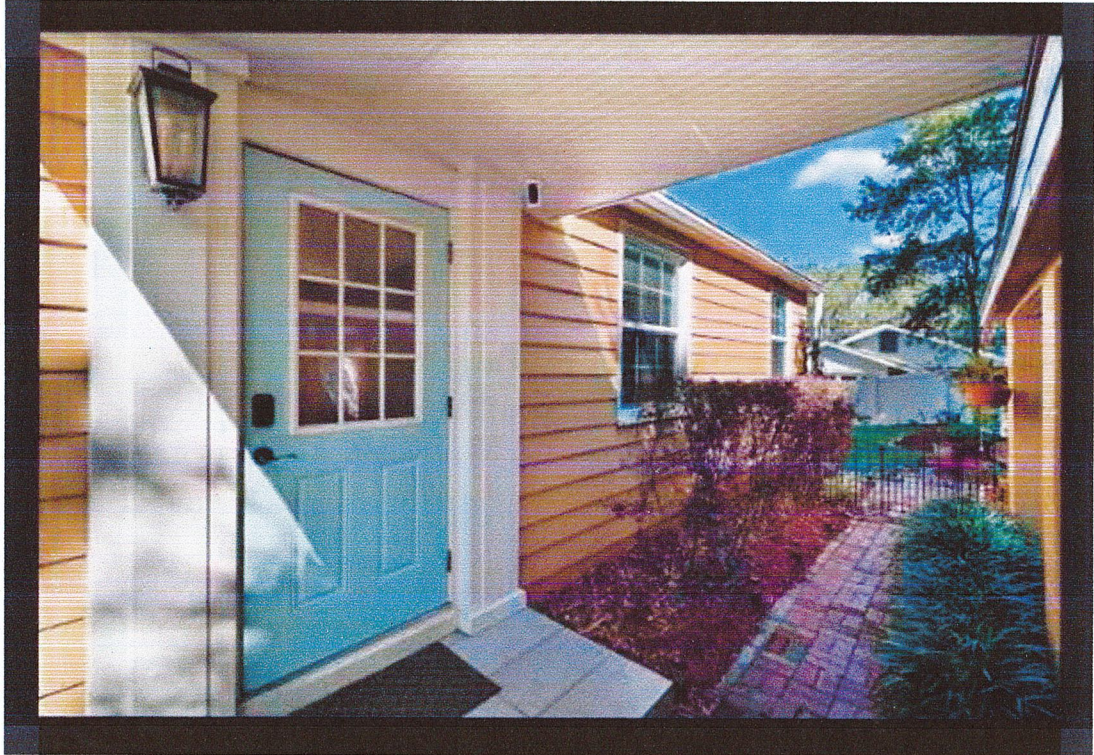
- "Wood-look" doors that preserve the original look but reduce maintenance and deterioration.
- Existing doors have 9 light panels:

- I am hoping to be able to use doors with less than 9 light panels for security and privacy reasons. Example images below.
