HISTORIC PRESERVATION BOARD
City Hall – 1st Floor Board Room, 510 N. Baker Street, Mount Dora, FL
December 10, 2025 at 3:00 PM

AGENDA

**CITY OF MOUNT DORA, FLORIDA
HISTORIC PRESERVATION BOARD
OCTOBER 29, 2025 MEETING MINUTES**

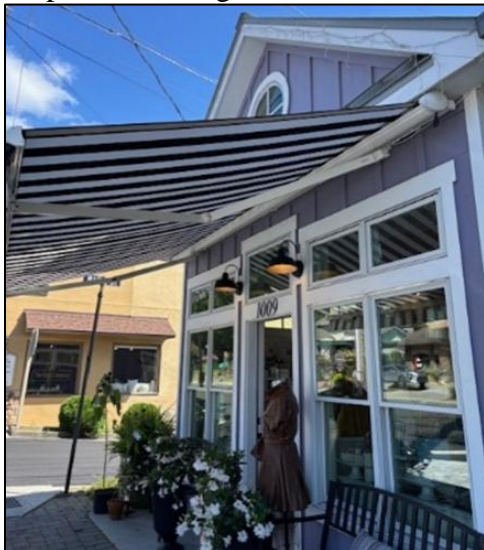
Proposed Awning:

Install a retractable, fabric awning on the northern façade of 100 E 4th Avenue to provide shade and weather protection for the customers of Waffles and Cream.

Therefore, based on these Findings of Fact, staff recommends **Approval** of the application, with the condition that the color of the awning matches the existing awnings.

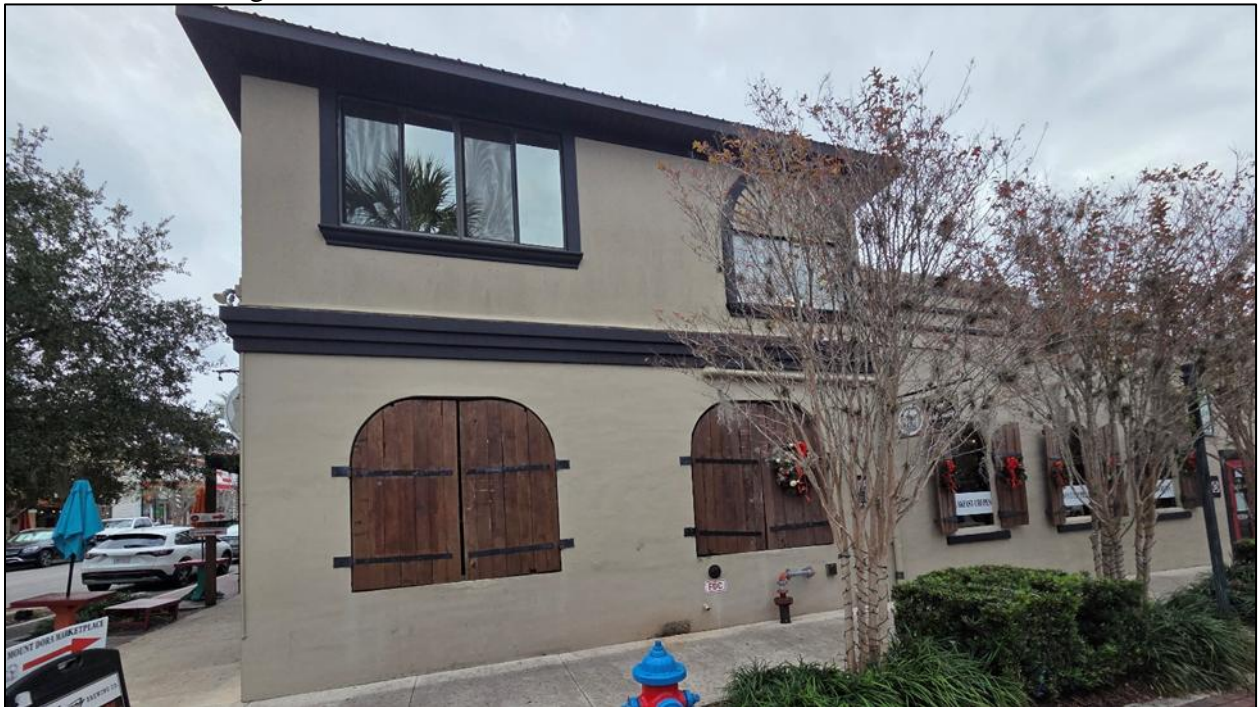
There are no awnings on the western elevation which fronts Fifth Avenue.

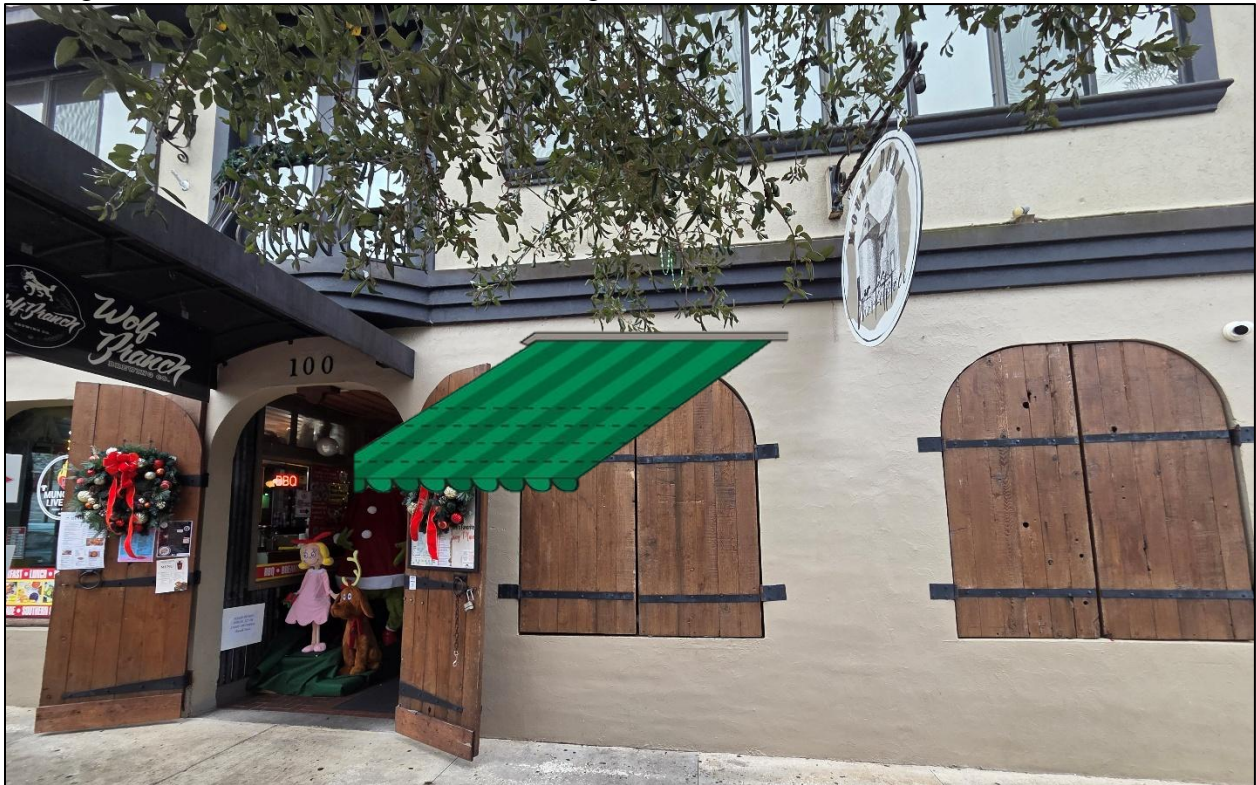
Location of the awning with the proposed awning superimposed on the structure. The imposed awning is not to scale nor is this the final design.

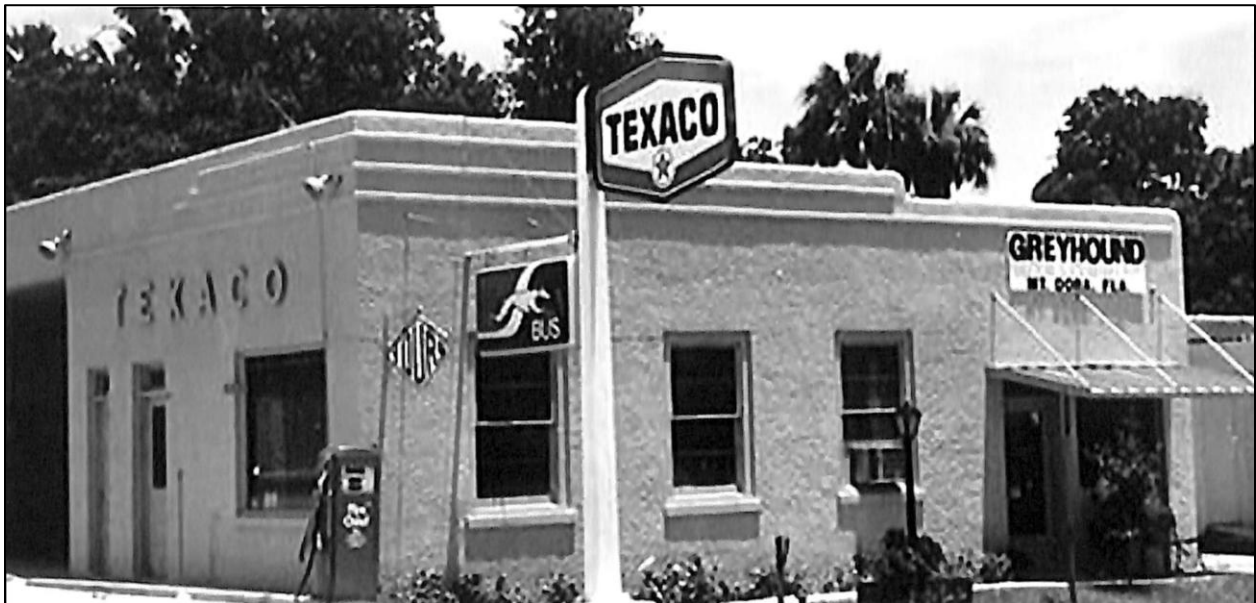
1946

The structure was originally constructed in 1940 but a two-story addition was added later on. As such, the structure has been heavily modified since its original construction but still contributes to the Historic District.

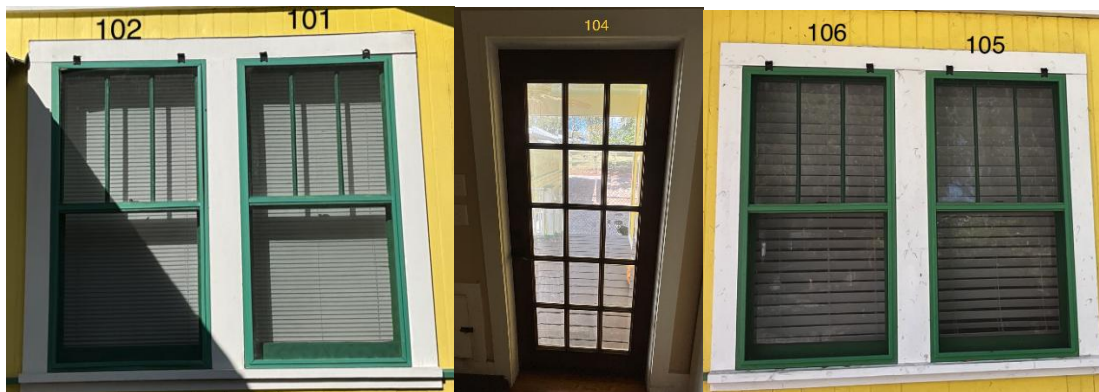
Remove five wood windows and one wood patio door and replace with FIBREX windows (a composite material, that consists of 40% wood fiber and 60% polymer) in the same size and style with the same grid pattern. Existing windows are painted green and the proposed windows will be white.

Existing Windows and Door. Grid Pattern to be Replicated on the New Windows and Door.

Therefore, based on these Findings of Fact, staff recommends **Approval** of the application, if the windows are unable to be repaired, with the condition that the grid patterns match the existing windows.

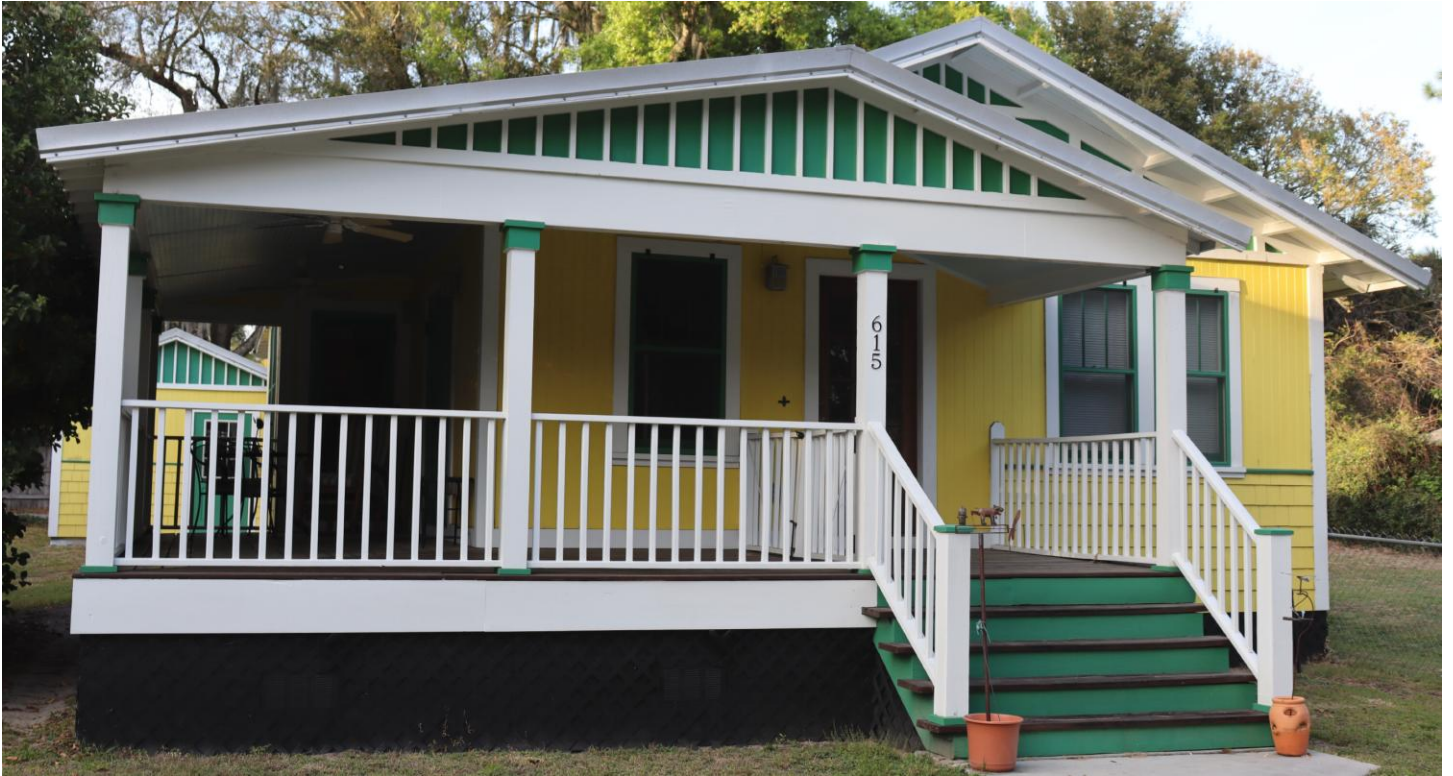
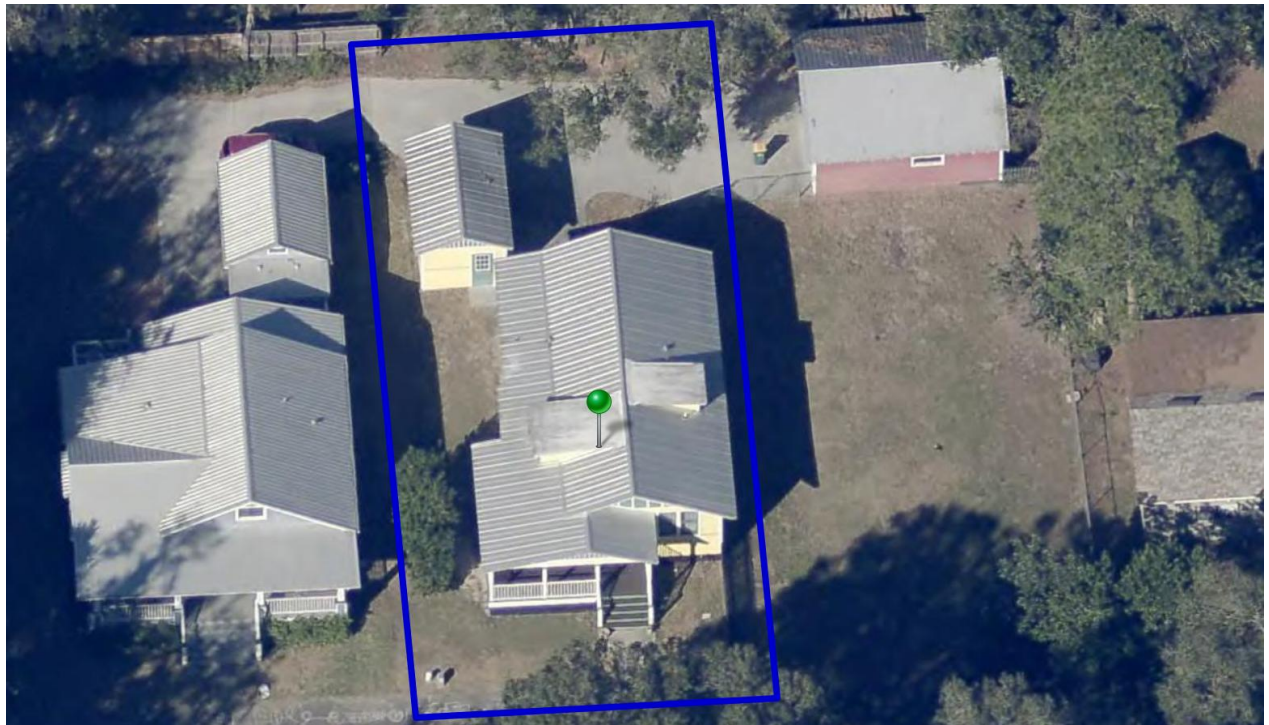
Site Photos

- Original
- Update

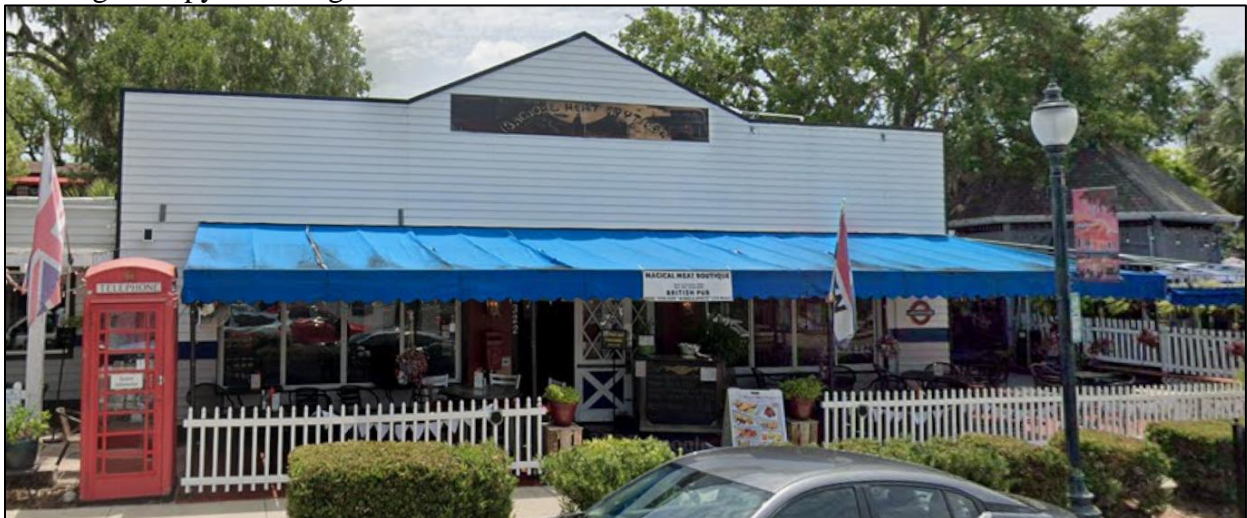
Existing Canopy / Awning Constructed of Metal and Canvas

Remove the metal canopy with canvas cover and replace with a canopy constructed of pressure treated wood and metal roof panels.

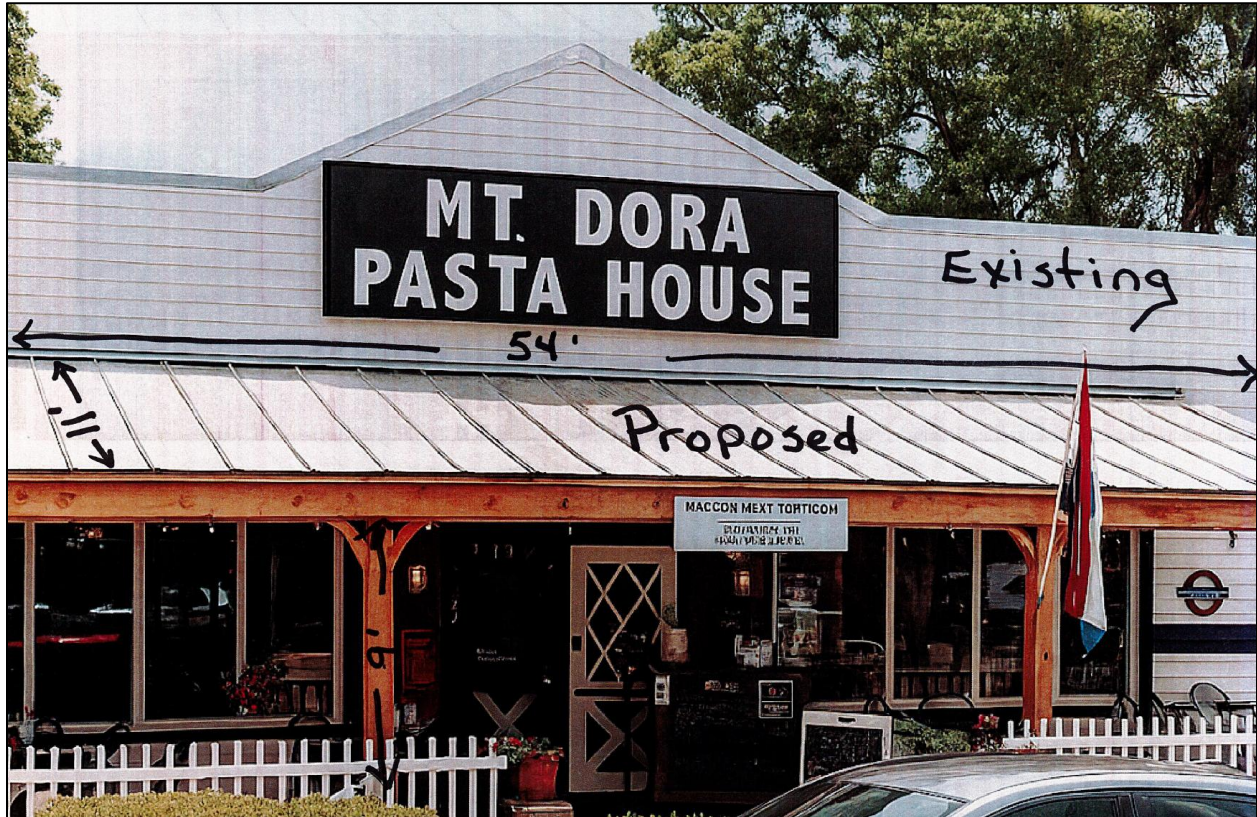
Proposed Canopy / Awning Constructed of Pressure Treated Wood and Metal Panels

1. The request is consistent with the Mount Dora Historic Design Guidelines which recommend to use historically appropriate awning shapes like simple shed awnings for rectangular openings which is consistent with the application; and
2. The request is consistent with the Mount Dora Historic Design Guidelines which do not recommend covering up any character defining features and the proposal awning/canopy does not cover any features on the building; and
3. The proposed work is compatible with the architectural style of the building; and
4. The request is promotes visual compatibility with the exterior architectural of adjacent, neighboring or visually related buildings, structures, sites and streetscapes as required by LDC Section 3.6.4 (2)(b).

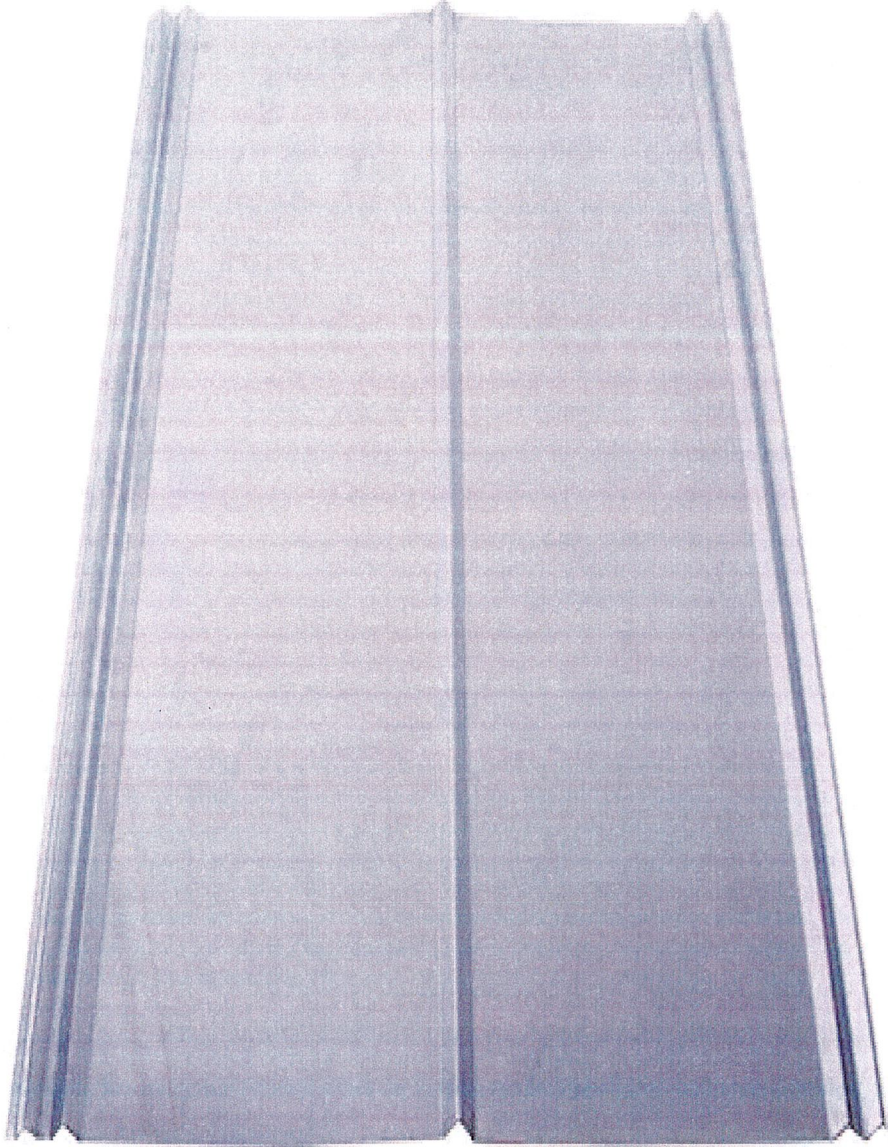
Materials:

2" x 4" pressure treated wood

12' x 2' 5V Crimp Galvanized Steel

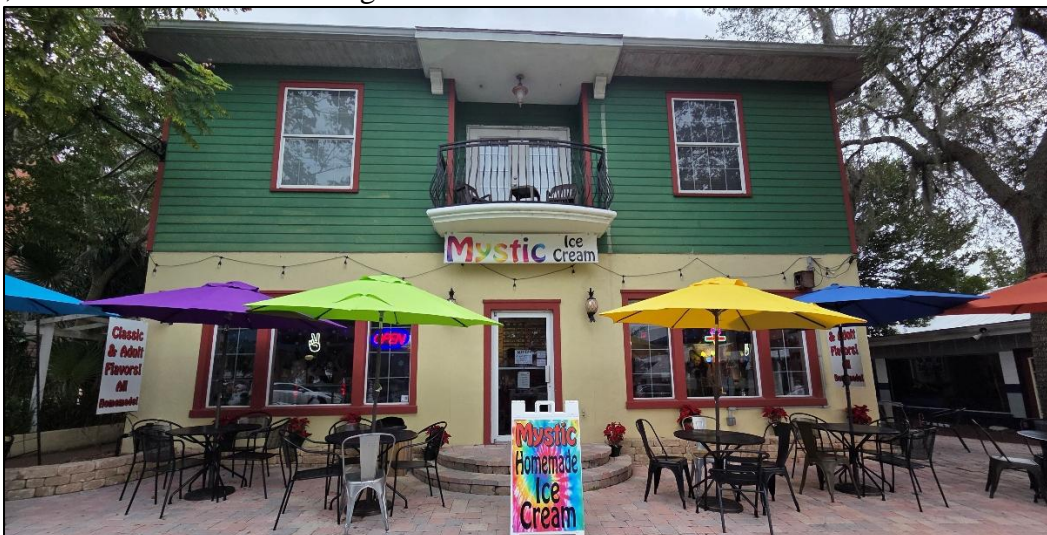
Current, Western Elevation Fronting on Alexander Street

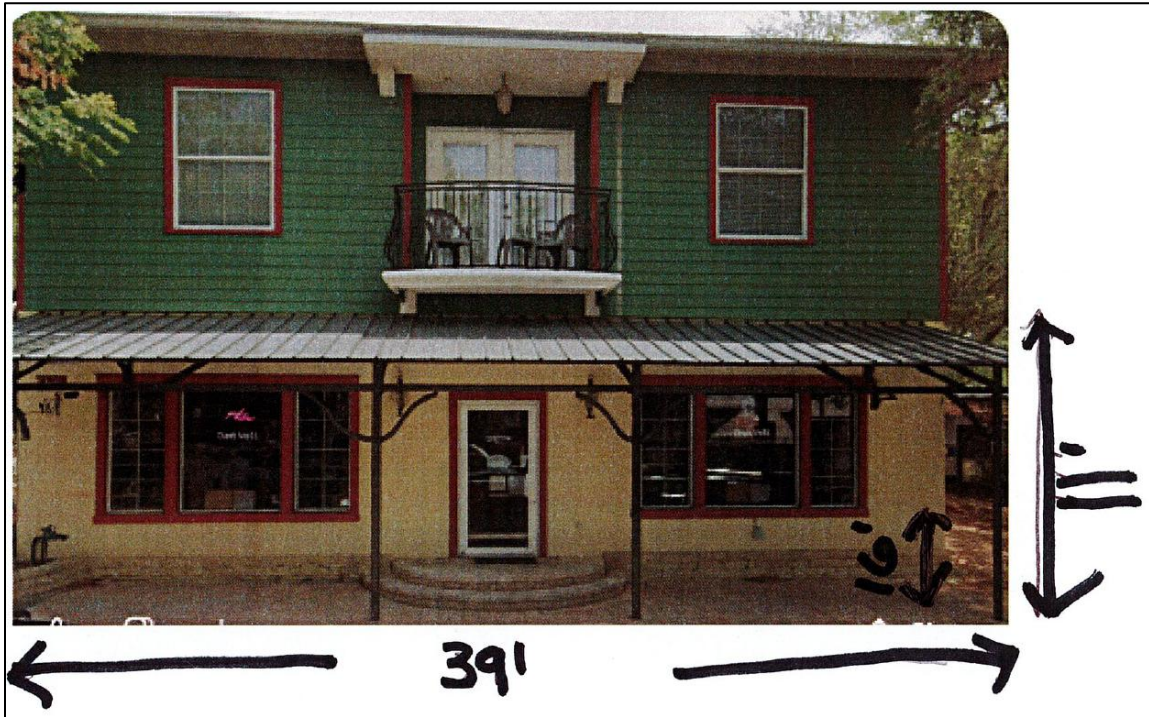
Proposed Awning

Construct an awning / canopy constructed of pressure treated wood and metal roof panels.

1. The request is consistent with the Mount Dora Historic Design Guidelines which recommend the new awnings should be designed and placed so that they do not span or detract from character-defining details and features of the building and the proposed awning will not conceal any character-defining features; and
2. The proposed work is compatible with the architectural style of the building; and
3. The request is promotes visual compatibility with the exterior architectural of adjacent, neighboring or visually related buildings, structures, sites and streetscapes as required by LDC Section 3.6.4 (2)(b).

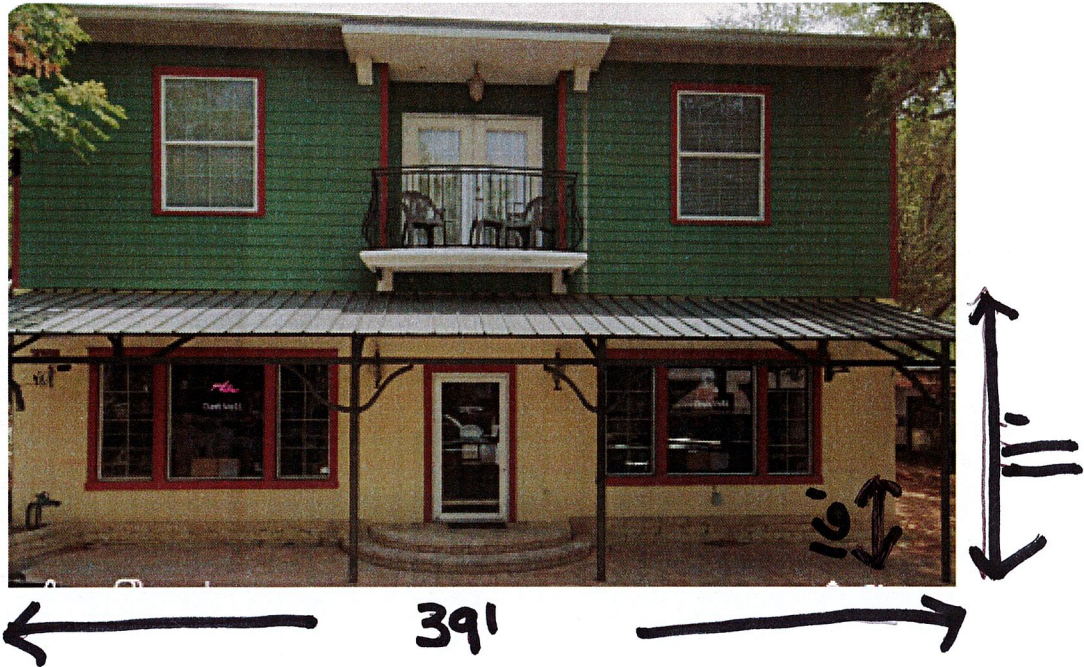
Proposed
with awning

39' across front

16' from front of building to sidewalk

11' tall

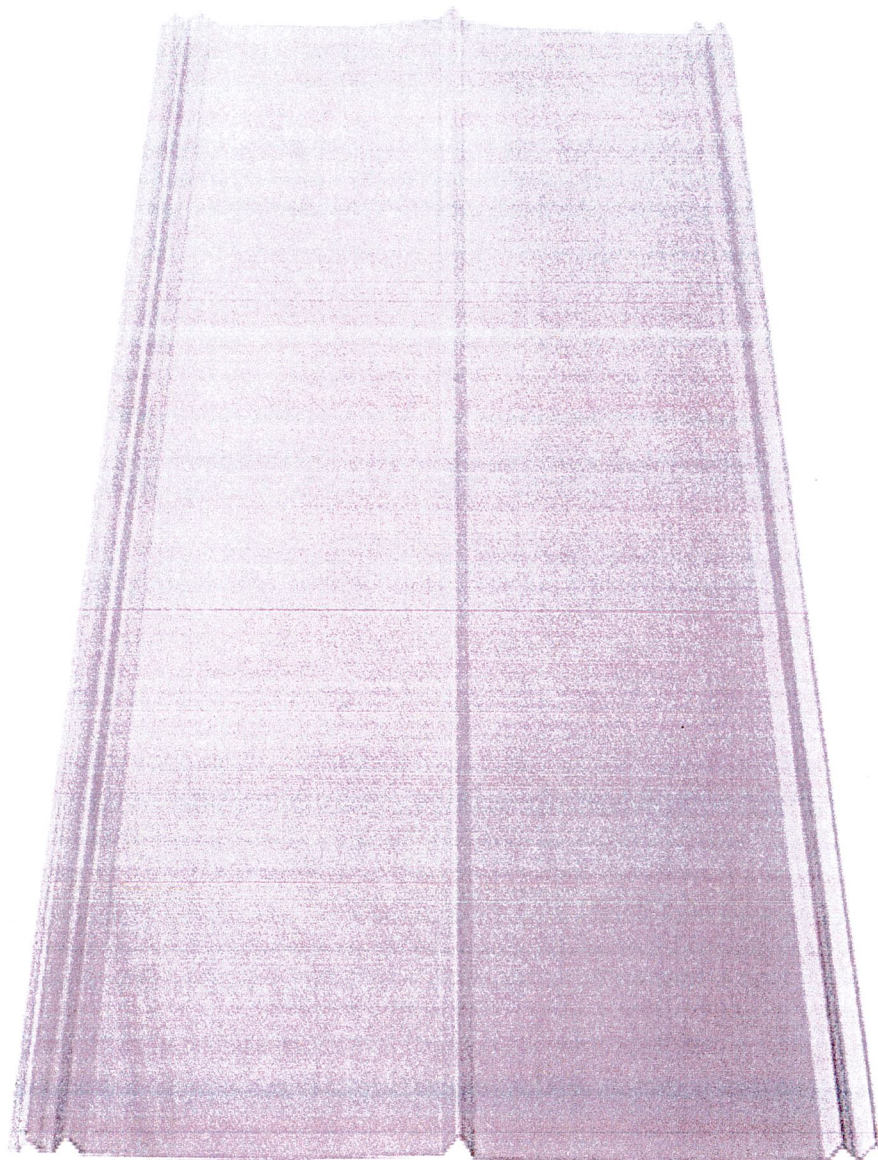
Materials:

2" x 4" pressure treated wood

12' x 2' 5V Crimp Galvanized Steel
