HISTORIC PRESERVATION BOARD

City Hall – 1st Floor Board Room, 510 N. Baker Street, Mount Dora, FL
January 28, 2026 at 3:00 PM

AGENDA

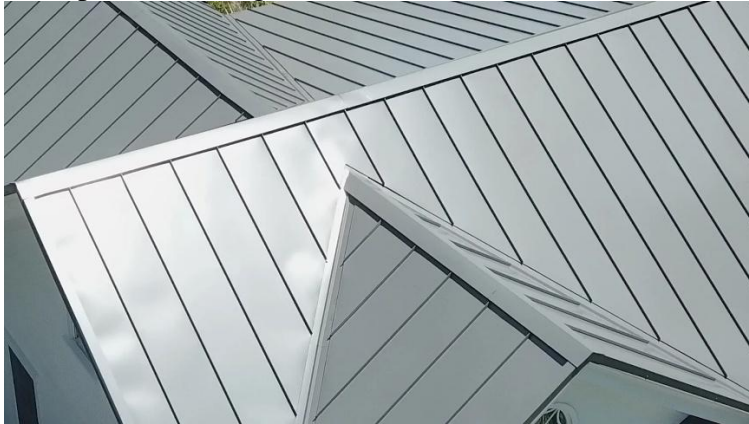
Example of standing seam metal roof:

Remove the existing asphalt shingle roof and replace it with Standing seam metal mill finish roof.

Therefore, based on these Findings of Fact, staff recommends **Approval** of the application, with the condition that the metal roof is an earthy or muted color and not silver.

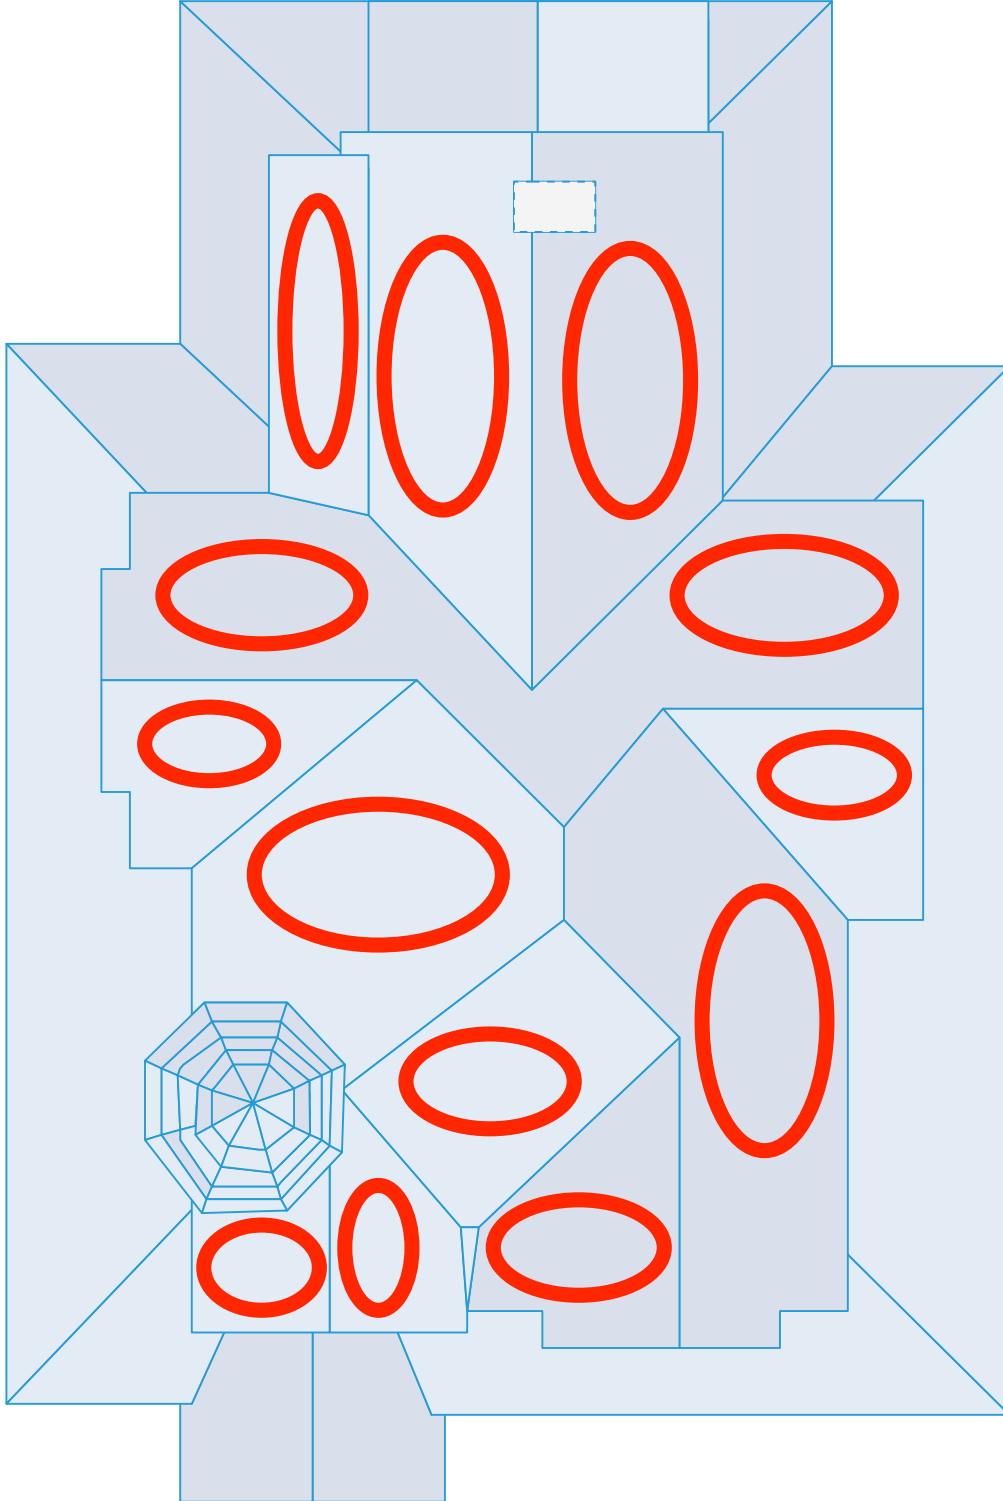
Length measurement report

- Eaves: 397ft 4in
- Valleys: 137ft 0in
- Hips: 244ft 5in
- Ridges: 97ft 3in
- Rakes: 175ft 5in
- Wall flashing: 169ft 7in
- Step flashing: 125ft 0in
- Transitions: 75ft 3in
- Parapet wall: 0ft 0in
- Unspecified: 30ft 8in

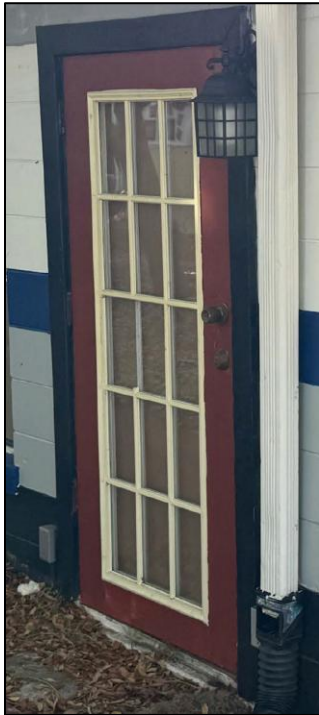
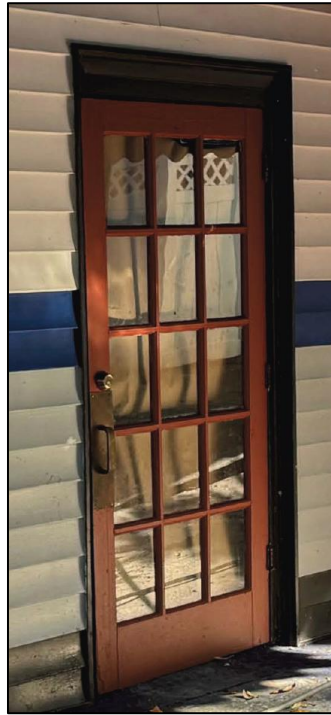
Remove two, exterior wood doors and replace with composite doors. The Applicant indicated that the proposed doors will look exactly the same as the existing doors.
