**HISTORIC PRESERVATION BOARD**  
**Mount Dora City Hall Board Room**  
**510 North Baker Street, Mount Dora, Florida**  
**March 25, 2026 at 3:00 PM**

**AGENDA**

**RE:** **Tab 1 - Certificate of Appropriateness; 610 N Tremain Street (Location); Door Replacement (Proposed Work); John Cataldo and Arthur Natale (Owners and Applicant).**

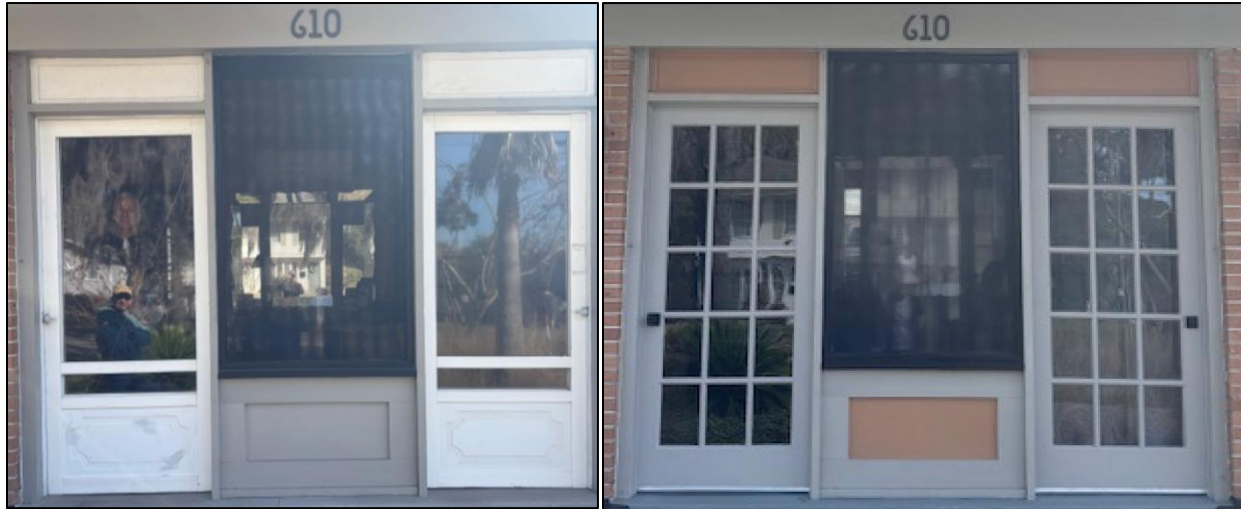
The Applicant is seeking to remove two, plastic screen doors and replace them with wooden doors with 3/5 windows. Below are the existing (left) and proposed (right) doors.

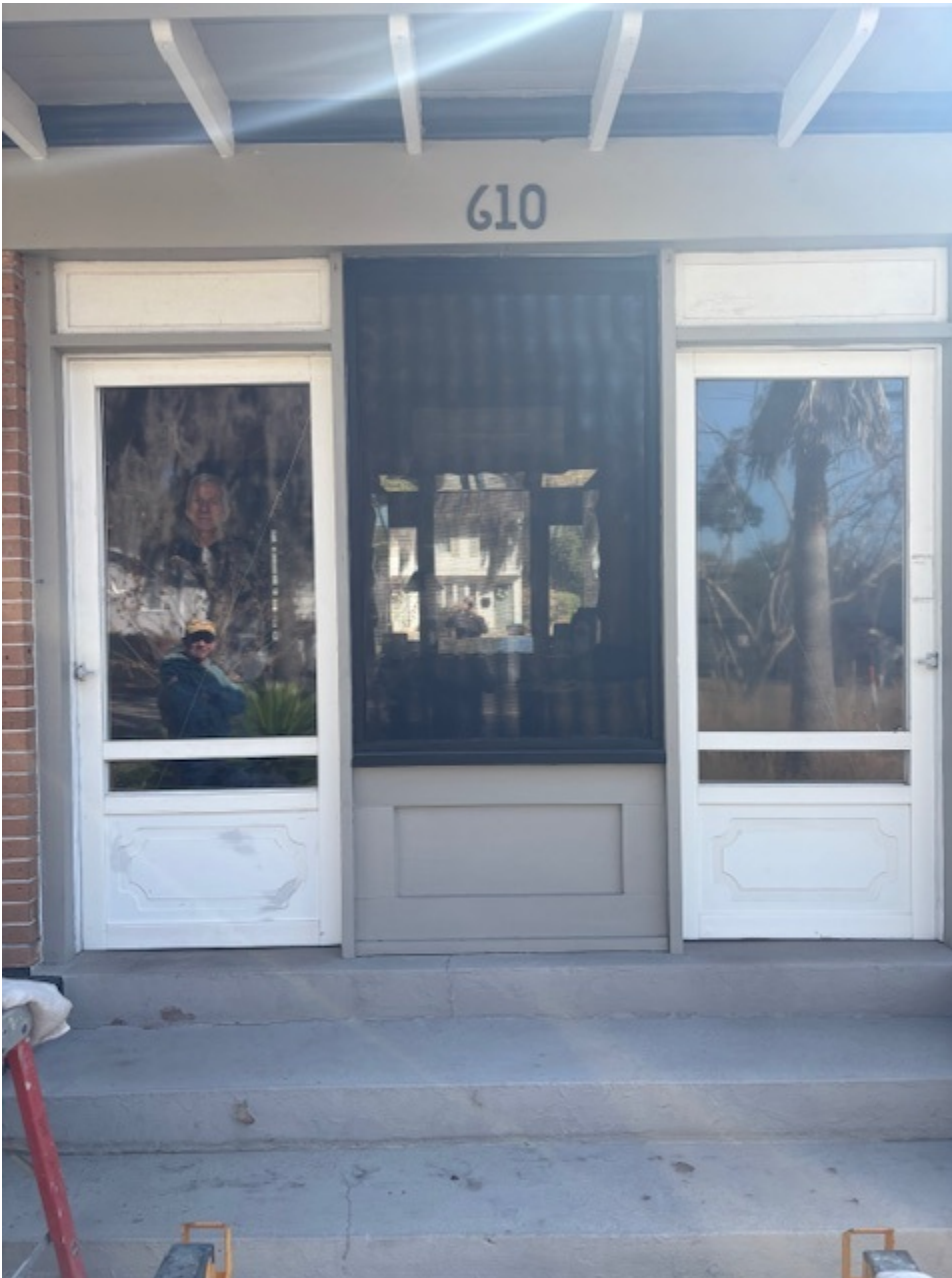
First: Old Doors

Hi Michelle, as discussed here are the photos of our front doors for the Historic Board review.

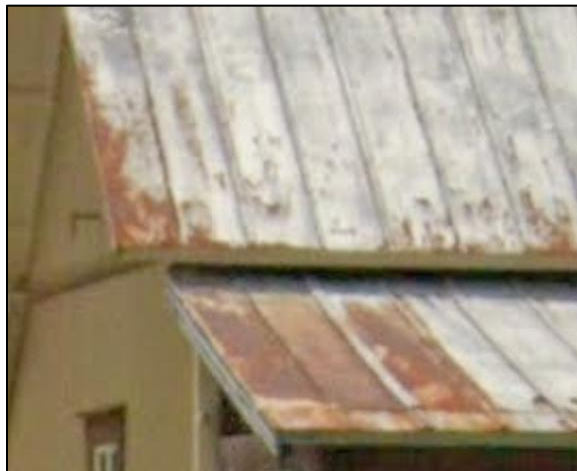
5V Metal Roofing panels have a classic look similar to one of the oldest profiles on the market.

- Applications: Residential, Agricultural
- Gauge: 26 gauge 24 gauge, or 0.32 Aluminum
- Panel Profile: 24" Net Coverage
- Substrate: Steel or Aluminum
- Finish: Acrylic coated Galvalume® AZ55, Silver Metallic (0.32 Aluminum), or Regal White. Check with sales representative for other color availability
- Warranty: 50-year limited paint warranty Core or Max, 25-year limited paint warranty Coastal, or 45 years limited Mill Finish warranty
